**SOUTHERN REGION GEOHAZARD ASSESSMENT
ANNUAL ASSESSMENT REPORT
2007**

CG25263

**Re: Southern Region Geohazard Assessment
Annual Assessment Report, 2007**

4.26 S29 – HIGHWAY 1 – SEVEN PERSONS CREEK

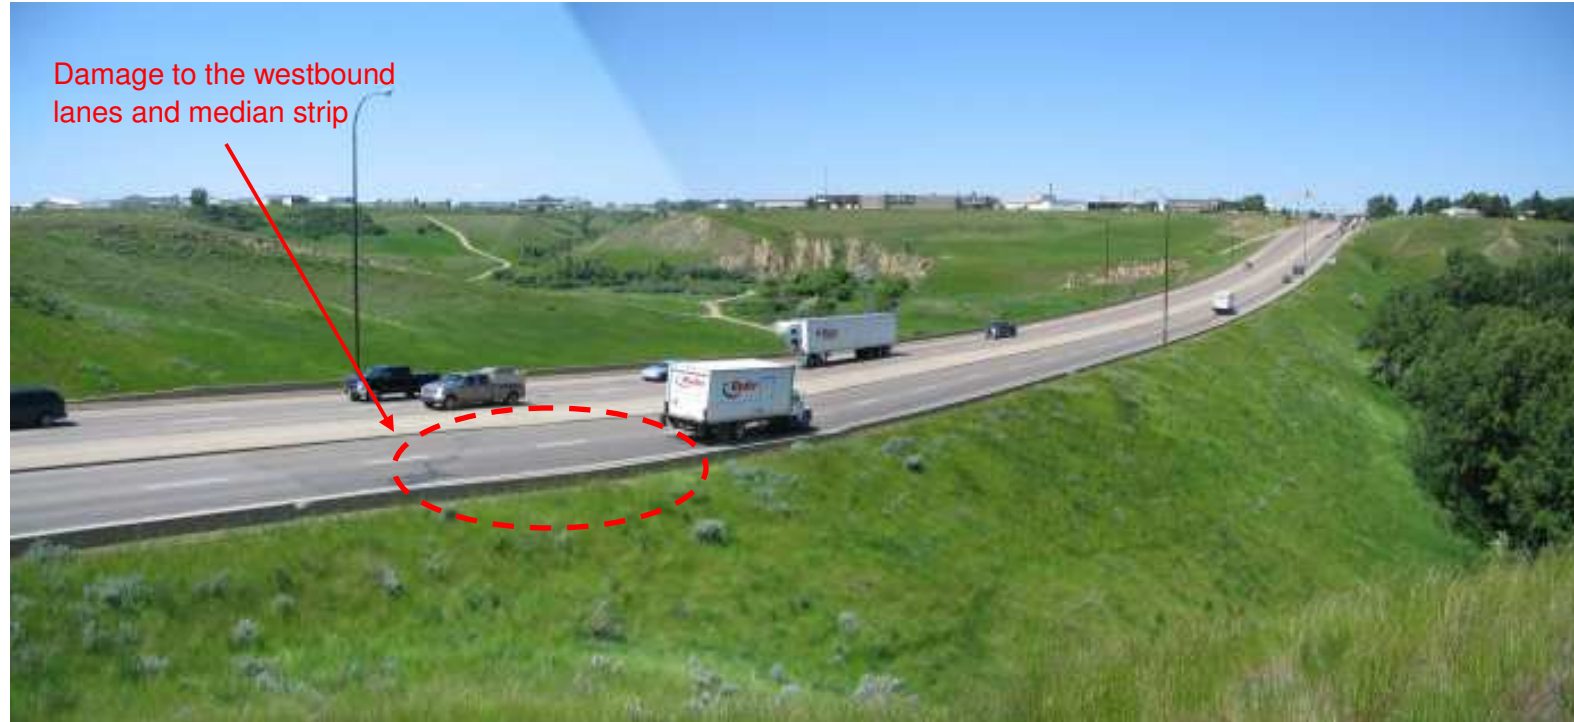
The highway is oriented southeast/northwest at this site and is divided with two lanes in both directions. The highway crosses the Seven Persons Creek valley via a large embankment over a culvert. The embankment sideslopes are at roughly 2H:1V inclination. The valley depth is in the order of 30 m. There are through-cuts at the upper portion of each valley slope. The creek channel is relatively small and underfit within the flat-bottomed valley floor. Photo S29-1 shows an overview of the site and the creek valley.

Photo S29-1– June 2007 (top)
Facing northwest across the site and the Seven Persons Creek valley. The location with the cracking and settlement of the westbound lanes and cracking of the concrete median strip is marked.

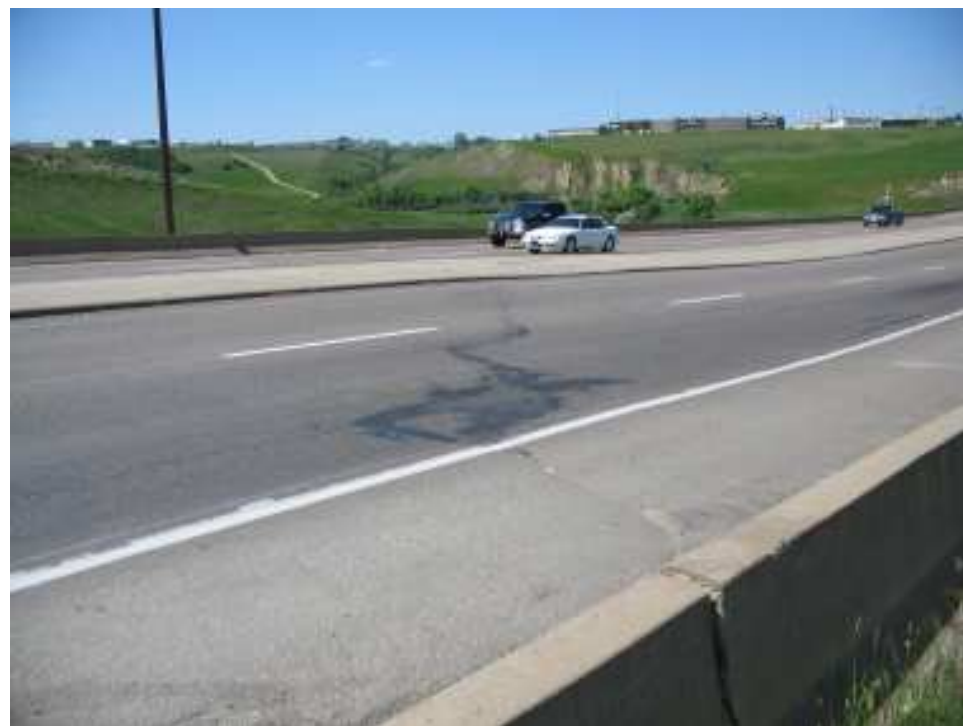
- A diagonal crack was visible across the westbound lanes (Photos S29-2 and S29-3). The road surface had also settled around the crack with a noticeable dip in the road grade as vehicles drove over it. The crack was located just downslope (westbound) from the cut/fill transition along the highway. The fill thickness below the crack was estimated to be approximately 3 to 5 m.
- There was cracking in the concrete median strip that appeared to be an extension of the crack in the westbound lane. See Photos S29-4 and S29-5.
- There did not appear to be any corresponding damage to the eastbound lanes. There was a single crack perpendicular to the eastbound lanes (Photo S29-6), however it did not appear to be of the same nature as the westbound lane cracking. There was possibly very slight dip in the road grade in the eastbound lane.

The cracking and settlement of the road surface in the westbound lanes and the cracking in the concrete median strip may be the result of settlement of the underlying road fill and possibly movement of the underlying creek valley slope. However, the magnitude of the damage is relatively minor and a definitive geohazard at this site cannot be confirmed on the basis of the available information.

Photo S29-2– June 2007 (bottom)
Closer view of the cracking in the westbound lanes.

AMEC recommends that a follow-up annual inspection be performed in 2008 in order to check if the cracking and settlement has worsened since the June 2007 inspection. If it has not, then the annual inspections for this site can likely be discontinued.

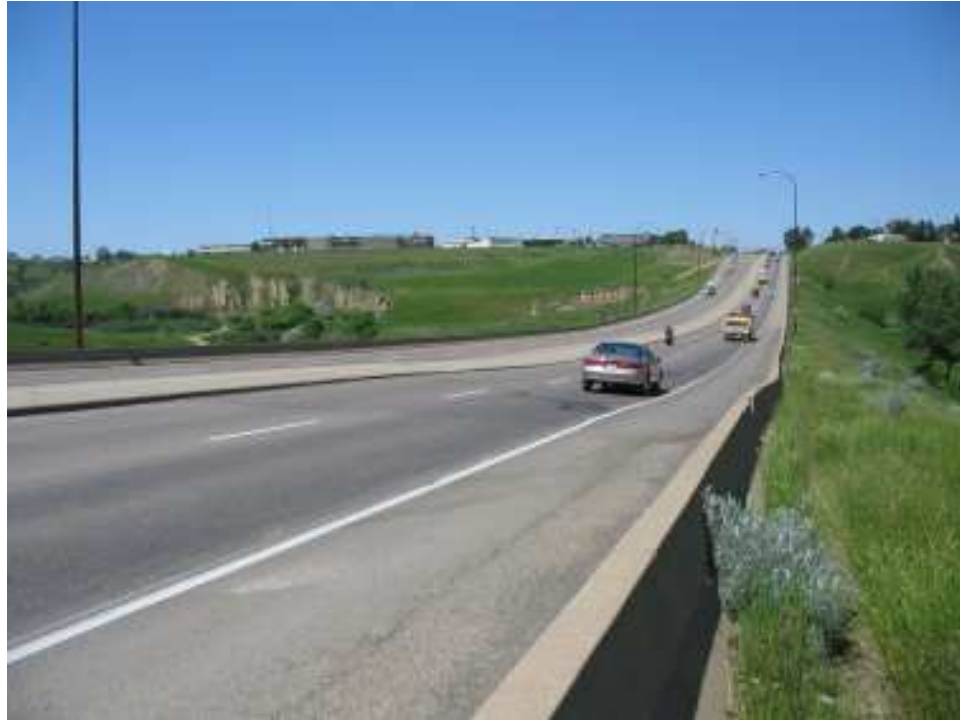
Photo S29-3– June 2007 (upper left)
Facing northwest along the highway and across the cracking and settlement area in the westbound lanes.

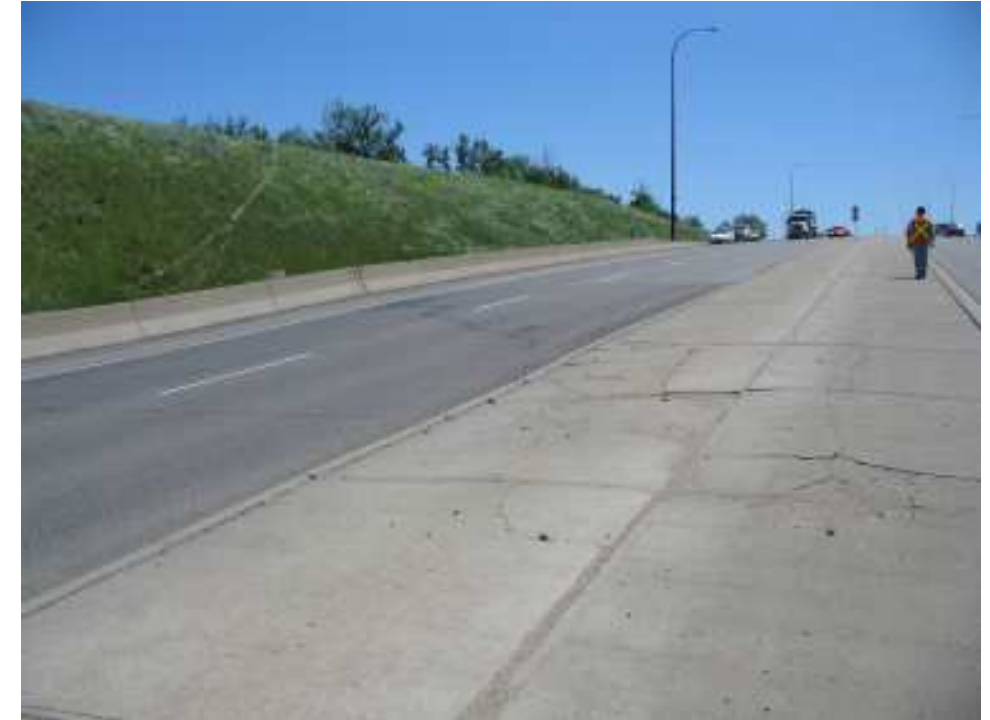
Photo S29-4– June 2007 (upper right)
Facing southeast/uphill along the concrete median strip. The cracking in the concrete appears to follow the alignment of the cracking in the westbound lanes.

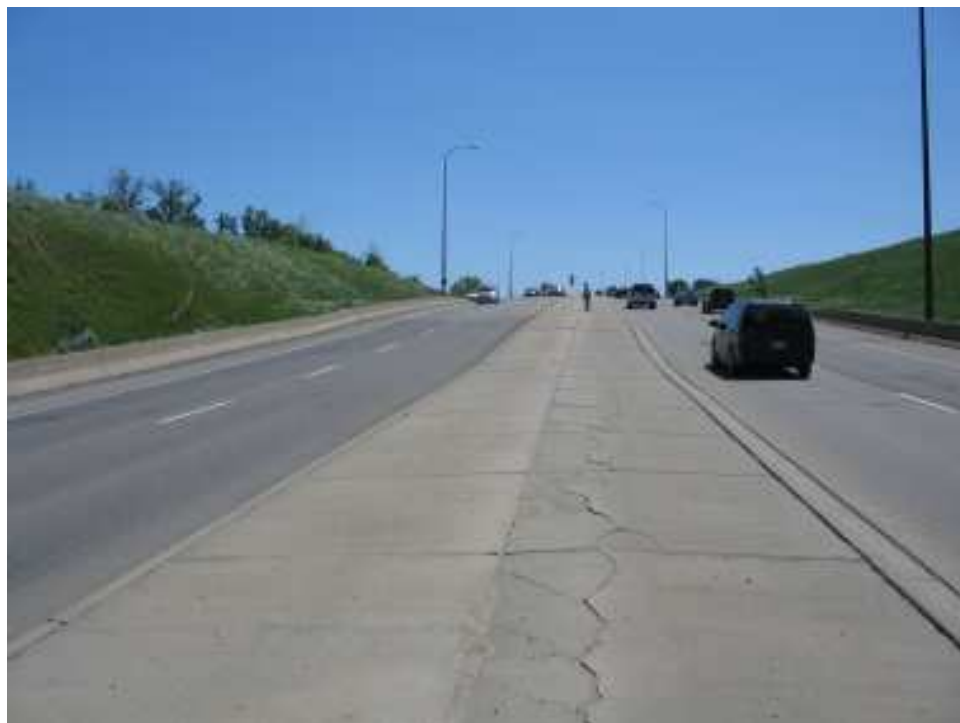
Photo S29-5– June 2007 (lower left)
Another view of the cracking in the concrete median strip.

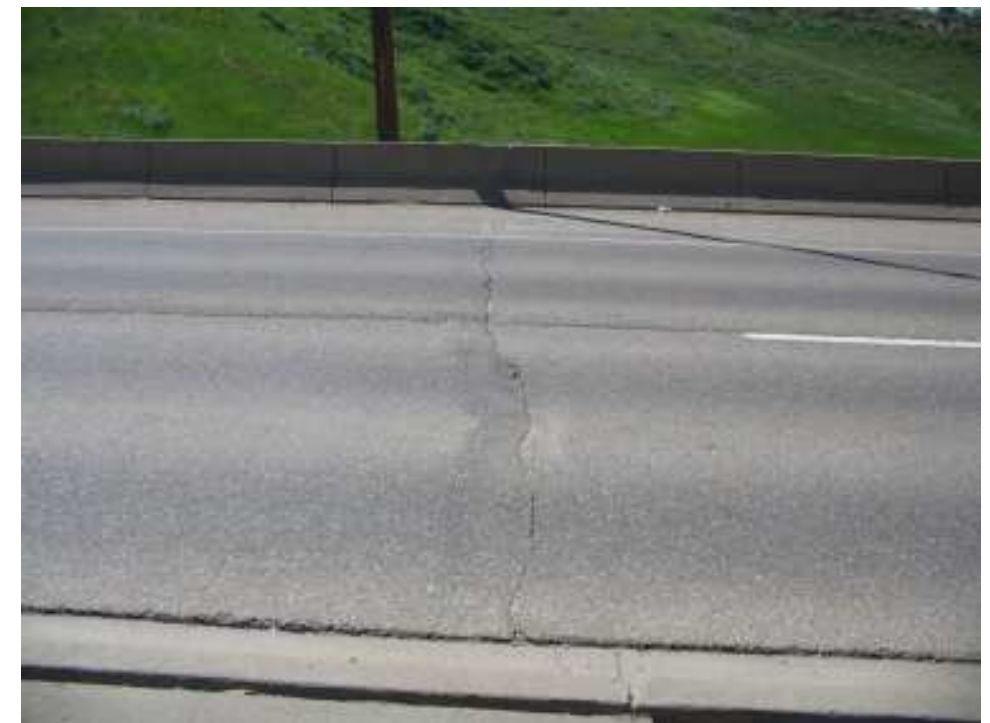
Photo S29-6– June 2007 (lower right)
An old crack perpendicular to the eastbound lanes and in the same general area as the more well-defined cracking in the westbound lanes.
