SITE NUMBER AND NAME: <b>S047 Coleman Bin Wall</b>		HIGHWAY & KM: 3:02, 13.283	PREVIOUS INSPECTION DATE: June 2016	INSPECTION DATE: <b>June 1, 2017</b>
LEGAL DESCRIPTION: 09-07-008-04 W5M 12-08-008-04 W5M	NAD 83 COORDINATES: UTM Northing Easting 11 5500995 679014		RISK ASSESMENT: PF: 8 CF: 8 TOTAL: 64	
AVERAGE ANNUAL DAILY TRAFFIC (AADT): On Hwy 3. 7,830 (west), 8,810 (east), (Ref No. 70060)			CONTRACTOR MAINTENANCE AREA (CMA): 26

PROJECT SOUTHERN REGION GEOHAZARD RISK MANAGEMENT PROGRAM		
TITLE Site Plan S047 - Coleman Bin Wall Hwy 3:02, km 13.283		
SCALE 1:1,000	PROJECT No. A05115A03	FIG No. 2

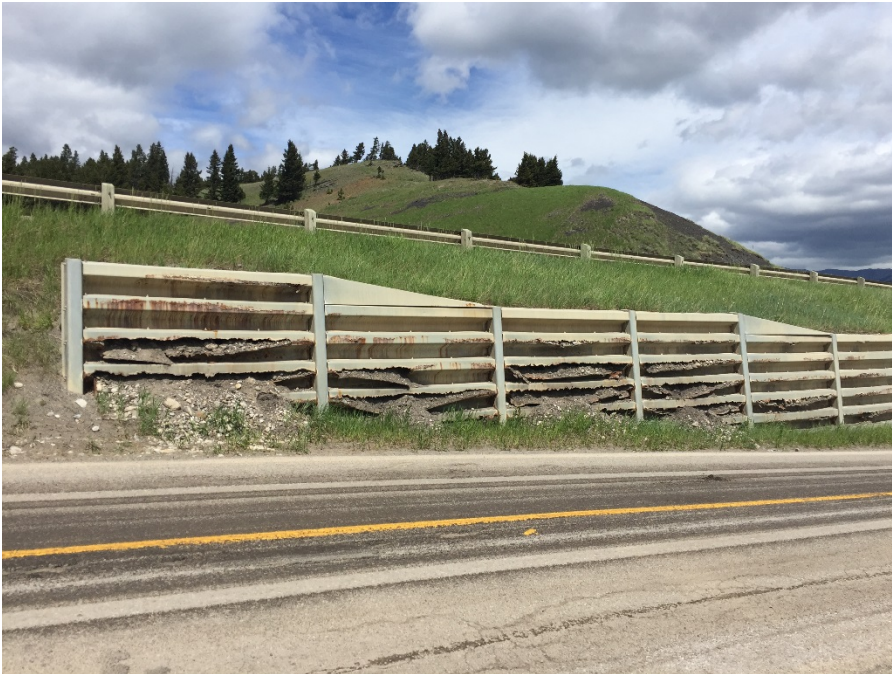
**Photo 1** West extent of bin wall. Severe corrosion with backfill spilling from voids. The photo was taken facing north on June 1, 2017.

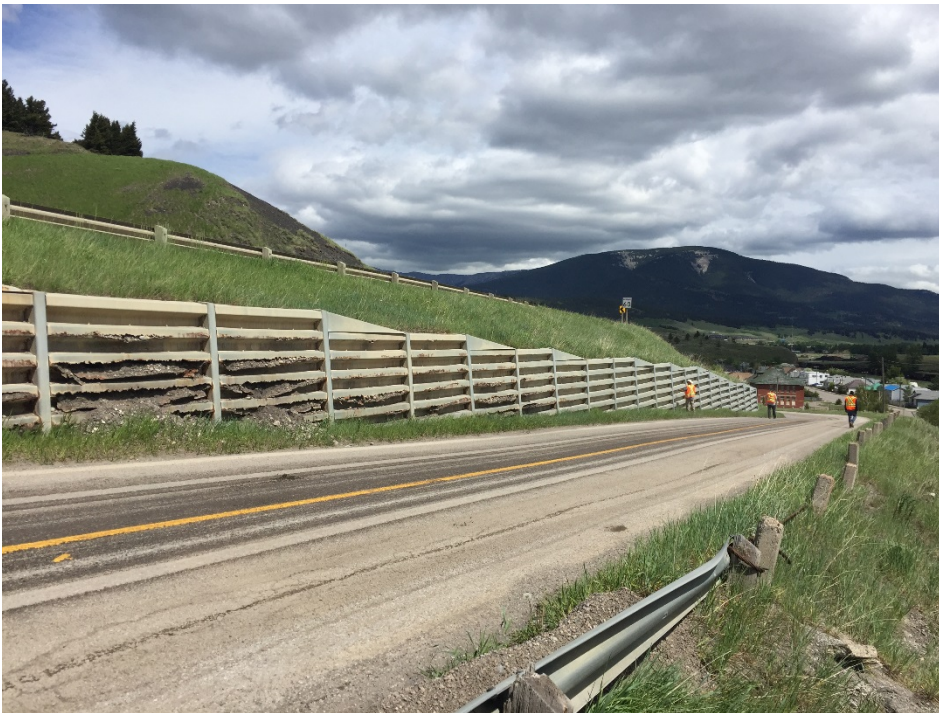
**Photo 2** East extent of bin wall. Moving from west to east, the corrosion severity decreases. The photo was taken facing northeast on June 1, 2017.

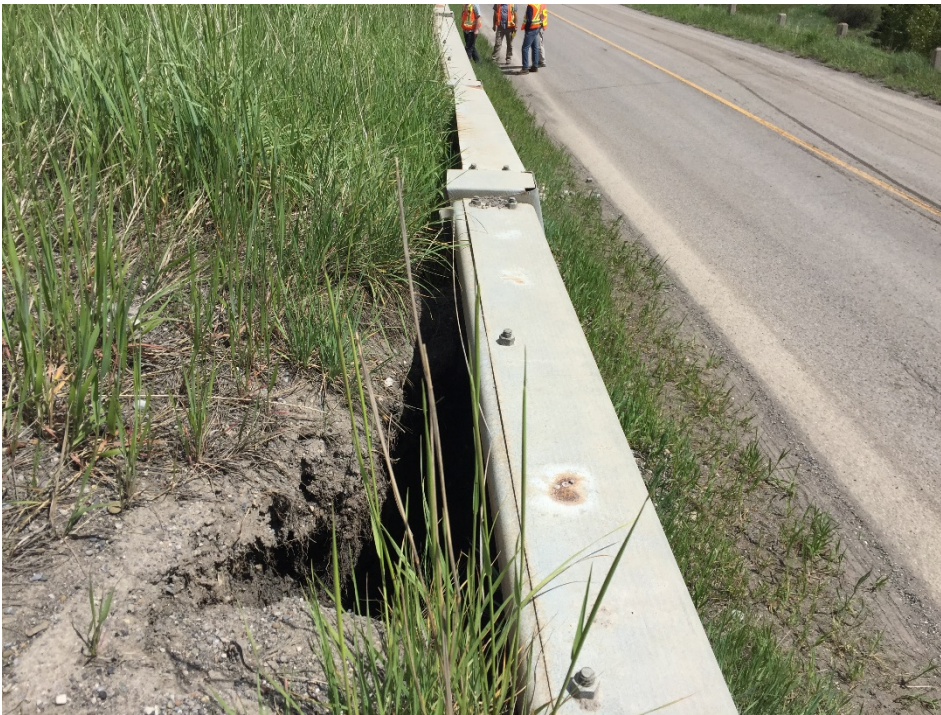
**Photo 4** Voids behind the wall have developed due to loss of material. The photo was taken on June 1, 2017.

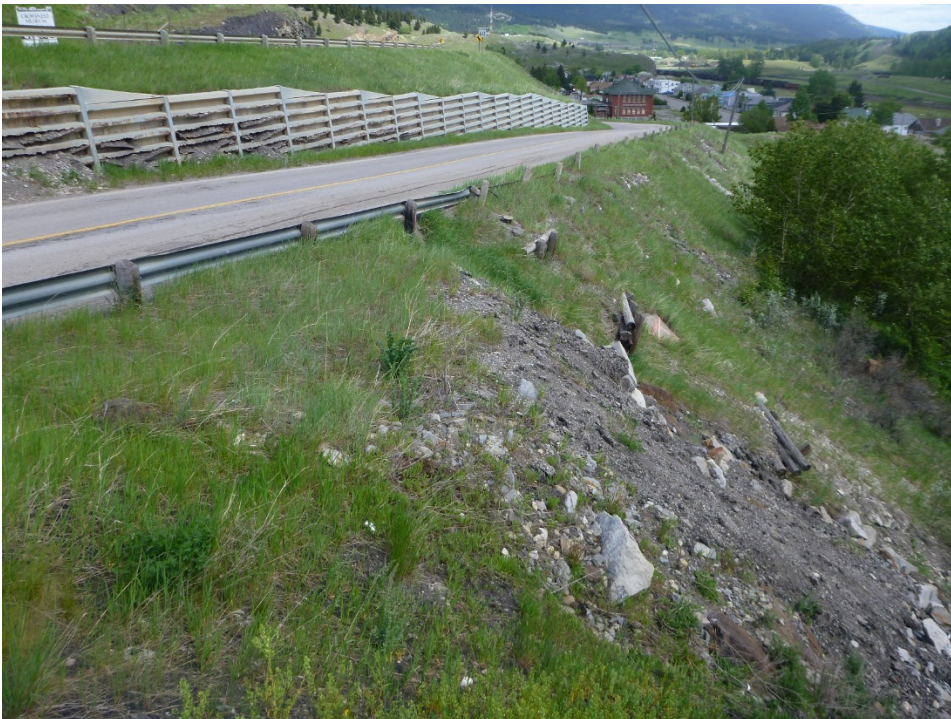
**Photo 5** Slope on the south side of the road. Stream outlet at the base of the slope. The photo was taken on June 1, 2017.
