SITE NUMBER AND NAME: S047 Coleman Bin Wall		HIGHWAY & KM: 3:02, 13.283	PREVIOUS INSPECTION DATE: June 1, 2017	INSPECTION DATE: May 2, 2018
LEGAL DESCRIPTION: 09-07-008-04 W5M 12-08-008-04 W5M	NAD 83 COORDINATES: UTM Northing Easting 11 5500995 679014		RISK ASSESMENT: PF: 1 CF: 6 TOTAL: 6	
AVERAGE ANNUAL DAILY TRAFFIC (AADT): On Hwy 3. 7,830 (west), 8,810 (east), (Ref No. 70060)			CONTRACTOR MAINTENANCE AREA (CMA): 26

PROJECT
SOUTHERN REGION GEOHAZARD RISK MANAGEMENT PROGRAM

TITLE
Site Plan
S047 - Coleman Bin Wall
Hwy 3:02, km 13.283

FIG No.
2

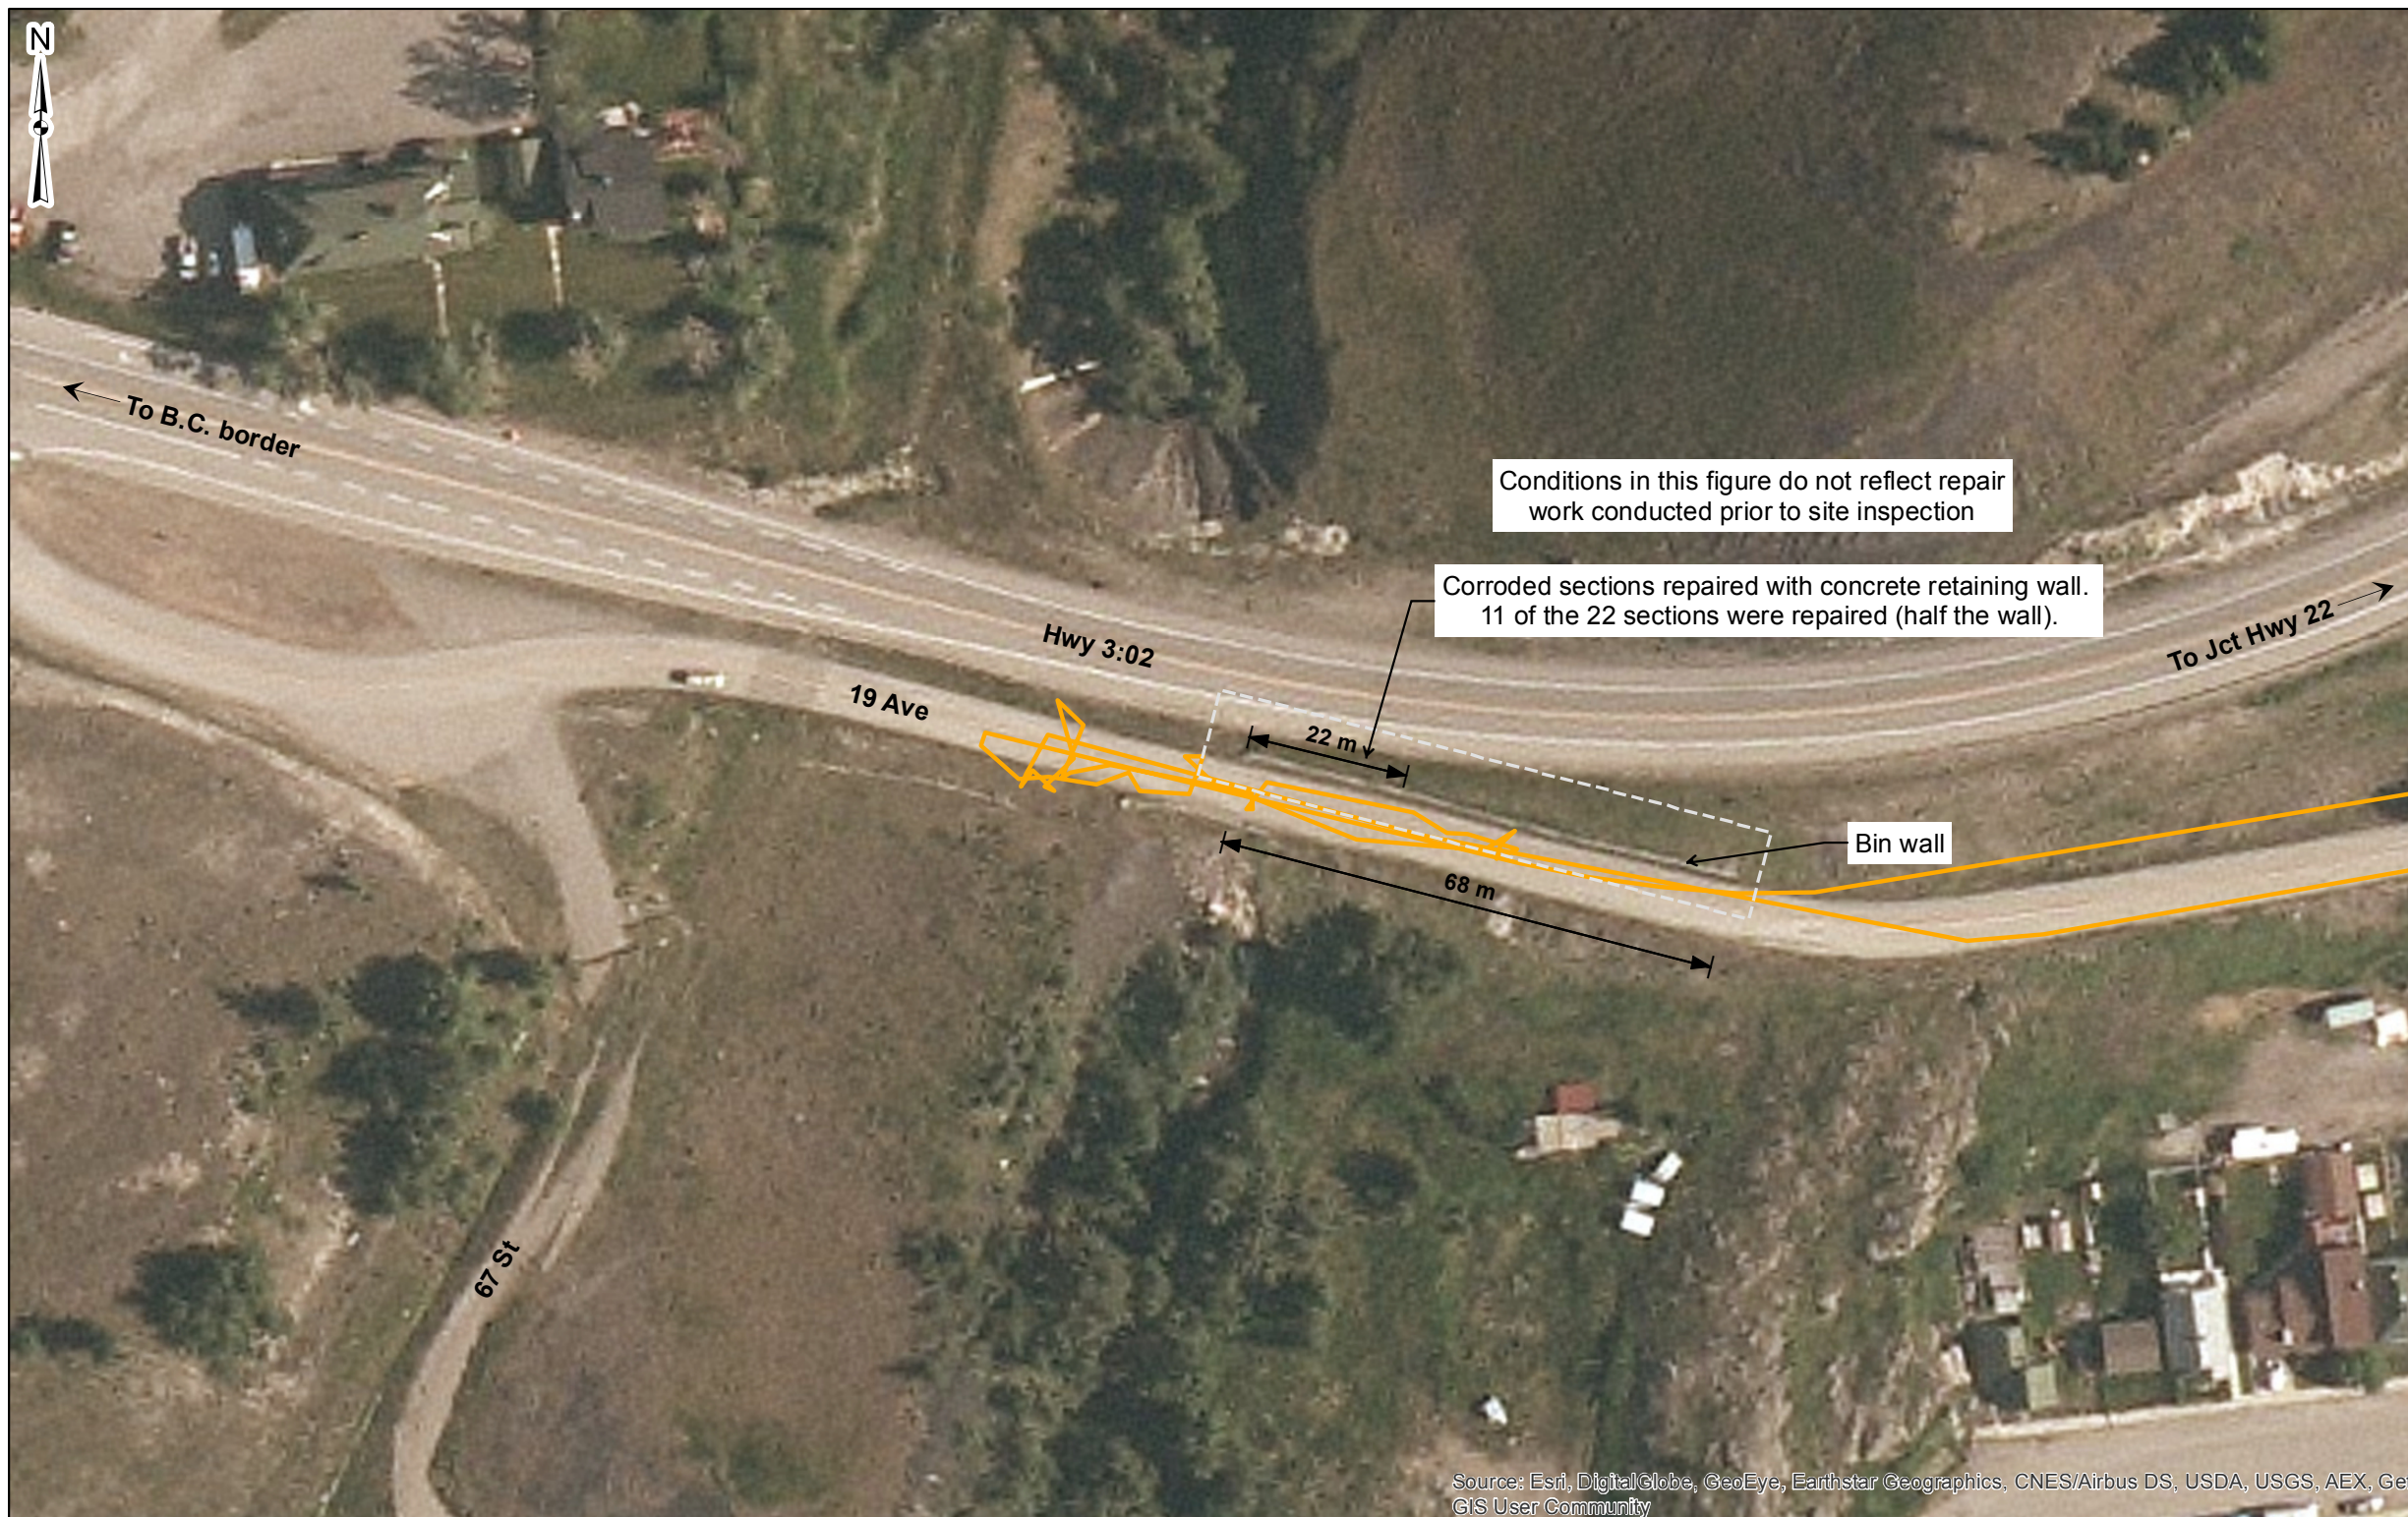
Conditions in this figure do not reflect repair work conducted prior to site inspection

Corroded sections repaired with concrete retaining wall. 11 of the 22 sections were repaired (half the wall).

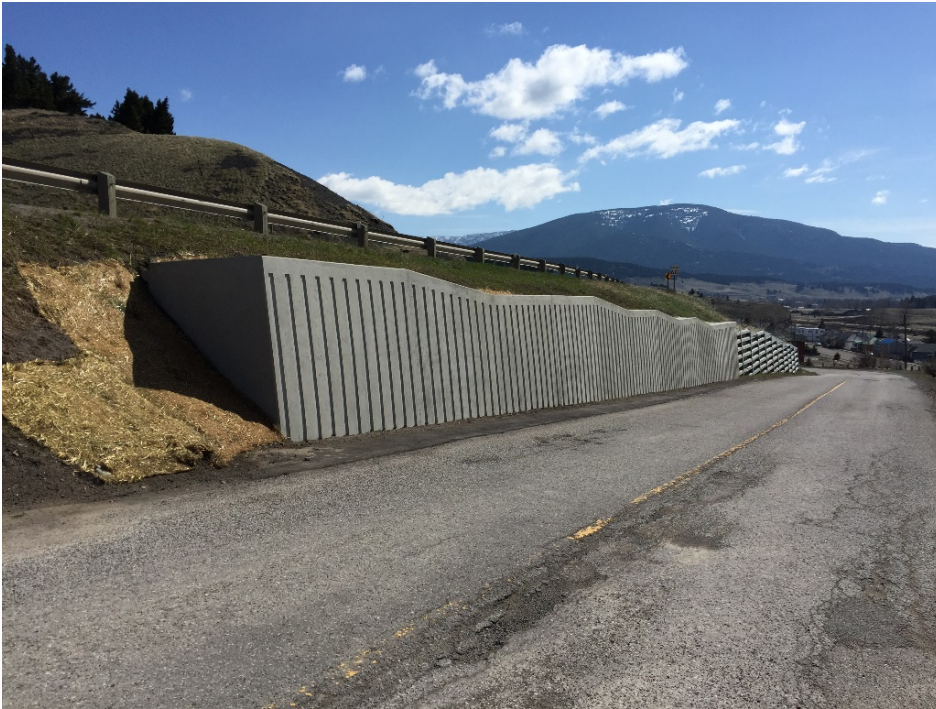
Photo 1 West extent of retaining wall. 11 corroded steel sections repaired with concrete retaining wall. The photo was taken facing east on May 2, 2018.

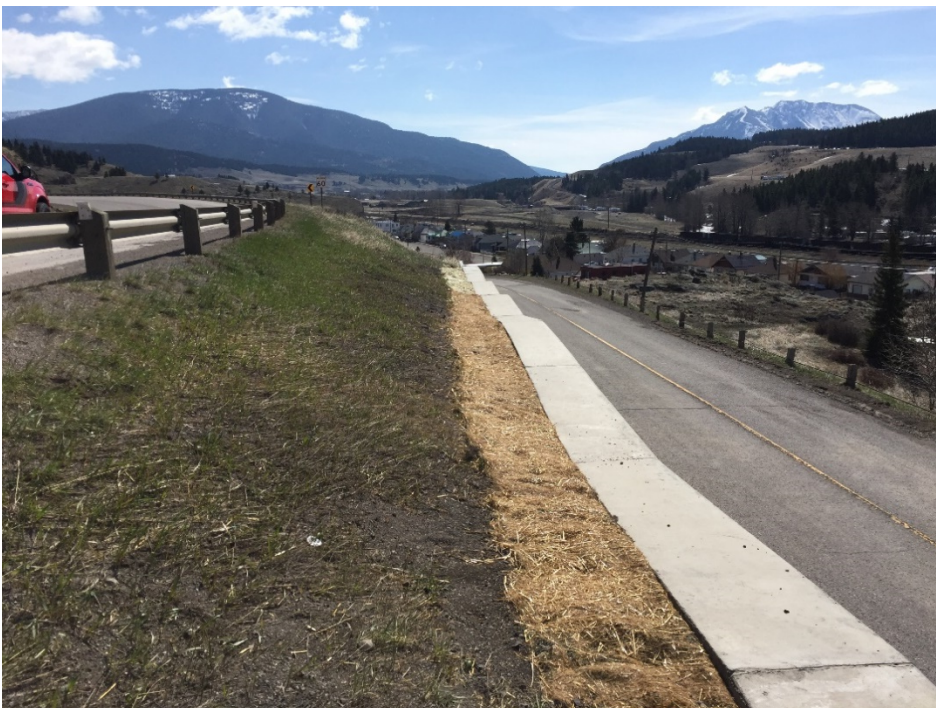
Photo 2 Voids behind the previous steel wall have been filled in. The photo was taken facing southeast on May 2, 2018.

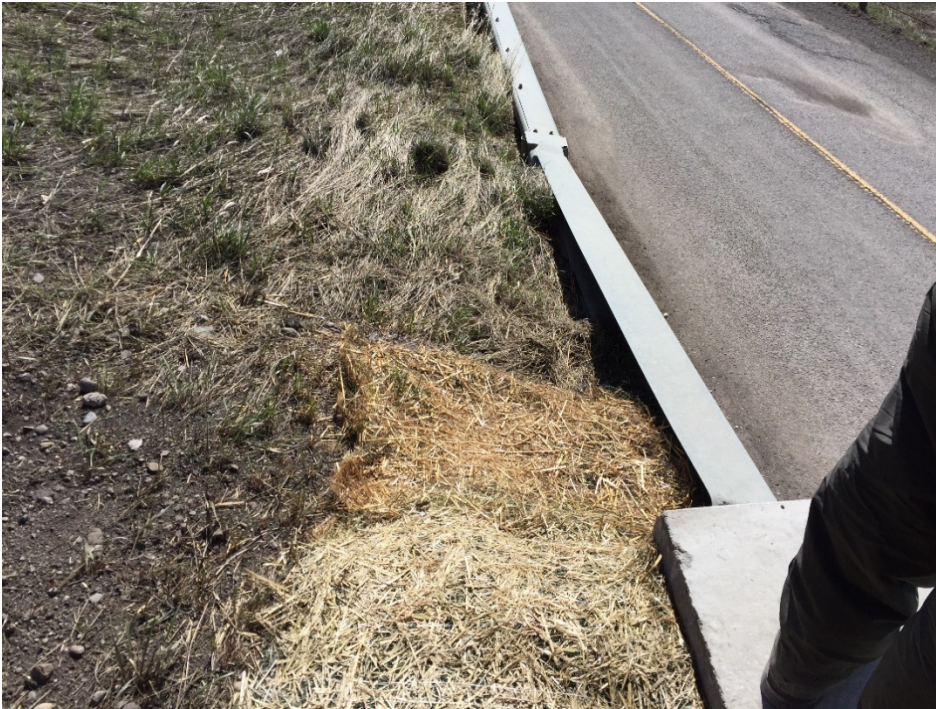
Small void behind the steel bin wall at the transition zone between the concrete and steel sections.

Photo 3 Transition area from new concrete retaining wall to existing steel bin wall. Small voids still remain.
