**SOUTHERN REGION GEOHAZARD ASSESSMENT  
ANNUAL ASSESSMENT REPORT  
2007**

November 2007

#### **4.24 S27 – HIGHWAY 3 – WINDMILL**

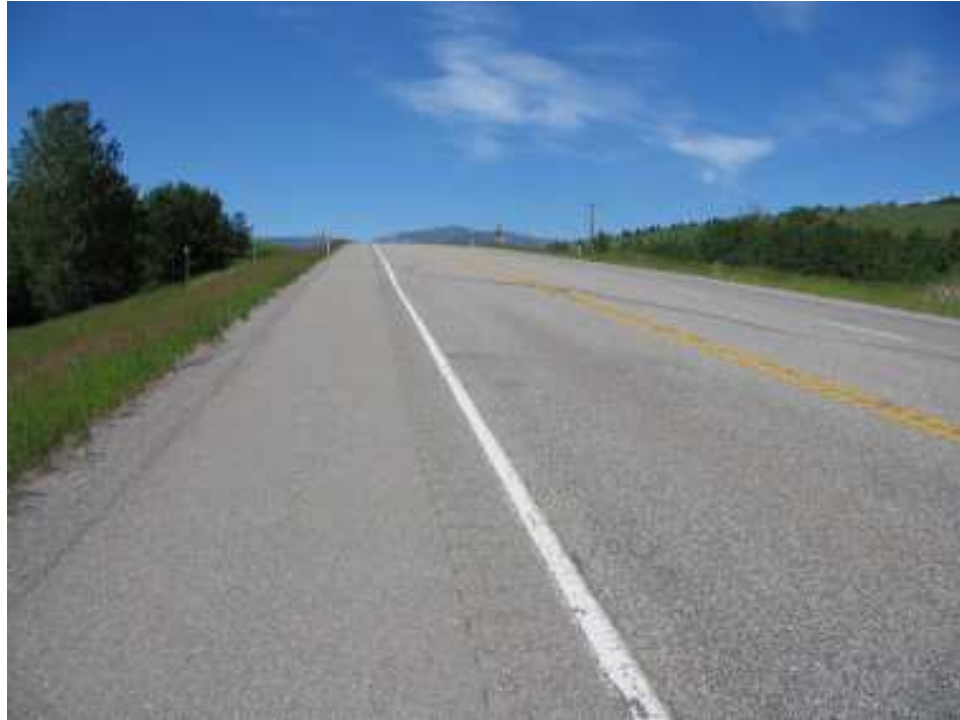
- A diagonal crack was noted across the entire road along an approximately 65 m segment of the highway. There was a slight bump felt when driving across the crack, with the portion of the road to the east of the crack very subtly downdropped relative to the west side. Photos S27-1 to S27-3 in Appendix S27 show views of the highway and cracking.
- The crack had previously been sealed, but was open at the time of the site inspection with a maximum aperture in the order of 25 to 50 mm.
- This site is located near the Crowsnest River channel and there is a gravel pit located in the area to the north of the site. This suggests that the native soils underlying the site are gravelly and cobbly. The embankment fill slope on the south side of the highway

The orientation of the diagonal crack in the road surface suggests that the road embankment is being damaged by landslide movement down towards the south/southeast. However, the magnitude of dropdown of the portion of the road east of the crack was very minor to negligible at the time of the inspection and there was no other visual evidence of landslide movement in the area.

**Photo S27-1– June 2007** (upper left)  
Facing west along the highway with the diagonal crack visible across the entire road width.

As discussed on site, it is recommended that this site be included on the list of annual site inspections in 2008 in order to take another look at the site conditions and estimate if the crack is becoming worse over time and if further work is warranted at this site.

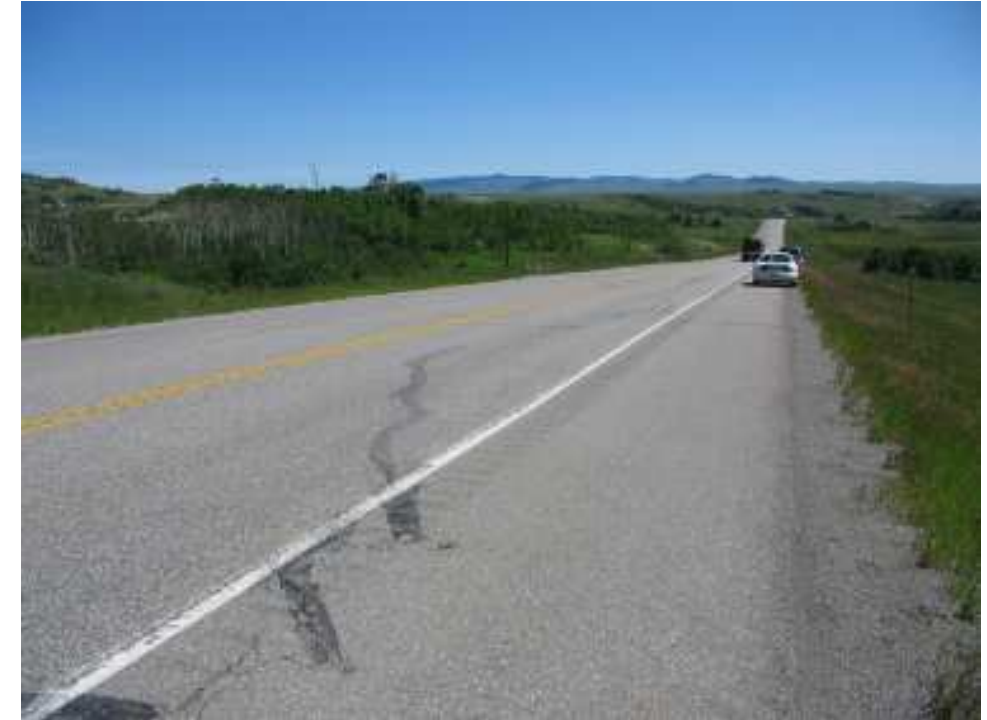
**Photo S27-2– June 2007** (upper right)  
Facing east across the very west end of the cracking area.

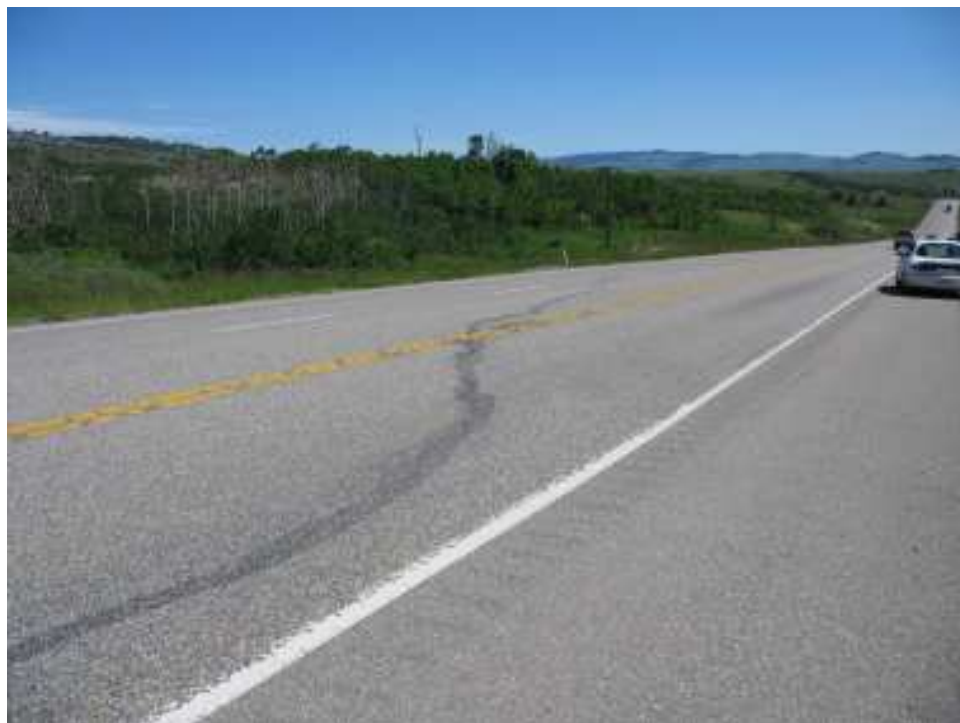
Based on the visual observations from the site inspection, it appears that there may be slow, ongoing slope movement as described above. However, the damage to the road surface to date has been relatively minor. It is also possible that the damage to the road surface is due to differential settlement of the embankment fill, however the age of the highway and the pattern of cracking is not entirely consistent with such a scenario.

**Photo S27-3– June 2007** (lower left)  
Closer view, facing east, of the east end of the cracking area. At the time of the June 2007 site inspection the portion of the highway to the east of the crack was subtly downdropped relative to the west.

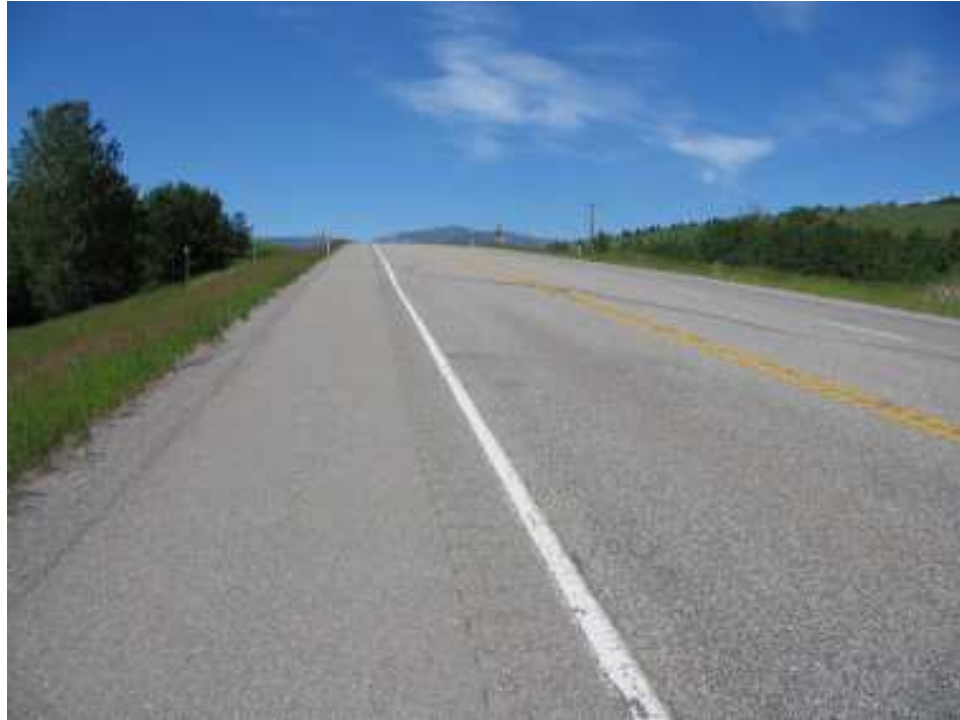
**Photo S27-1– June 2007** (upper left)  
Facing west along the highway with the diagonal crack visible across the entire road width.

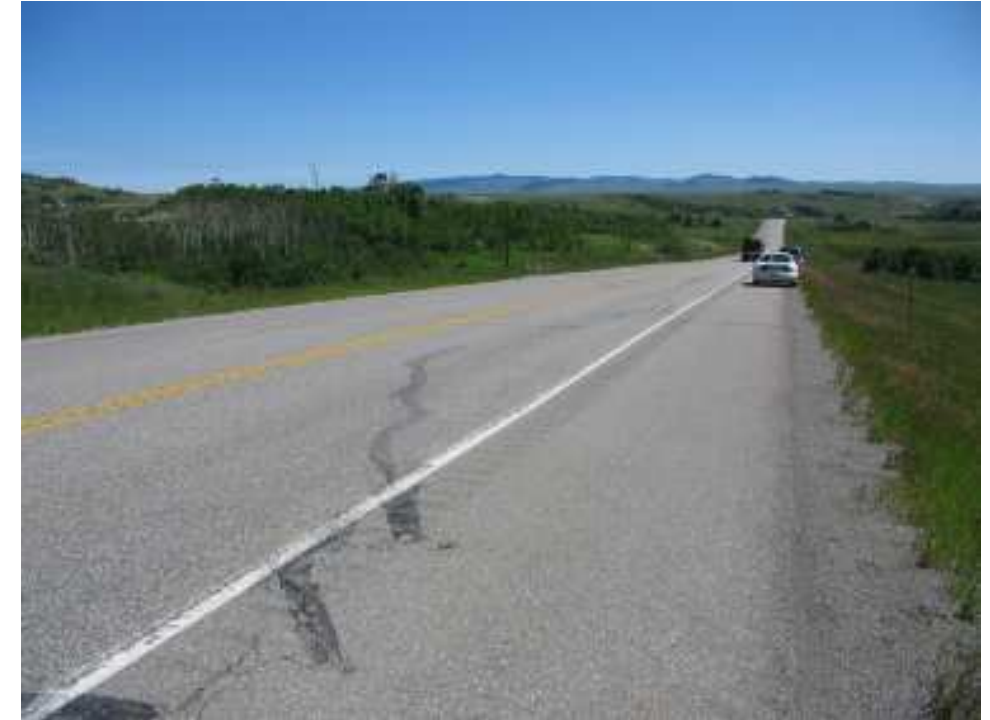
**Photo S27-2– June 2007** (upper right)  
Facing east across the very west end of the cracking area.

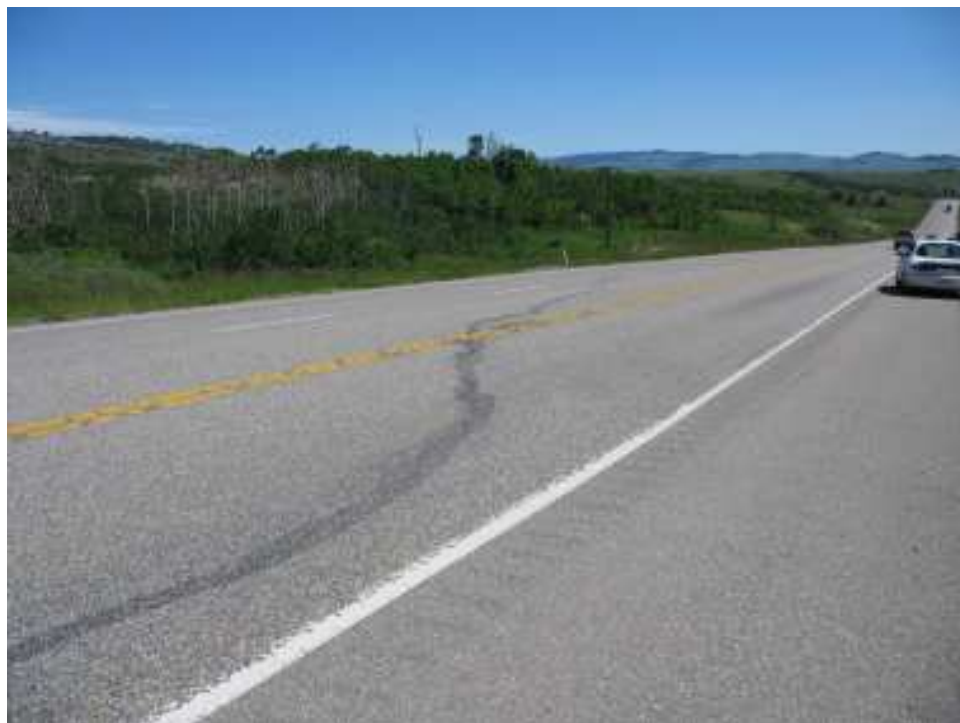
**Photo S27-3– June 2007** (lower left)  
Closer view, facing east, of the east end of the cracking area. At the time of the June 2007 site inspection the portion of the highway to the east of the crack was subtly down-dropped relative to the west.
