October 28, 2011

**Re: Southern Region Geohazard Assessment Program
S25 - Highway 3, Km 29.45, Near Monarch, AB
2011 Annual Inspection Report**

This letter documents the 2011 annual site inspection of Site S25 – Monarch, on Highway 22:14, near Monarch, AB.

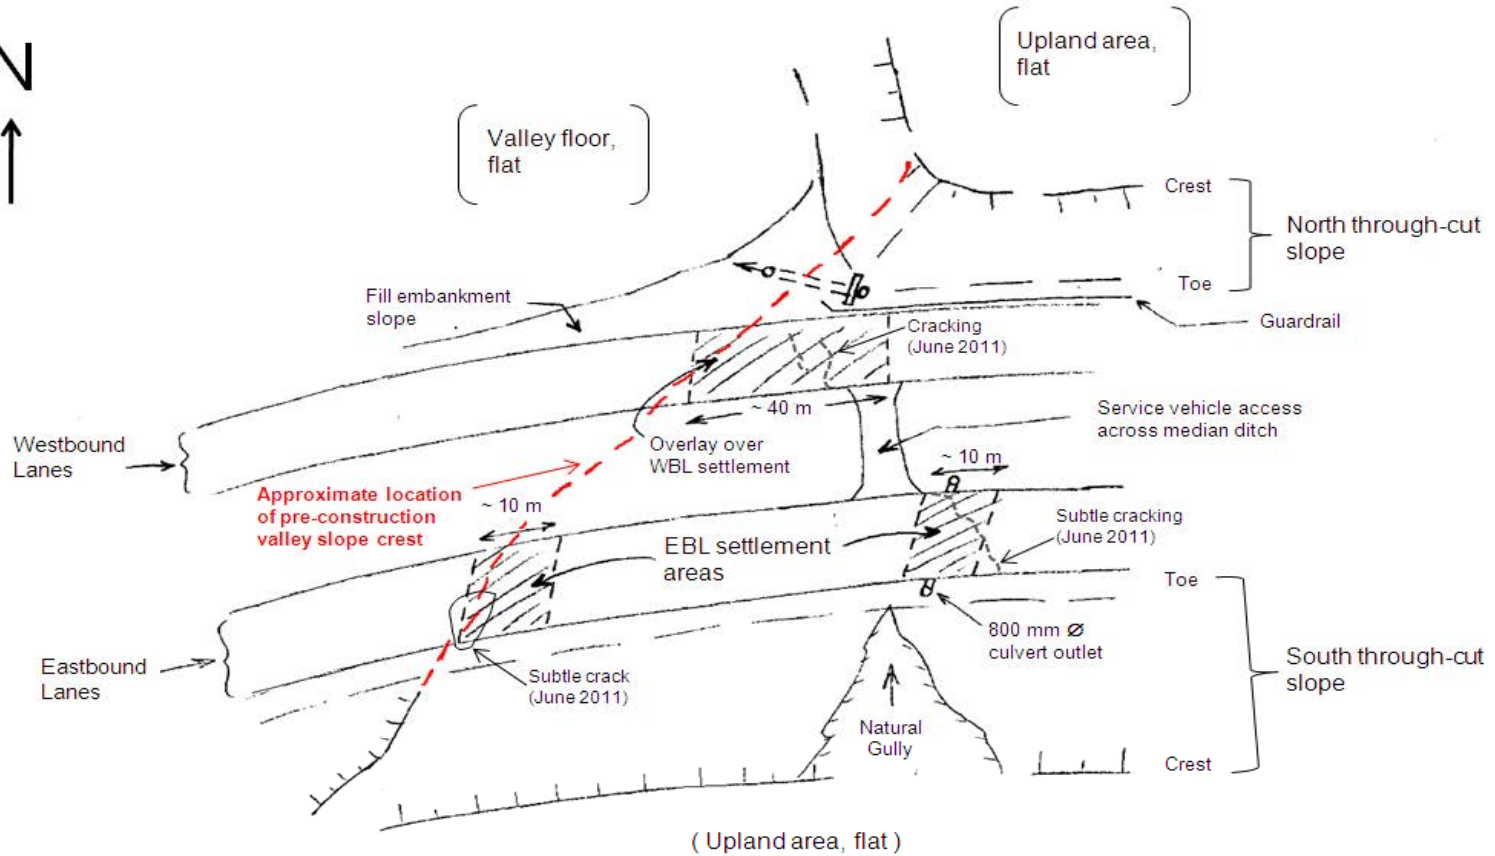
Client	Alberta Transportation		Figure S25-2	
Project	Southern Region Geohazard Assessment		Date:	Revision
	S25 - Hwy 3:29.45 - Monarch		Sep-11	
	Site Plan Schematic		Job No.	CG25352.200
			File No.:	AT_Monarch_siteplan(2011).xlsx

- An overlay had been placed at the previously noted settlement areas in the east and westbound lanes, likely in 2010. Refer to Figure S25-2 and Photo S25-1. Cracking had formed through the recent overlay following a similar pattern as was observed in 2007.
- The cracking was relatively minor and did not follow a definitive pattern that would be associated with landslide movement. There was settlement in the area near the cracking, but the settlement encompassed a broad area, and was not localized at the crack locations. The settlement was subtle and was noted by observing suspension compression of vehicles as they travelled through the site area. Refer to Photos S25-2 and S25-3.

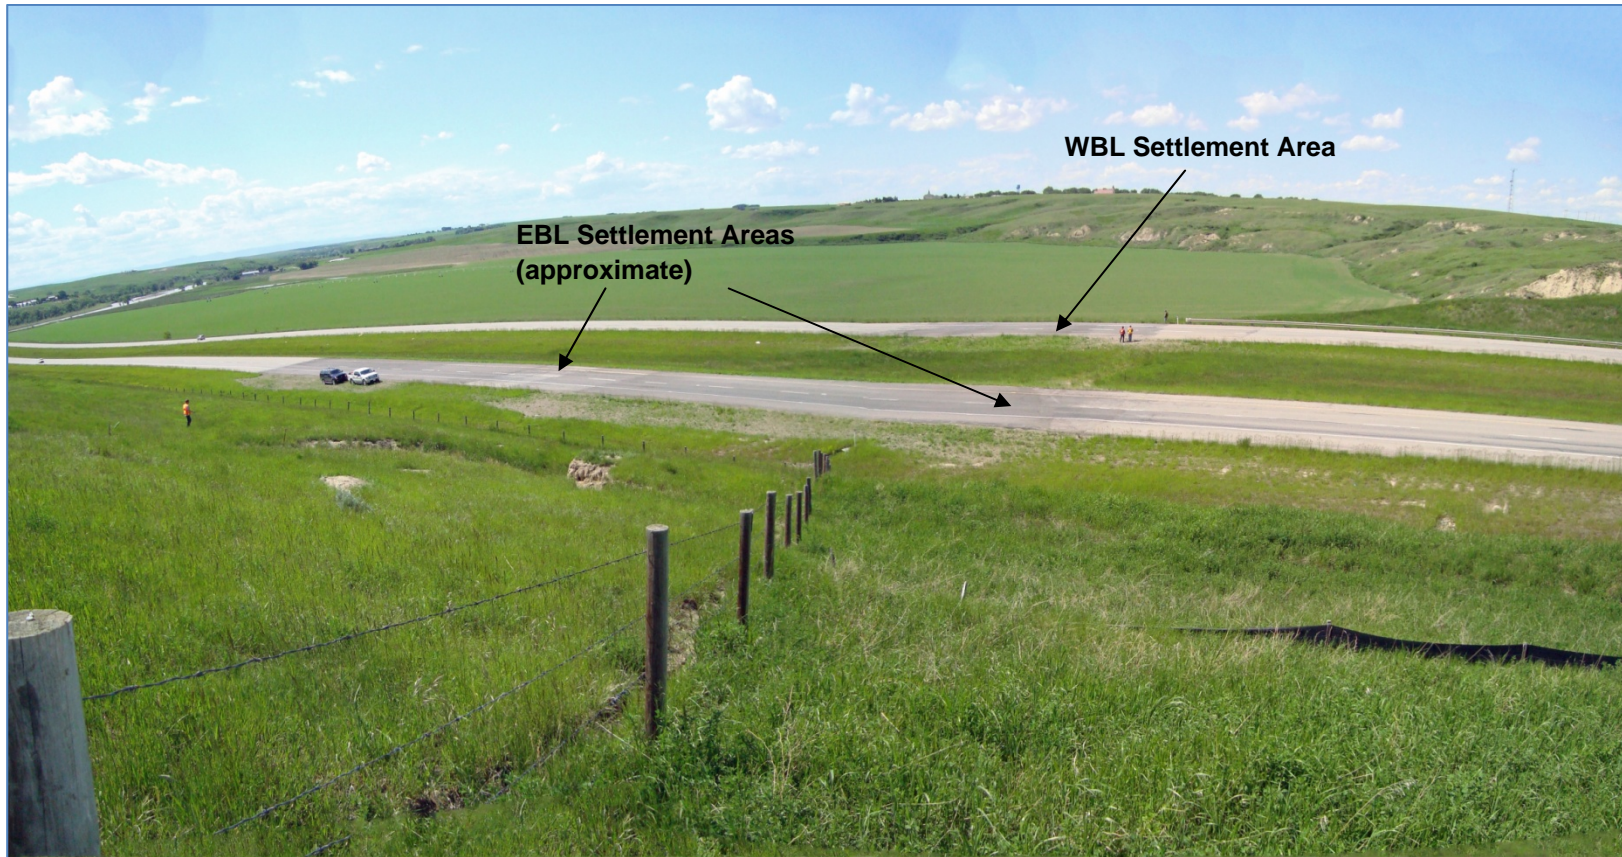
Photo S25-1 (June 2011)

Facing northwards across the site. The settlement areas are visible within the patched areas on both the eastbound and westbound lanes.

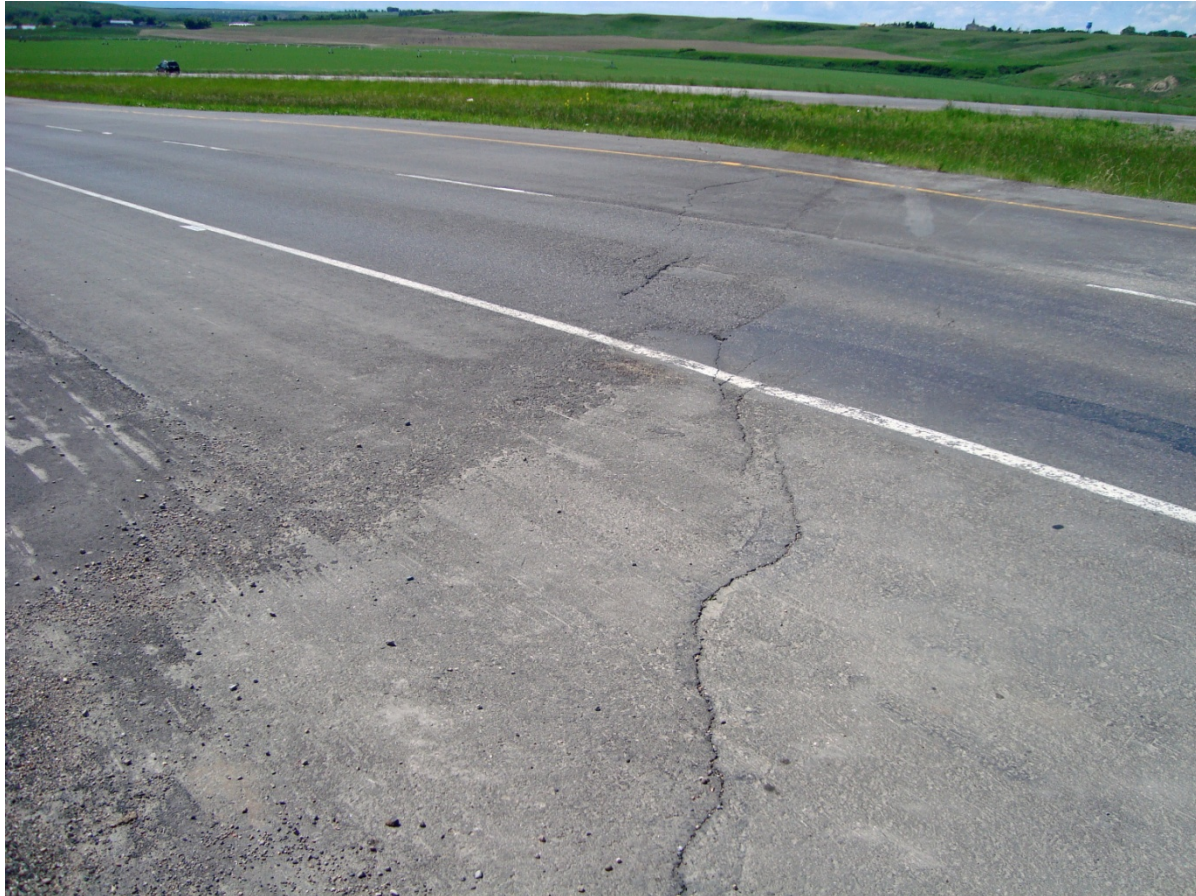
Photo S25-2 (June 2011)

Facing northwest across the eastbound lane. Diagonal cracking is visible across the patched area where subtle settlement has occurred.

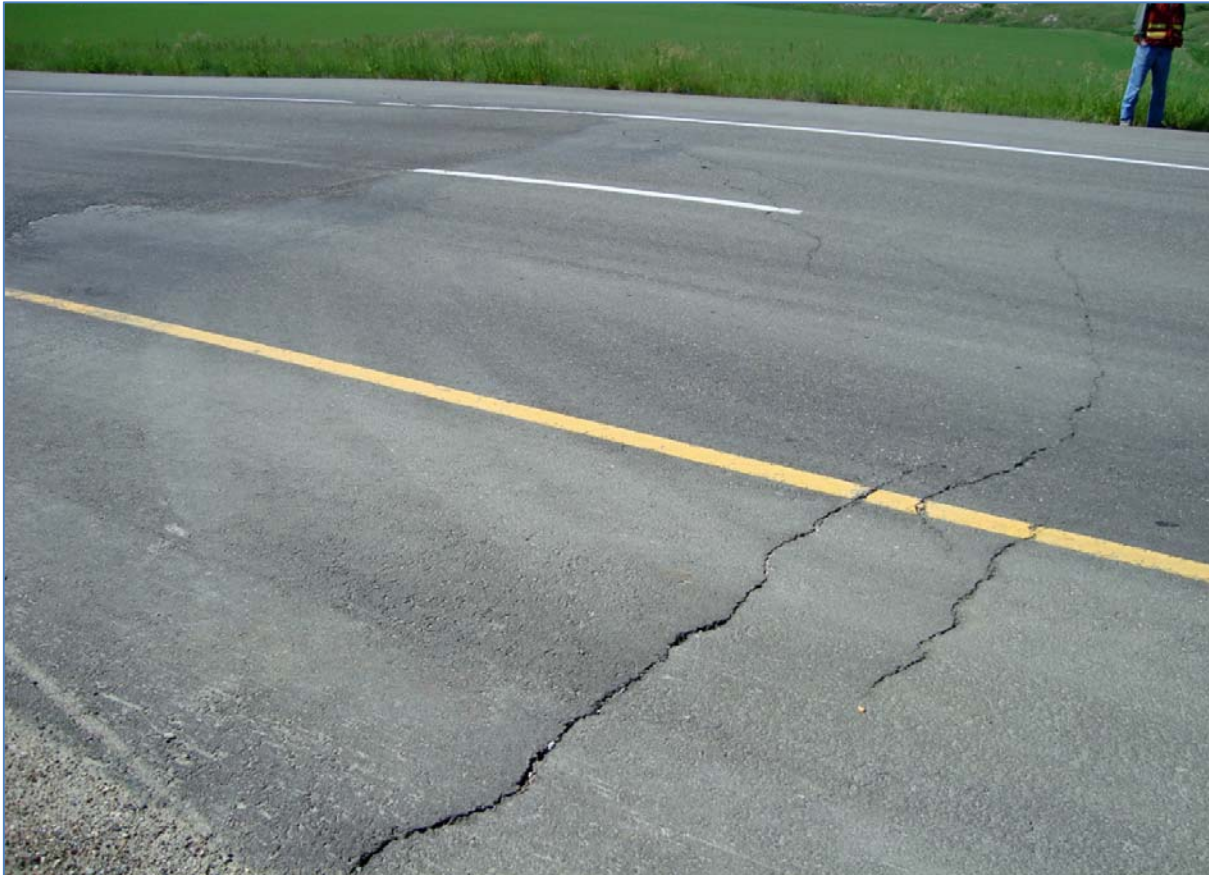
Photo S25-3 (June 2011)

Facing northwest from the south shoulder of the westbound lane. Similar cracking as was observed in the eastbound lane settlement area was visible in this recently patched area of the westbound lane. The amount of settlement was subtle at the time of inspection, but was noticeable when driving across the area at highway speed.
