CG25399

**Re: Southern Region Geohazard Assessment
2012 Annual Inspection Report
Site S25: Highway 3, Km 29.45, Near Monarch, AB**

This report documents the 2012 annual site inspection of Site S25 – Monarch, on Highway 22:14, near Monarch, AB.

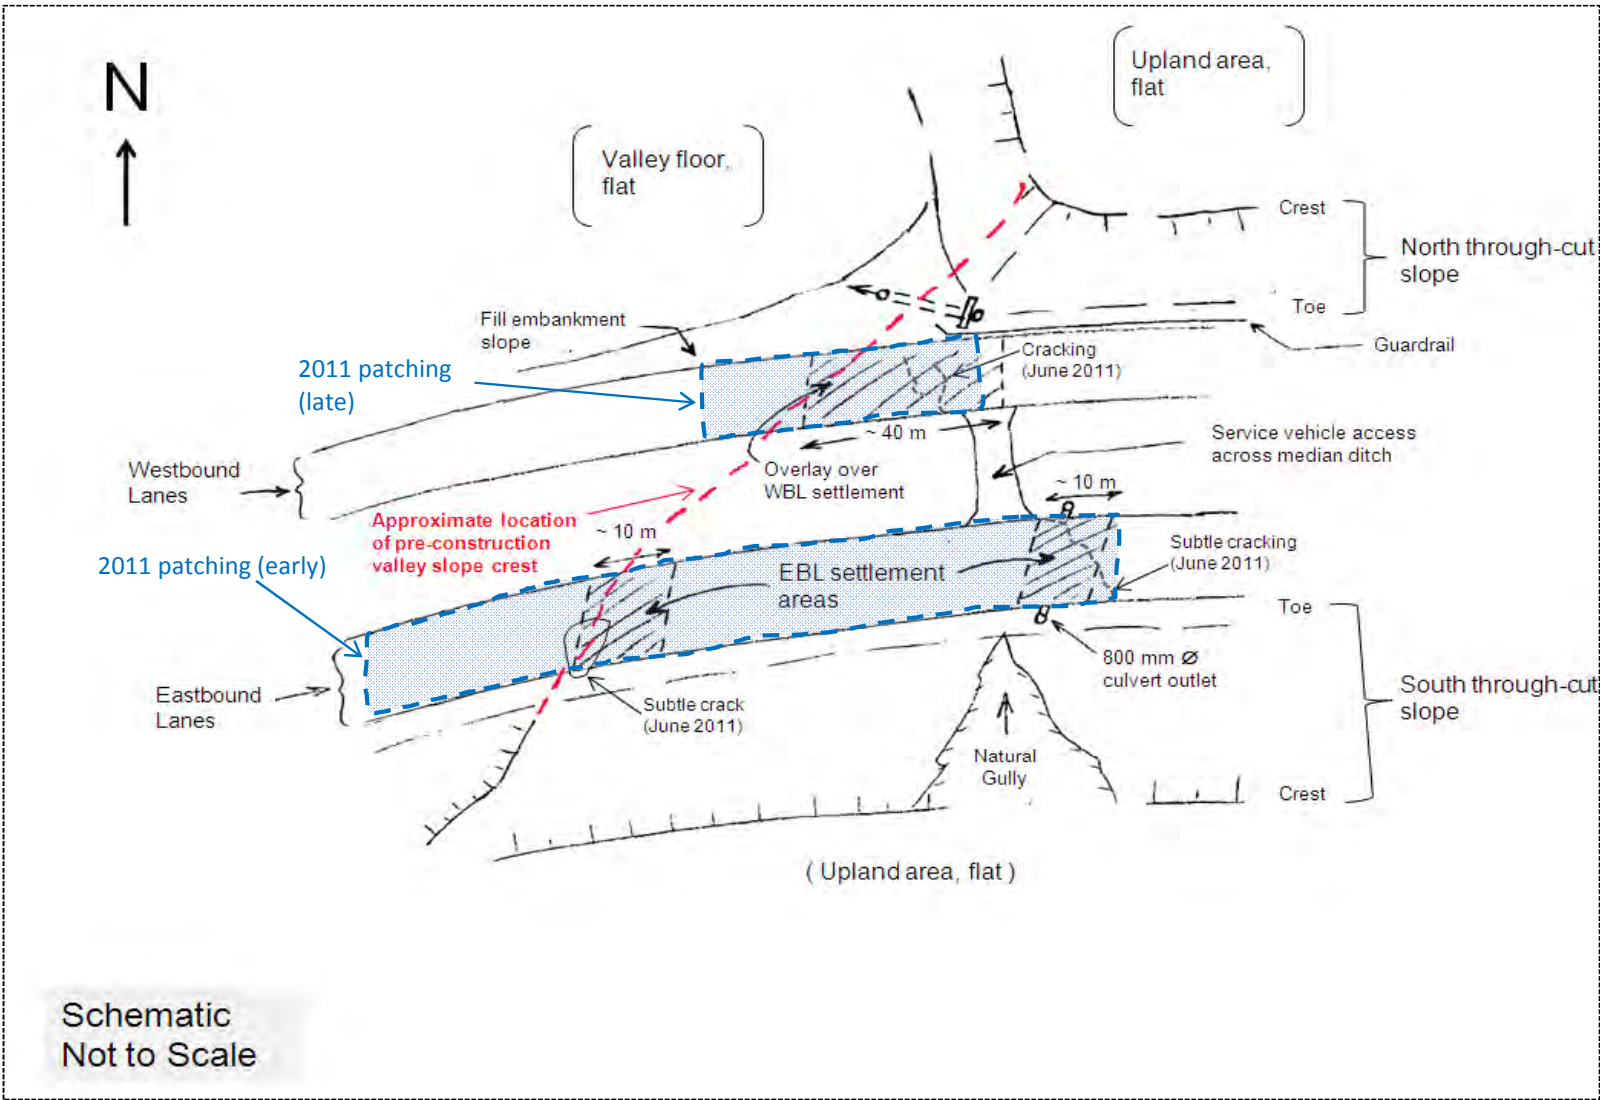
Client	Alberta Transportation		Figure S25-2	
Project	Southern Region Geohazard Assessment		Date:	Revision
	S25 - Hwy 3:29.45 - Monarch		Nov-12	
	Site Plan Schematic		Job No.	
			CG25399.200	
			File No.:	
			S25_siteplan(2012).xlsx

- The eastbound lanes had two areas of recent patching (possibly paved in early 2011). Refer to Figure S25-2. The westernmost patch had the most settlement, noted by the suspension compression of vehicles traveling through the area (refer to Photos S25-1 and S25-2).
- The westbound lane had been recently patched (possibly late 2011) with subtle settlement but no new cracks (refer to Photo S25-3).
- The road surface was in approximately the same condition as was observed in 2011, with continued deformation of the road surface.

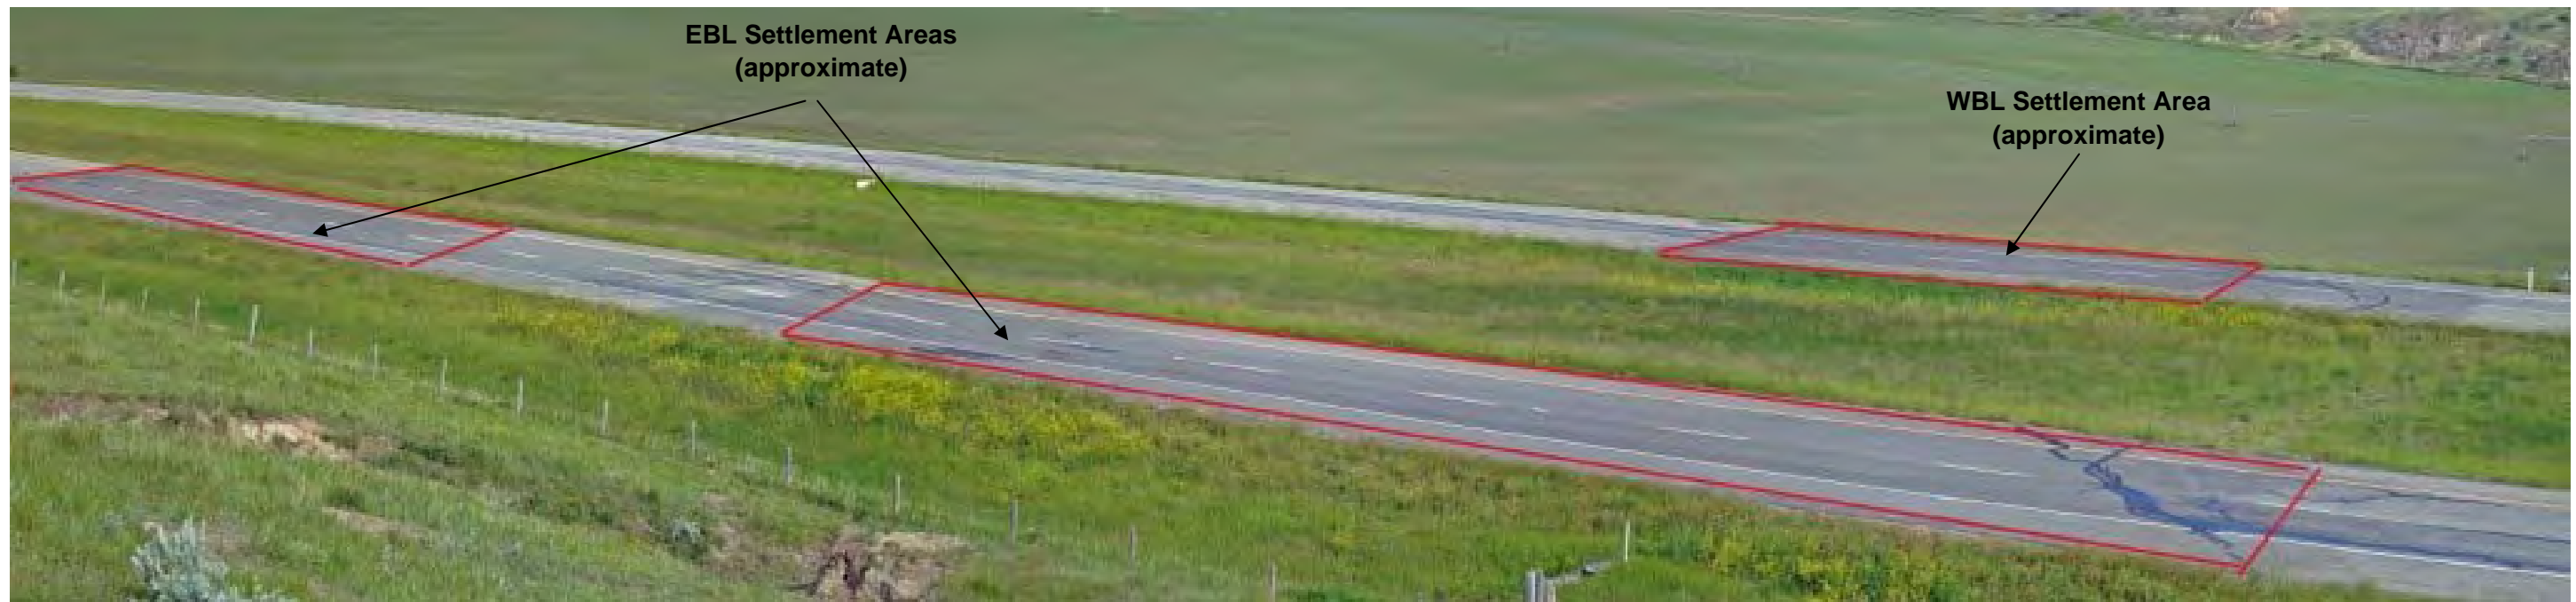
Photo S25-1 – June 2012

Facing north across the site. Settlement is present within the patched areas on both the eastbound and westbound lanes, marked with a red outline. The most settlement was noted in the westbound lane.

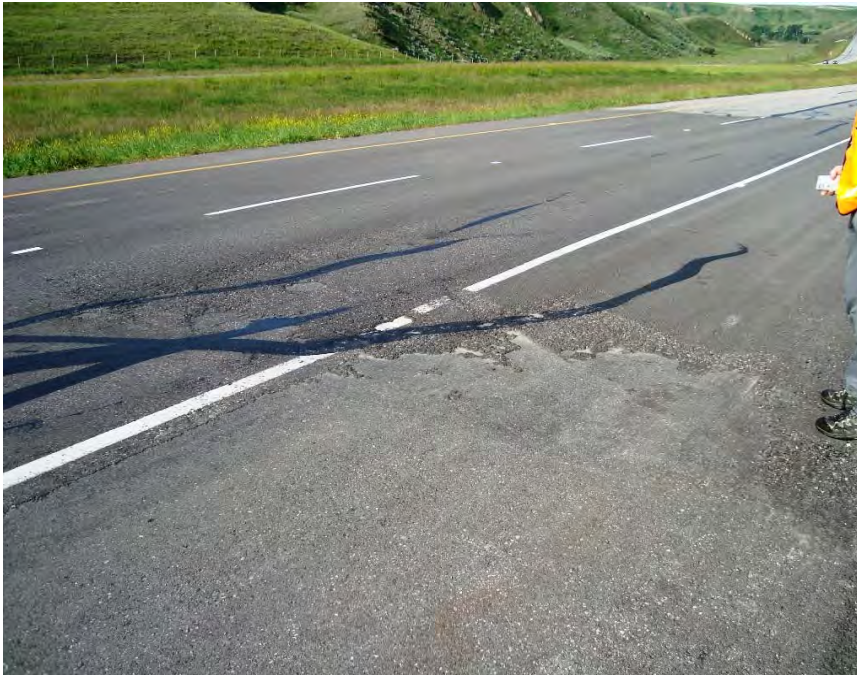
Photo S25-2 – June 2012
Facing southwest across the westbound lane at the main settlement area.

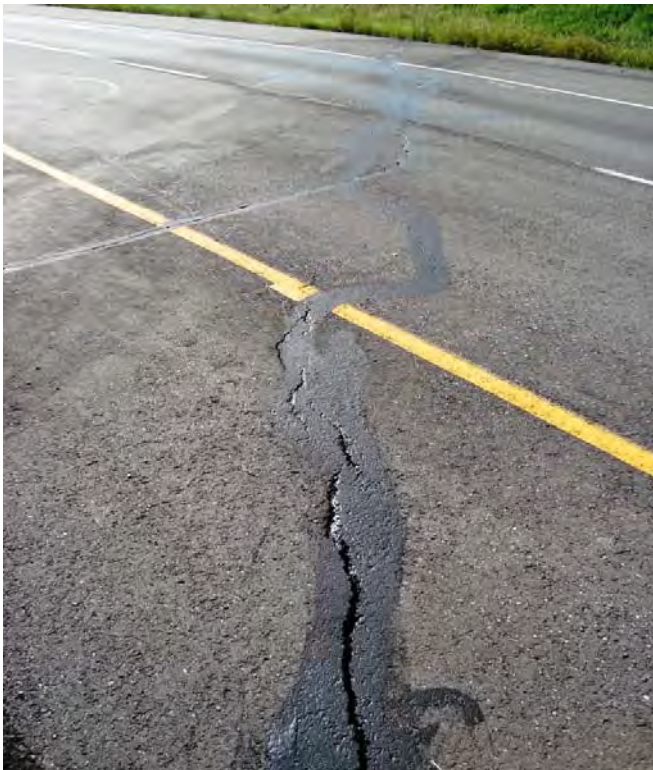
Photo S25-3 – June 2012
Facing southeast across the eastbound lane at the cracking in the easternmost patch. The cracking here had approximately 20 mm aperture with no down-drop and may be indicative of active sliding in this area.
