December 2015

Project Number: CG25399

**Re: Southern Region Geohazard Assessment
2015 Annual Inspection Report
Site S38: Highway 22:08, Callum Creek Landslide**

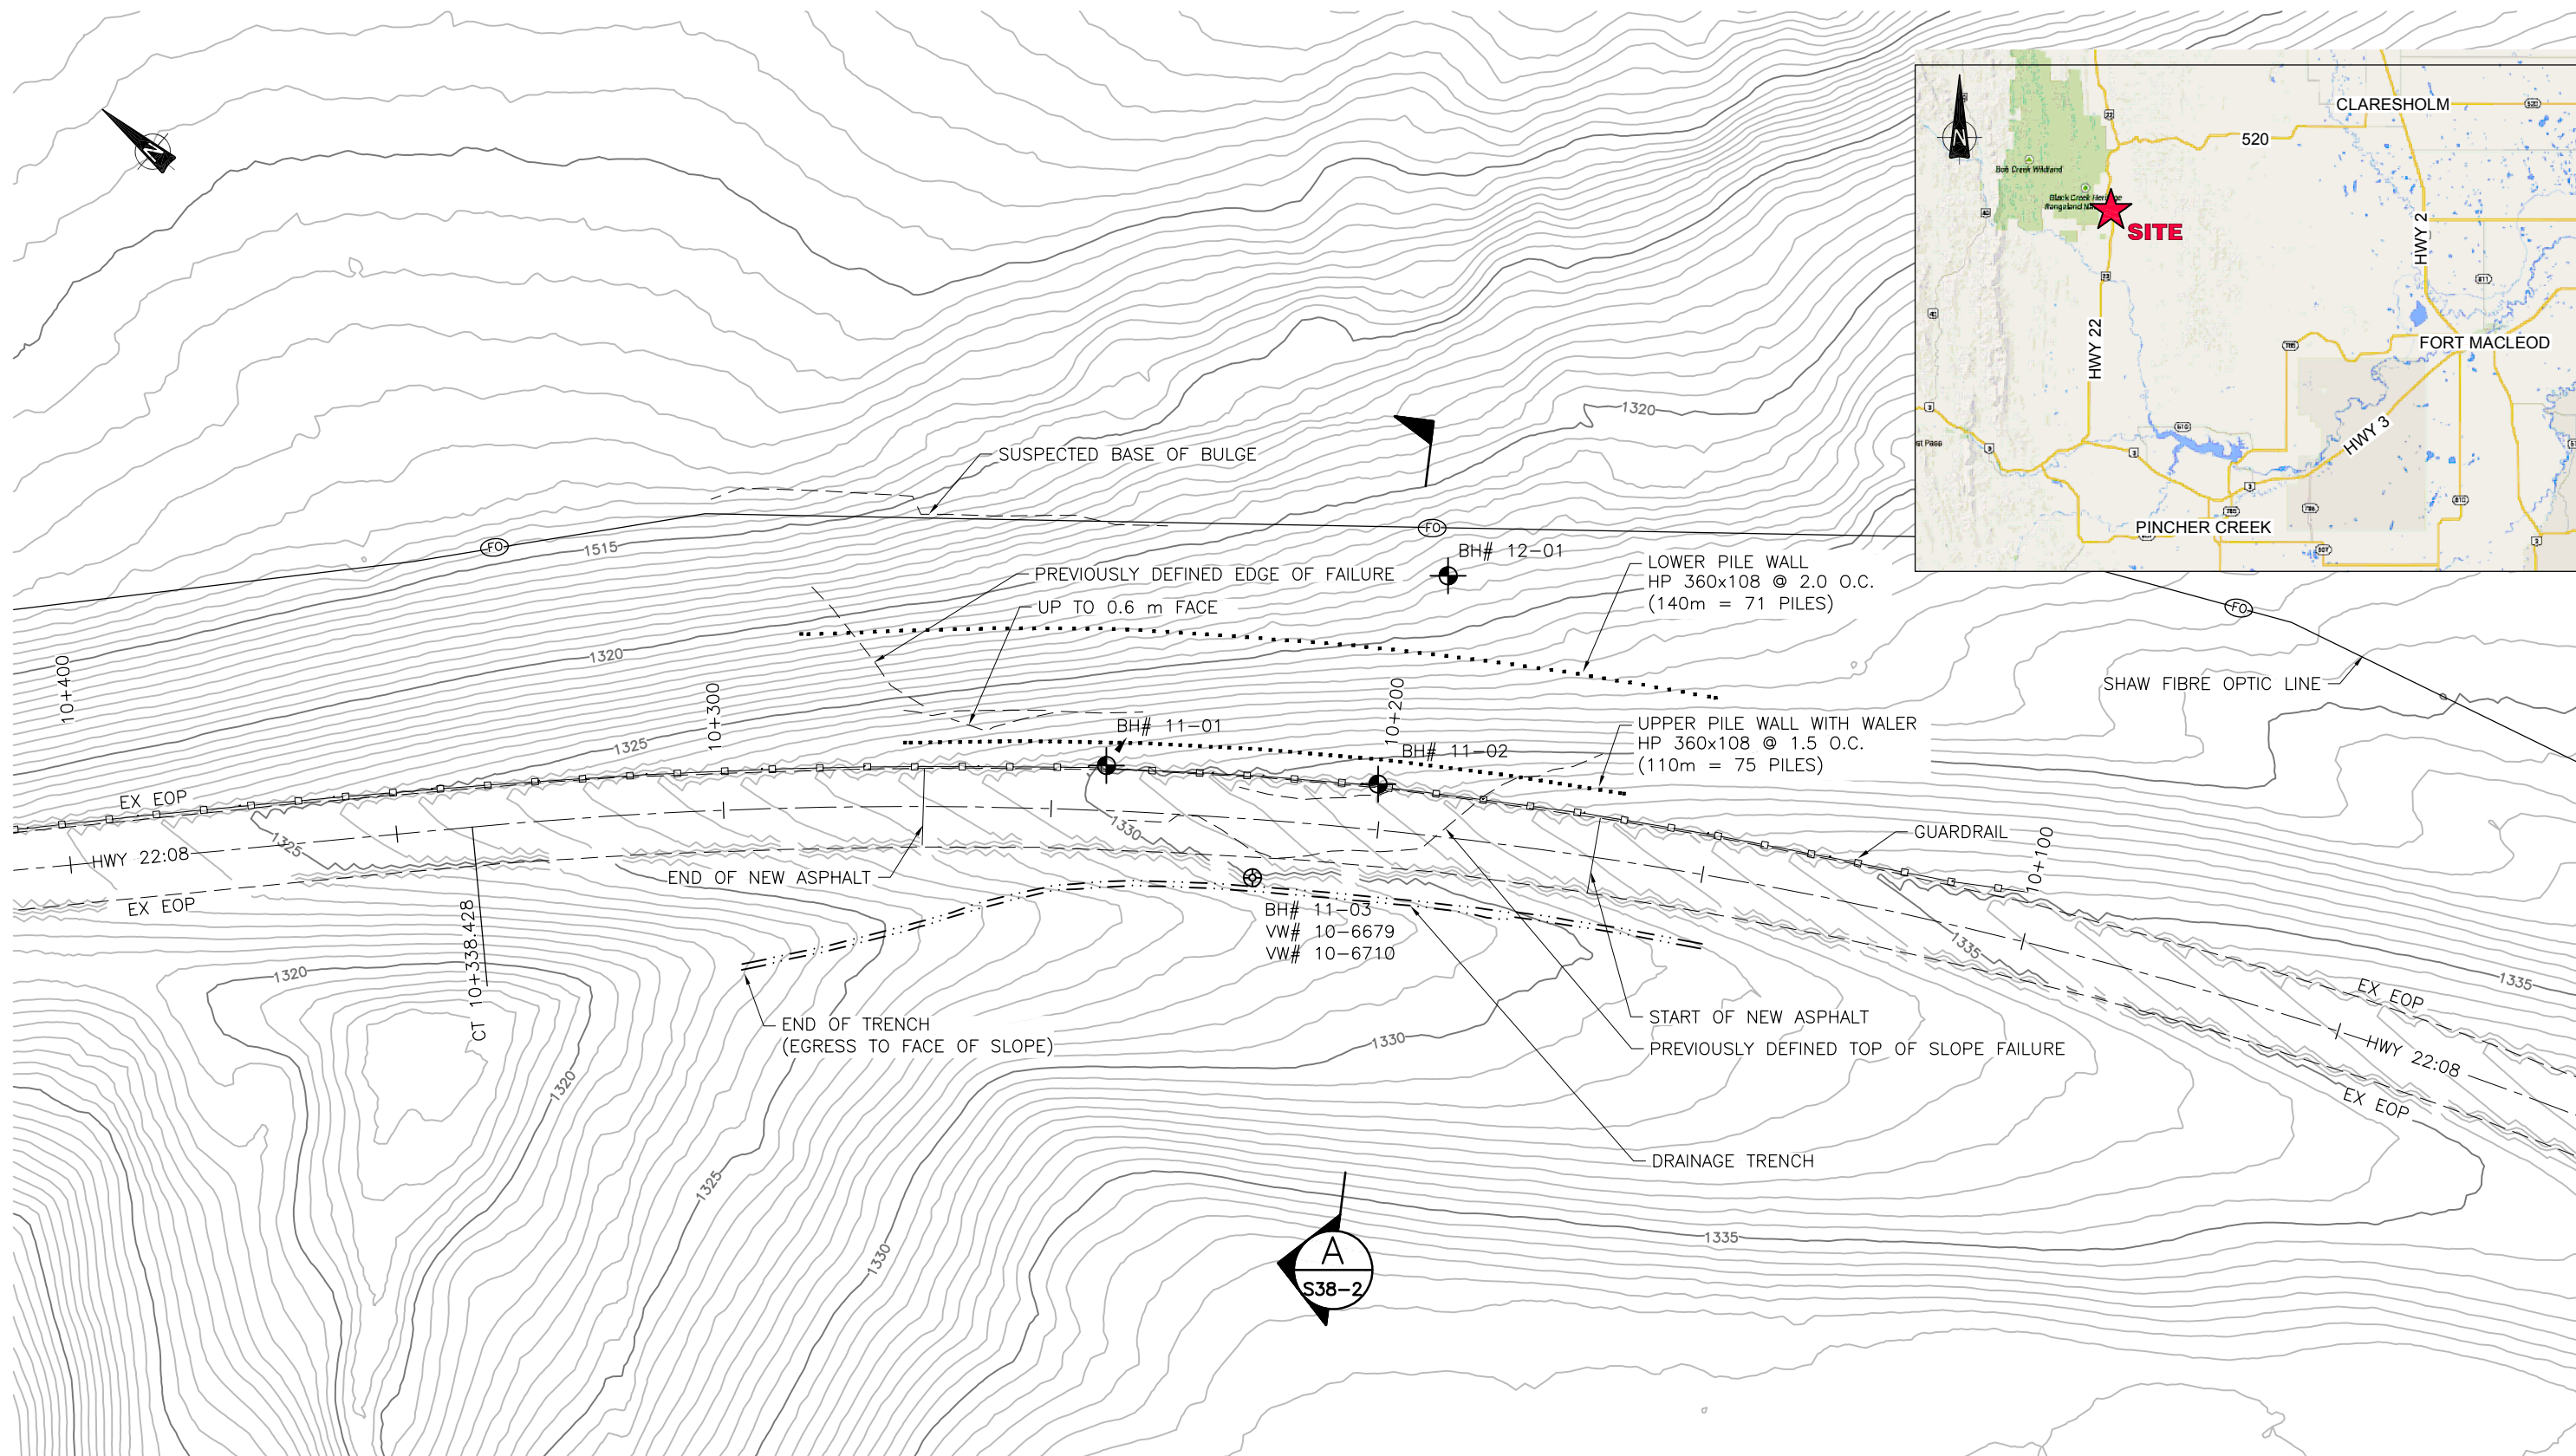
PROJECT: SOUTHERN REGION GEOHAZARD ASSESSMENT AND INSTRUMENTATION MONITORING			
		TITLE: S38 - HWY 22:08 - CALLUM CREEK LANDSLIDE SITE PLAN			
CLIENT:		DATE: JUNE 2015	JOB No.: CG25399.300	CAD FILE: 25399B08.dwg	FIGURE No.: FIG S38-1
					REV. A

1. BOTH SI'S OUT OF OPERATION.

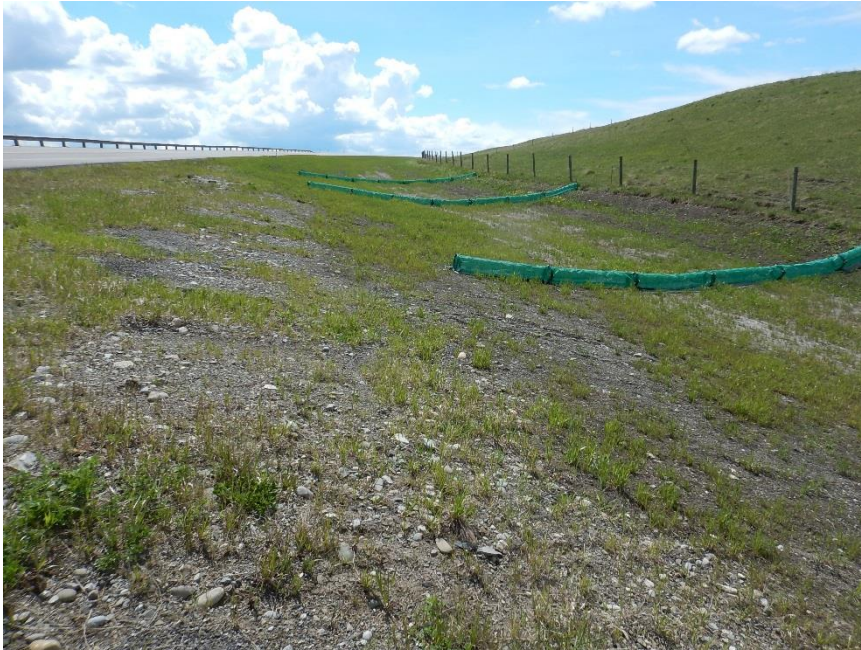
Vegetation had begun to grow on both slopes and the lower slope was well vegetated showing no signs of erosion.

Photo S38-1 (May 2015) – Facing south from the west side of the highway looking at erosion / sediment blanket and socks. Vegetation has started to grow on slope.

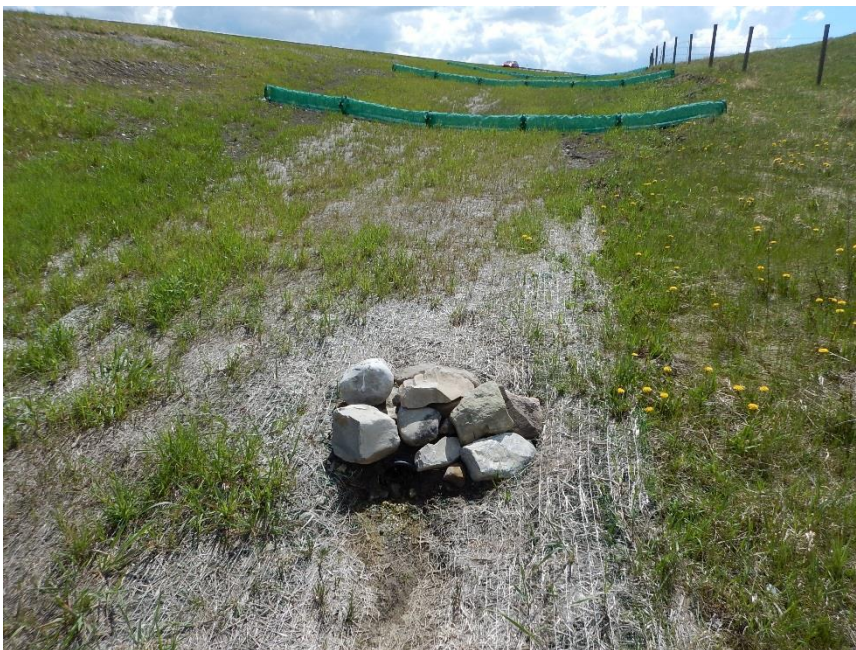
Photo S38-2 (May 2015) – Facing south along the drain ditch alignment at drain ditch outlet. Drain ditch outlet has seepage.

- The top of the piles should be monitored for exposure. Erosion may cause the piles to become exposed.
- If significant erosion is noted at the ditch drain outlet, possible erosion control measures could be recommended.

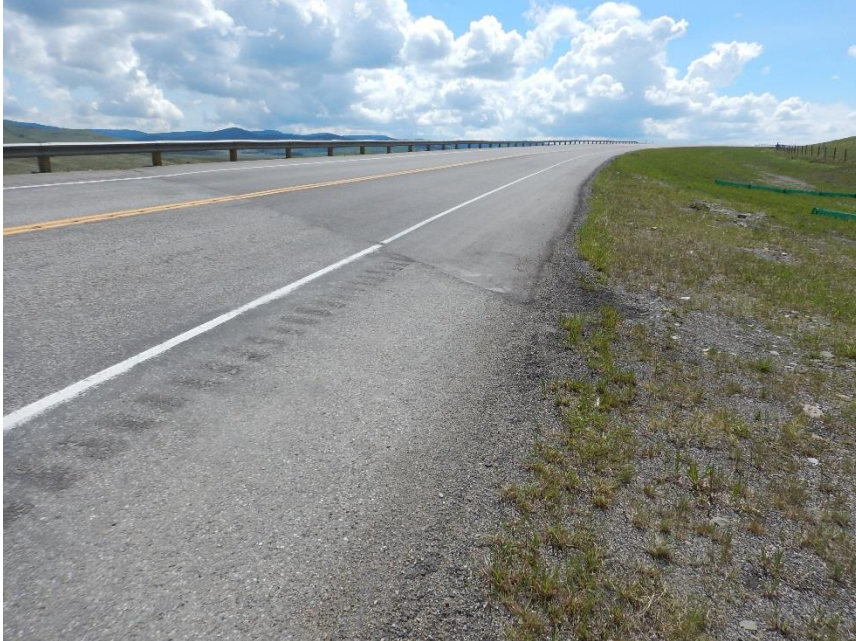
Photo S38-3 (May 2015) –
Facing south from the west
side of the highway. New
pavement overlay placed in
2014 was in good condition.

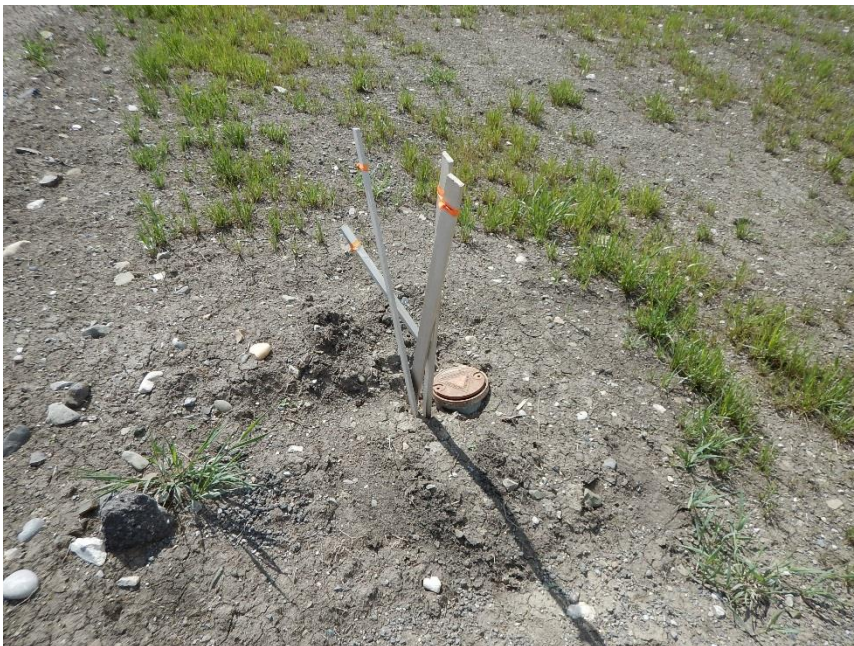
Photo S38-4 (May 2015) –
Current Instrumentation

The repair work appears to be performing well. However, as there is currently no instrumentation at this site, Amec Foster Wheeler cannot monitor the effectiveness of the pile walls.

- The instruments at the site should continue to be monitored semi-annually as part of the Southern Region Geohazard Program and the site should be inspected during the 2016 Annual Tour to evaluate the repair performance and check for changing conditions.
- Two SIs should be installed; one above the upper pile wall and one in between the two pile walls. The installation of these instruments is recommended in order to monitor the

performance of the pile walls rather than waiting for signs of deformation on the road surface to indicate a problem. Amec Foster Wheeler can submit the proposal for this work for AT's consideration.

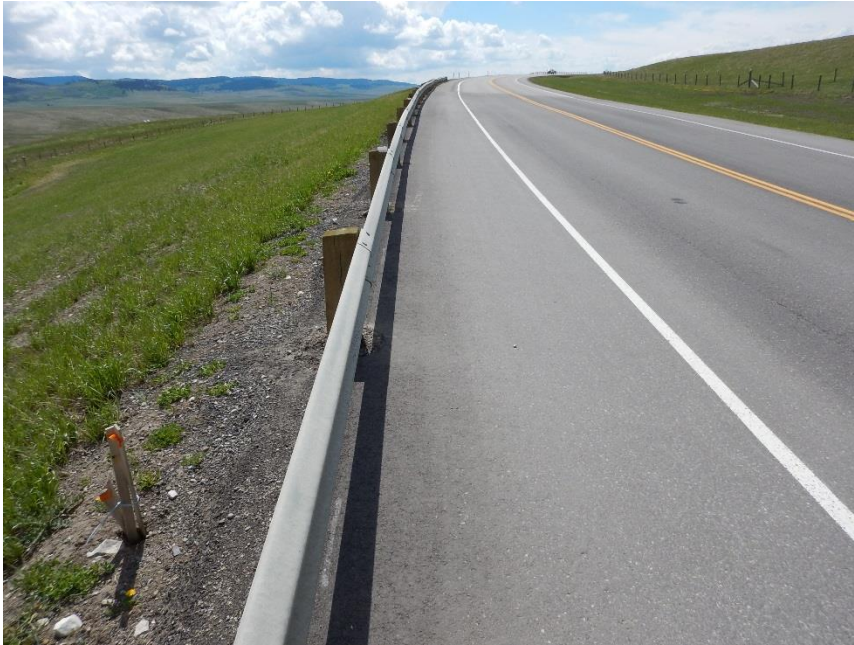
Photo S38-5 (May 2015) –
Facing south from the east
side of the highway. 2014
overlay is in good condition.

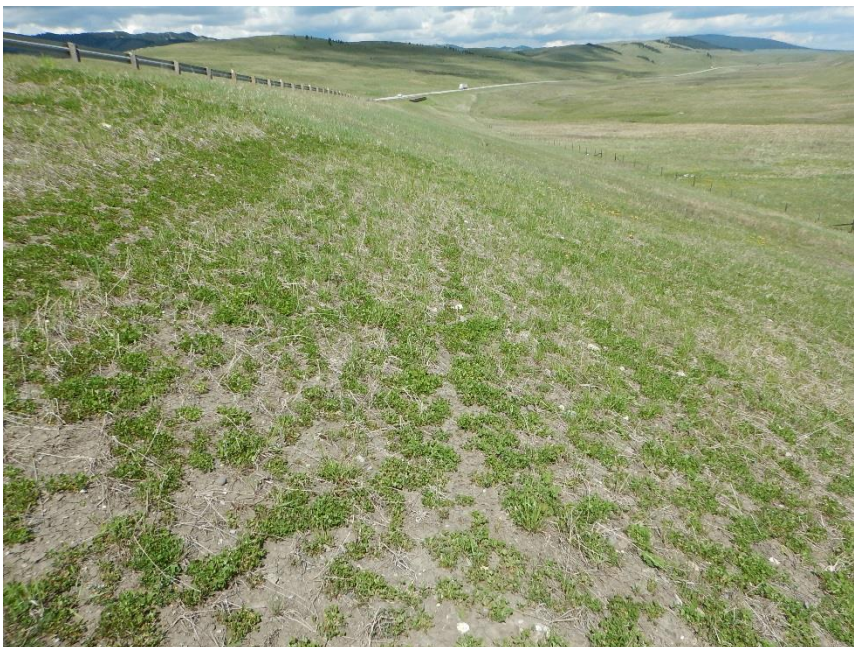
In general the repaired area appeared to be in good condition. There were areas where minor settlement of the fill had occurred but erosion was not evident. The observed settlement areas will be inspected in the future to ensure settlement does not worsen but this is not considered to affect the repair performance. No exposure of piles was noted.

Photo S38-6 (May 2015) –
Facing north standing on the
lower slope. Slope is well
vegetated and piles are not
exposed.
