SITE NUMBER AND NAME: S052 Nelson Creek		HIGHWAY & KM: 22:08, 34.25	PREVIOUS INSPECTION DATE: June 15, 2016	INSPECTION DATE: June 1, 2017
LEGAL DESCRIPTION: 10-14-013-02 W5M	NAD 83 COORDINATES: UTM Northing Easting 11 5552067 702482		RISK ASSESSMENT: PF: 7 CF: 2 TOTAL: 14	
AVERAGE ANNUAL DAILY TRAFFIC (AADT): 2,800 (south), (Ref. No. 75120)			CONTRACTOR MAINTENANCE AREA (CMA): 27

Alberta
Transportation

PROJECT SOUTHERN REGION GEOHAZARD RISK MANAGEMENT PROGRAM		
TITLE Site Plan S052 - Nelson Creek Hwy 22:08, km 34.25		
SCALE 1:2,000	PROJECT No. A05115A03	FIG No. 1

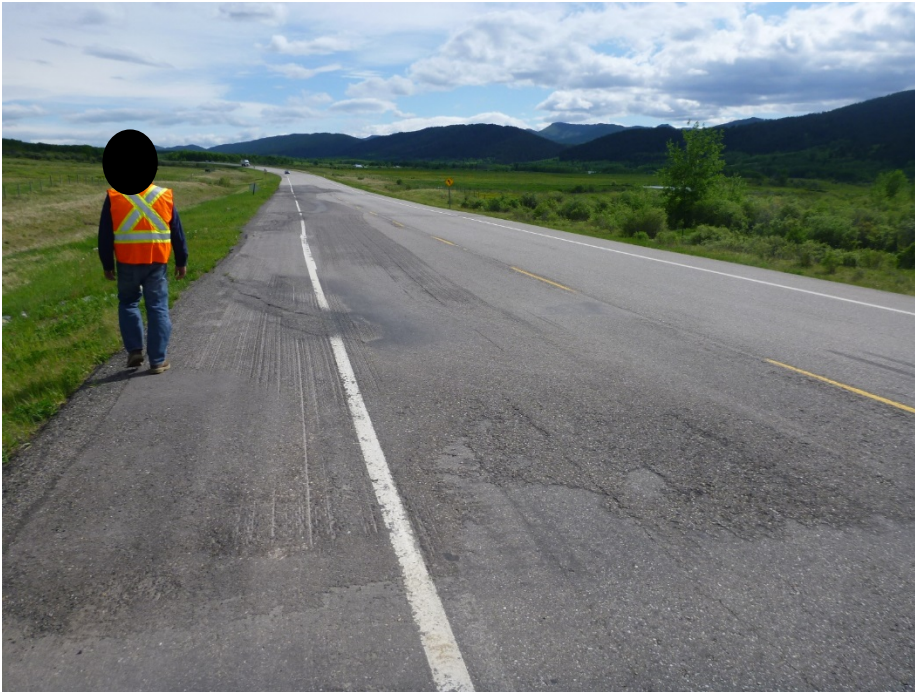
Photo 1 North extend of pavement distress area. Uneven pavement surface. Patching and asphalt milling done since previous inspection. Photo taken facing south on June 1, 2017.

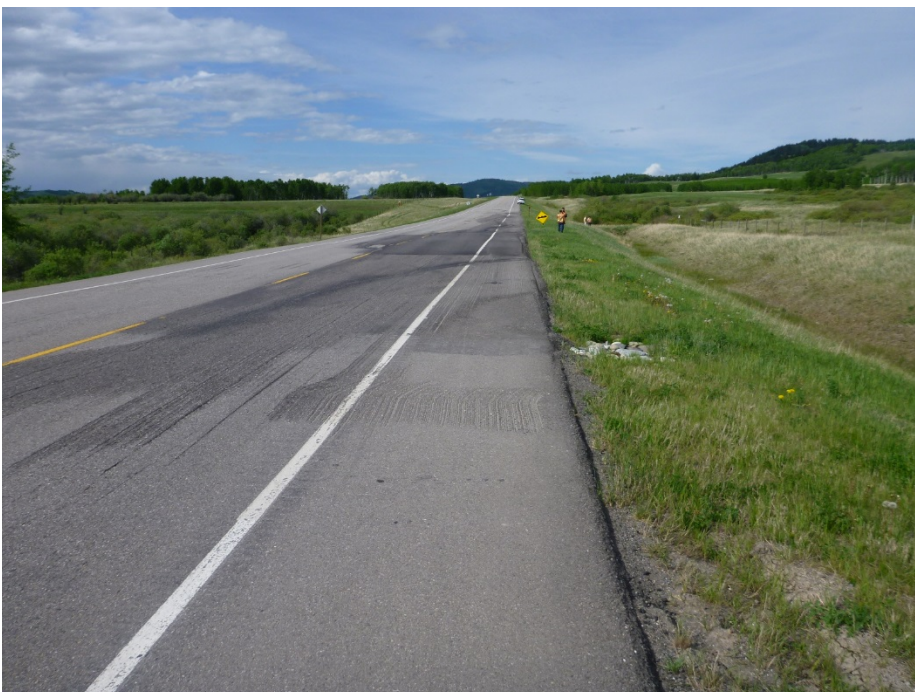
Photo 2 South extent of site. Note french drains off shoulder of the highway. Photo taken facing north on June 1, 2017.

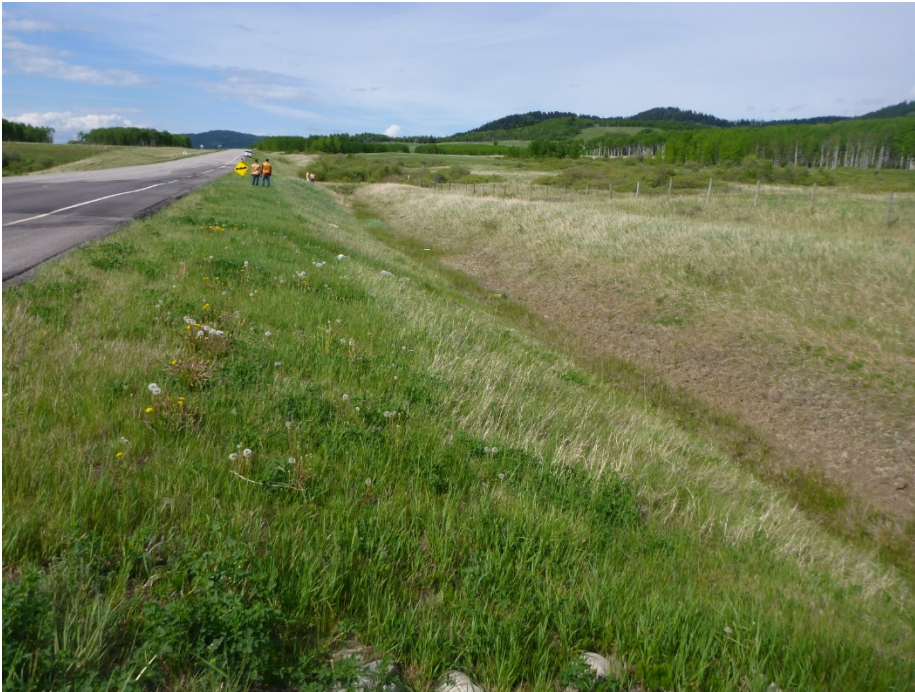
Photo 3 Deepened narrow ditch with steepened embankment slope on east side of highway. Standing water in ditch. Photo taken facing north on June 1, 2017.

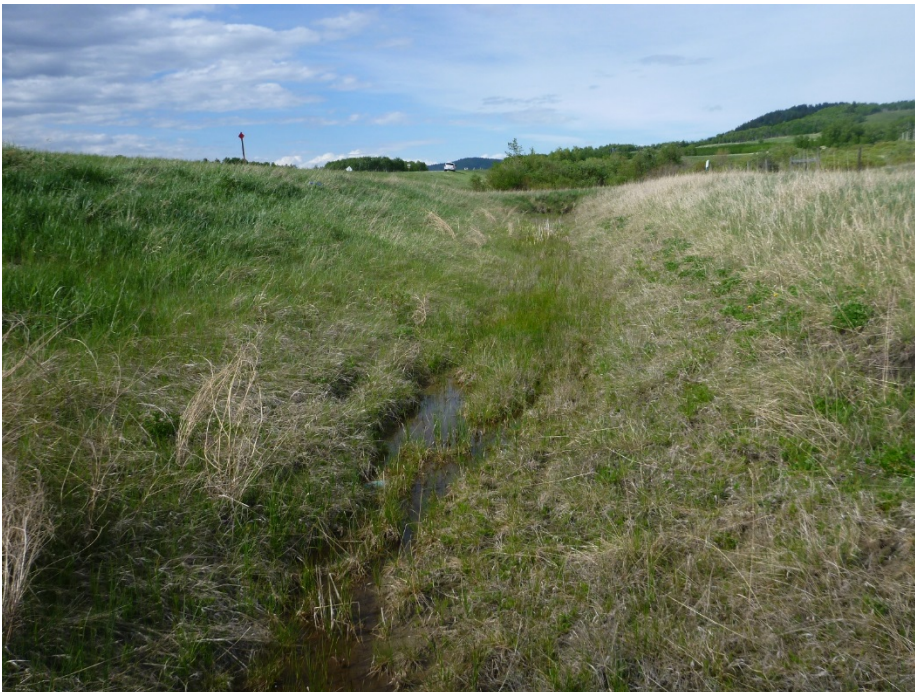
Photo 4 Base of ditch on east side of highway. Ditch unable to drain due change in ditch grade before culvert. Photo taken facing north on June 1, 2017.
