SITE NUMBER AND NAME: S052 Nelson Creek		HIGHWAY & KM: 22:08, 34.25	PREVIOUS INSPECTION DATE: June 1, 2017	INSPECTION DATE: July 7, 2020
LEGAL DESCRIPTION: 10-14-013-02 W5M	NAD 83 COORDINATES: UTM Northing Easting 11 5552067 702482		RISK ASSESMENT: PF: 5 CF: 2 TOTAL: 10	
AVERAGE ANNUAL DAILY TRAFFIC (AADT): 2,740 (north), 2,740 (south), (Ref. No. 77090)			CONTRACTOR MAINTENANCE AREA (CMA): 27

PROJECT
 SOUTHERN REGION GEOHAZARD RISK MANAGEMENT PROGRAM

TITLE
 Site Plan
 S052 - Nelson Creek
 Hwy 22:08, km 34.25

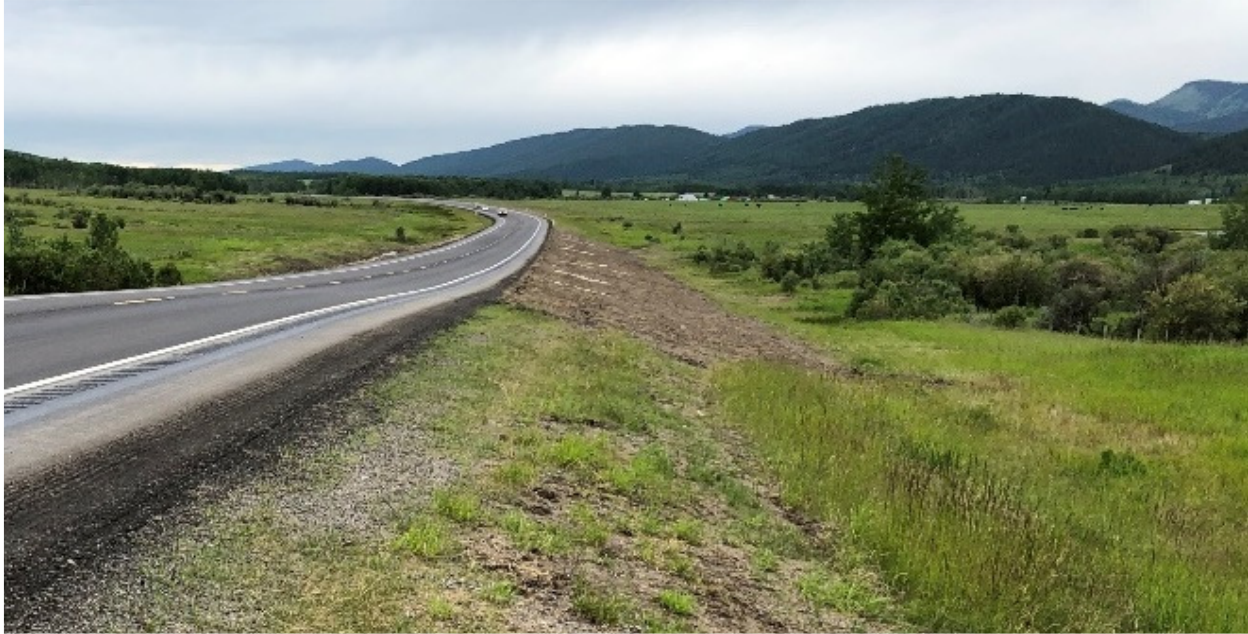
Photo 1 Highway overlay paving work and embankment regrading in progress. Photo taken facing south on July 7, 2020.

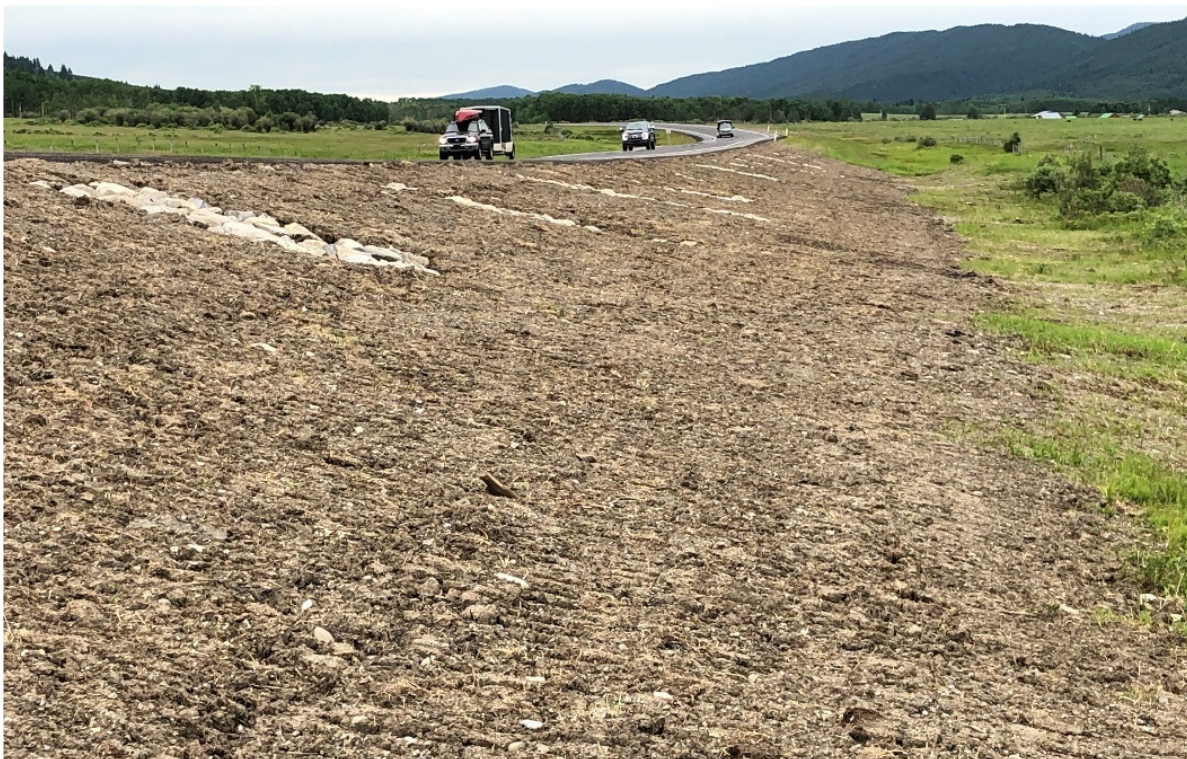
Photo 2 West slope has been stripped and regraded as part of ongoing highway overlay project. Photo taken facing south along the west side on July 7, 2020.

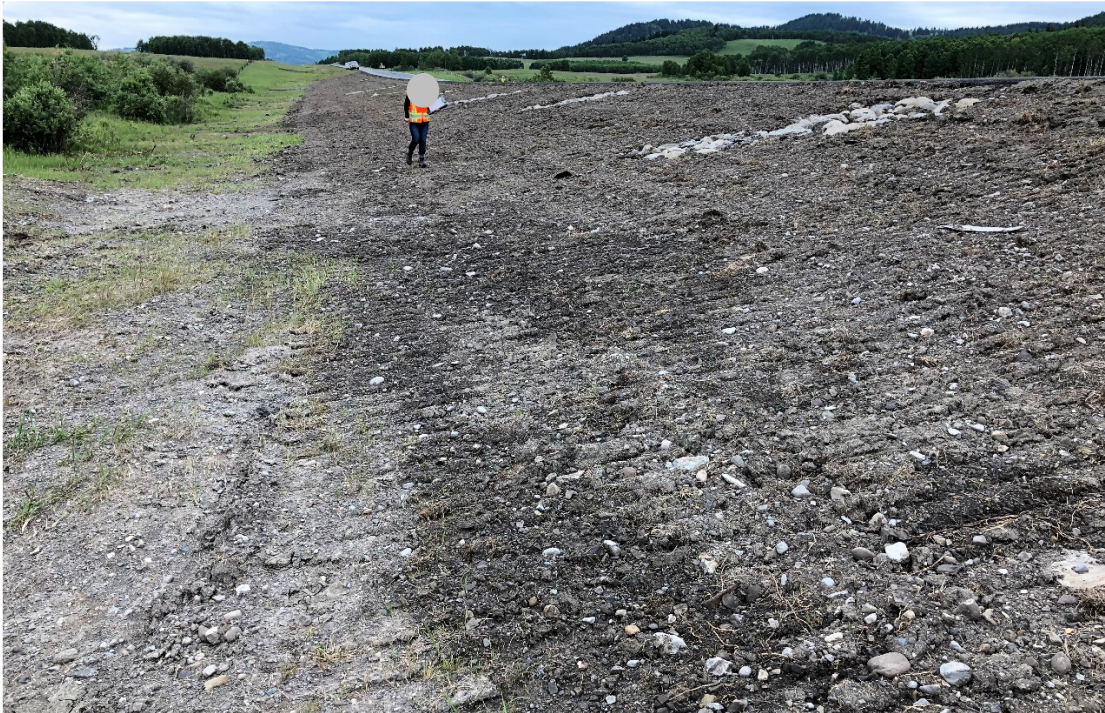
Photo 3 Seepage and saturated ground on the west slope. Photo taken facing north along the west side on July 7, 2020.

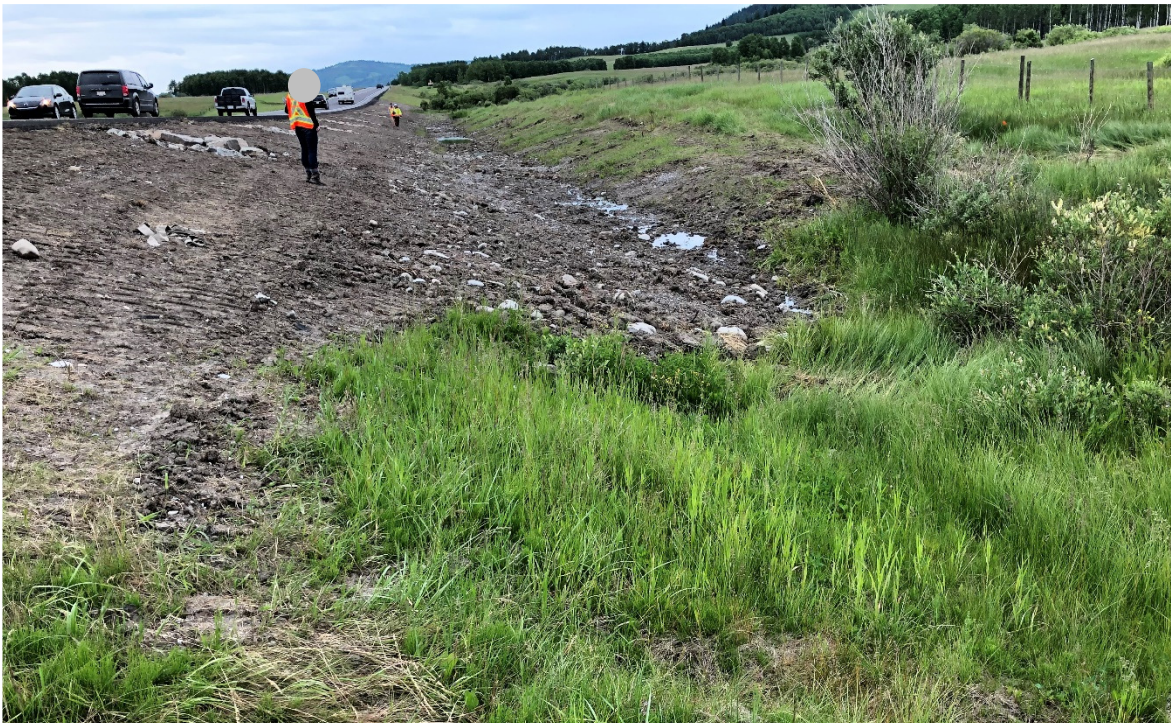
Photo 4 Seepage and saturated ground on the east slope. Standing water in the ditch due to poor grading of the ditch. Photo taken facing north on July 7, 2020.
