September 8, 2008

CG25277.B

**Re: Southern Region Geohazard Assessment Program
Site S16 – Chain Lakes, Highway 22:08
2008 Annual Inspection Report**

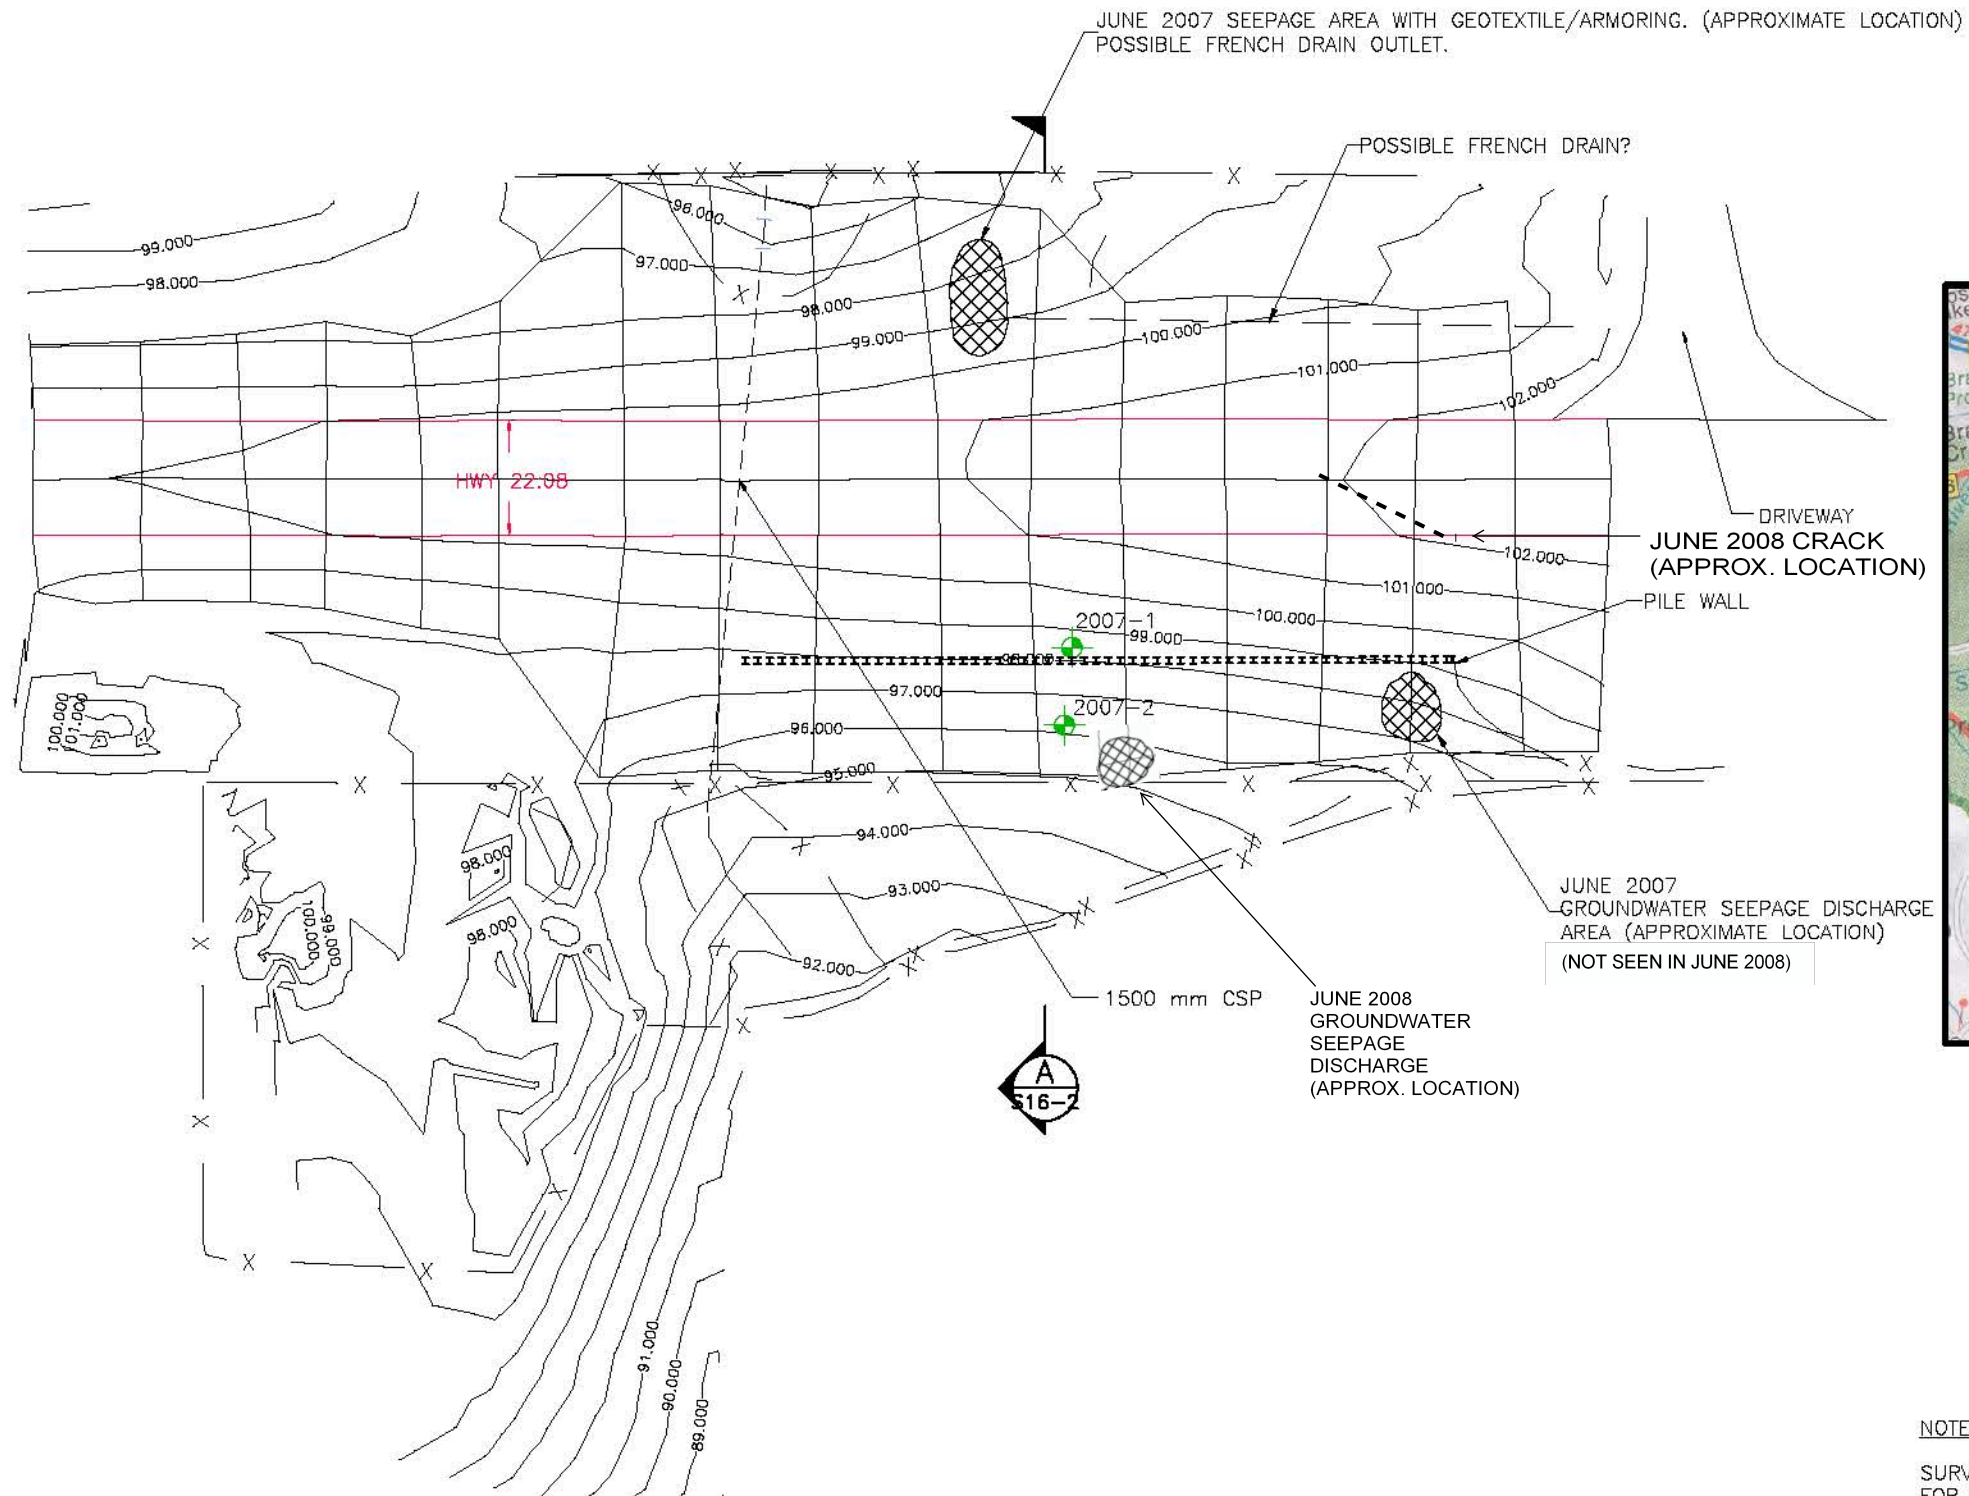
PROJECT: SOUTHERN REGION GEOHAZARD ASSESSMENT							
		TITLE: S16 - CHAIN LAKES, HWY 22:08 SITE PLAN							
DATE:	AUGUST 2008	JOB No.:	CG25277.B	CAD FILE:		FIGURE No.:	FIG. S16-1	REV.	A

- A groundwater discharge area was noted on the lower portion of the southwest embankment slope, approximately 3 to 5 m downslope and southwest of SI 2007-2 (see site plan). The discharge area was delineated by a clover patch underlain by moss cover on the slope. No distinct surface flow channel could be found through the thick vegetation, but the ground was soft and there was audible water flow.

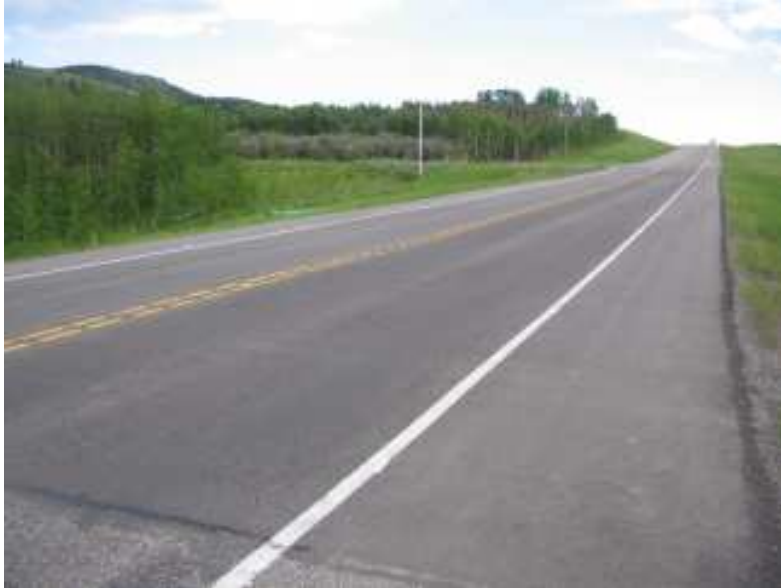
Photo S16-1 (top) – June 2008

- The segment of the road surface through the repair area that was repaved in early 2007 showed a diagonal crack across the southbound lane at the south end of the repaved area. Photo S16-1 shows the crack, which had an aperture of 5 to 10 mm at the time of the inspection. The portion of the southbound lane bounded by the crack had downdropped between roughly 0 and 5 mm relative to the northbound lane. The approximate location of the crack is shown on the attached site plan.

Overall, the site appears to be in good condition after the 2006 repair and to date the SI's installed in the west embankment slope have shown that the pile wall appears to be preventing significant, ongoing landslide movement below the road surface. However, the cracking in the southbound lane may represent the southern flank of ongoing landslide movement that is damaging the road surface despite the pile wall installation. The cracking may also simply be the result of normal post-construction settlement of the backfill used to reconstruct the upper portion of the road embankment. Future inspections of the site will help to determine if the damage to the road surface is continuing or worsening.

Facing south across the segment of the southbound lane that was taken out of the service by the 2005 landslide and repaved following the 2006 repair.

The visible crack in the foreground and extending across the southbound lane at the south end of the repair area has formed since the spring of 2007. It may represent the south flank of continued landsliding affecting the highway (despite the installation of the pile wall), or simply post-construction settlement of the upper portion of the road embankment fill that was reconstructed in 2006.

- AT's maintenance contractor should seal the crack across the southbound lane at the south end of the repaved area.

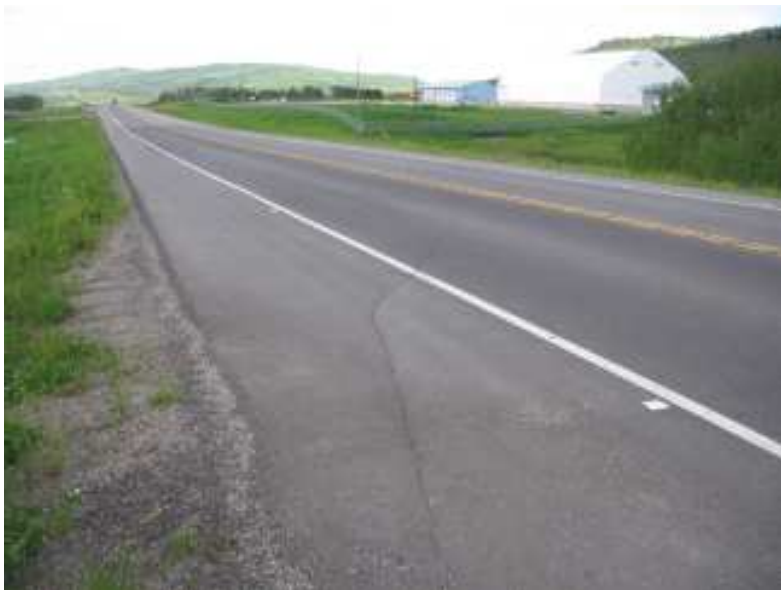
Photo S16-2 (bottom) – June 2008

- The north end of the repaved area did not show any signs of damage, as shown on Photo S16-2.
- The revegetation on the regraded embankment slopes was well-established, as shown on Photo S16-3.

Facing north across the segment of the southbound lane that was taken out of the service by the 2005 landslide and repaved following the 2006 repair.

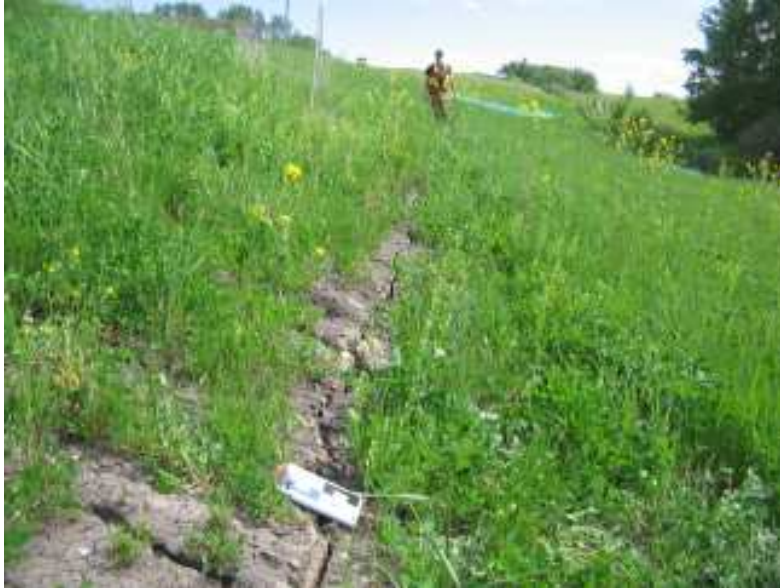
Photo S16-3 (top) – June 2008

- Settlement of the backfill used to bury the pile wall and reconstruct the west embankment slope had exposed the tops of most of the piles with an open tension crack having formed between the downslope side of the piles. Photos S16-3 and S16-4 show typical views of the exposed piles. The downdrop of the backfill on the downslope side of the pile wall was up to approximately 50 mm and the open tension crack along the downslope side of the pile wall varied in aperture up to approximately 30 mm.

Typical view facing south along the pile wall alignment on the west embankment slope. Settlement of the backfill used to bury the top of the pile wall and reconstruct the embankment slope has exposed the tops of most of the piles and opened a tension crack along the pile wall alignment.

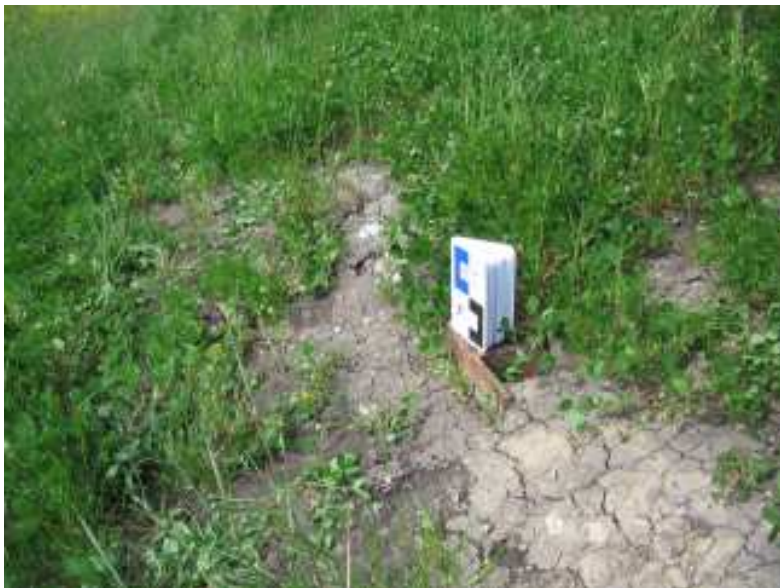
Photo S16-4 (bottom) – June 2008

Closer view of the exposed top of one of the piles.
