August 20, 2009

CG25309.B

**Re: Southern Region Geohazard Assessment Program
Site S16 – Chain Lakes, Highway 22:08
2009 Annual Inspection Report**

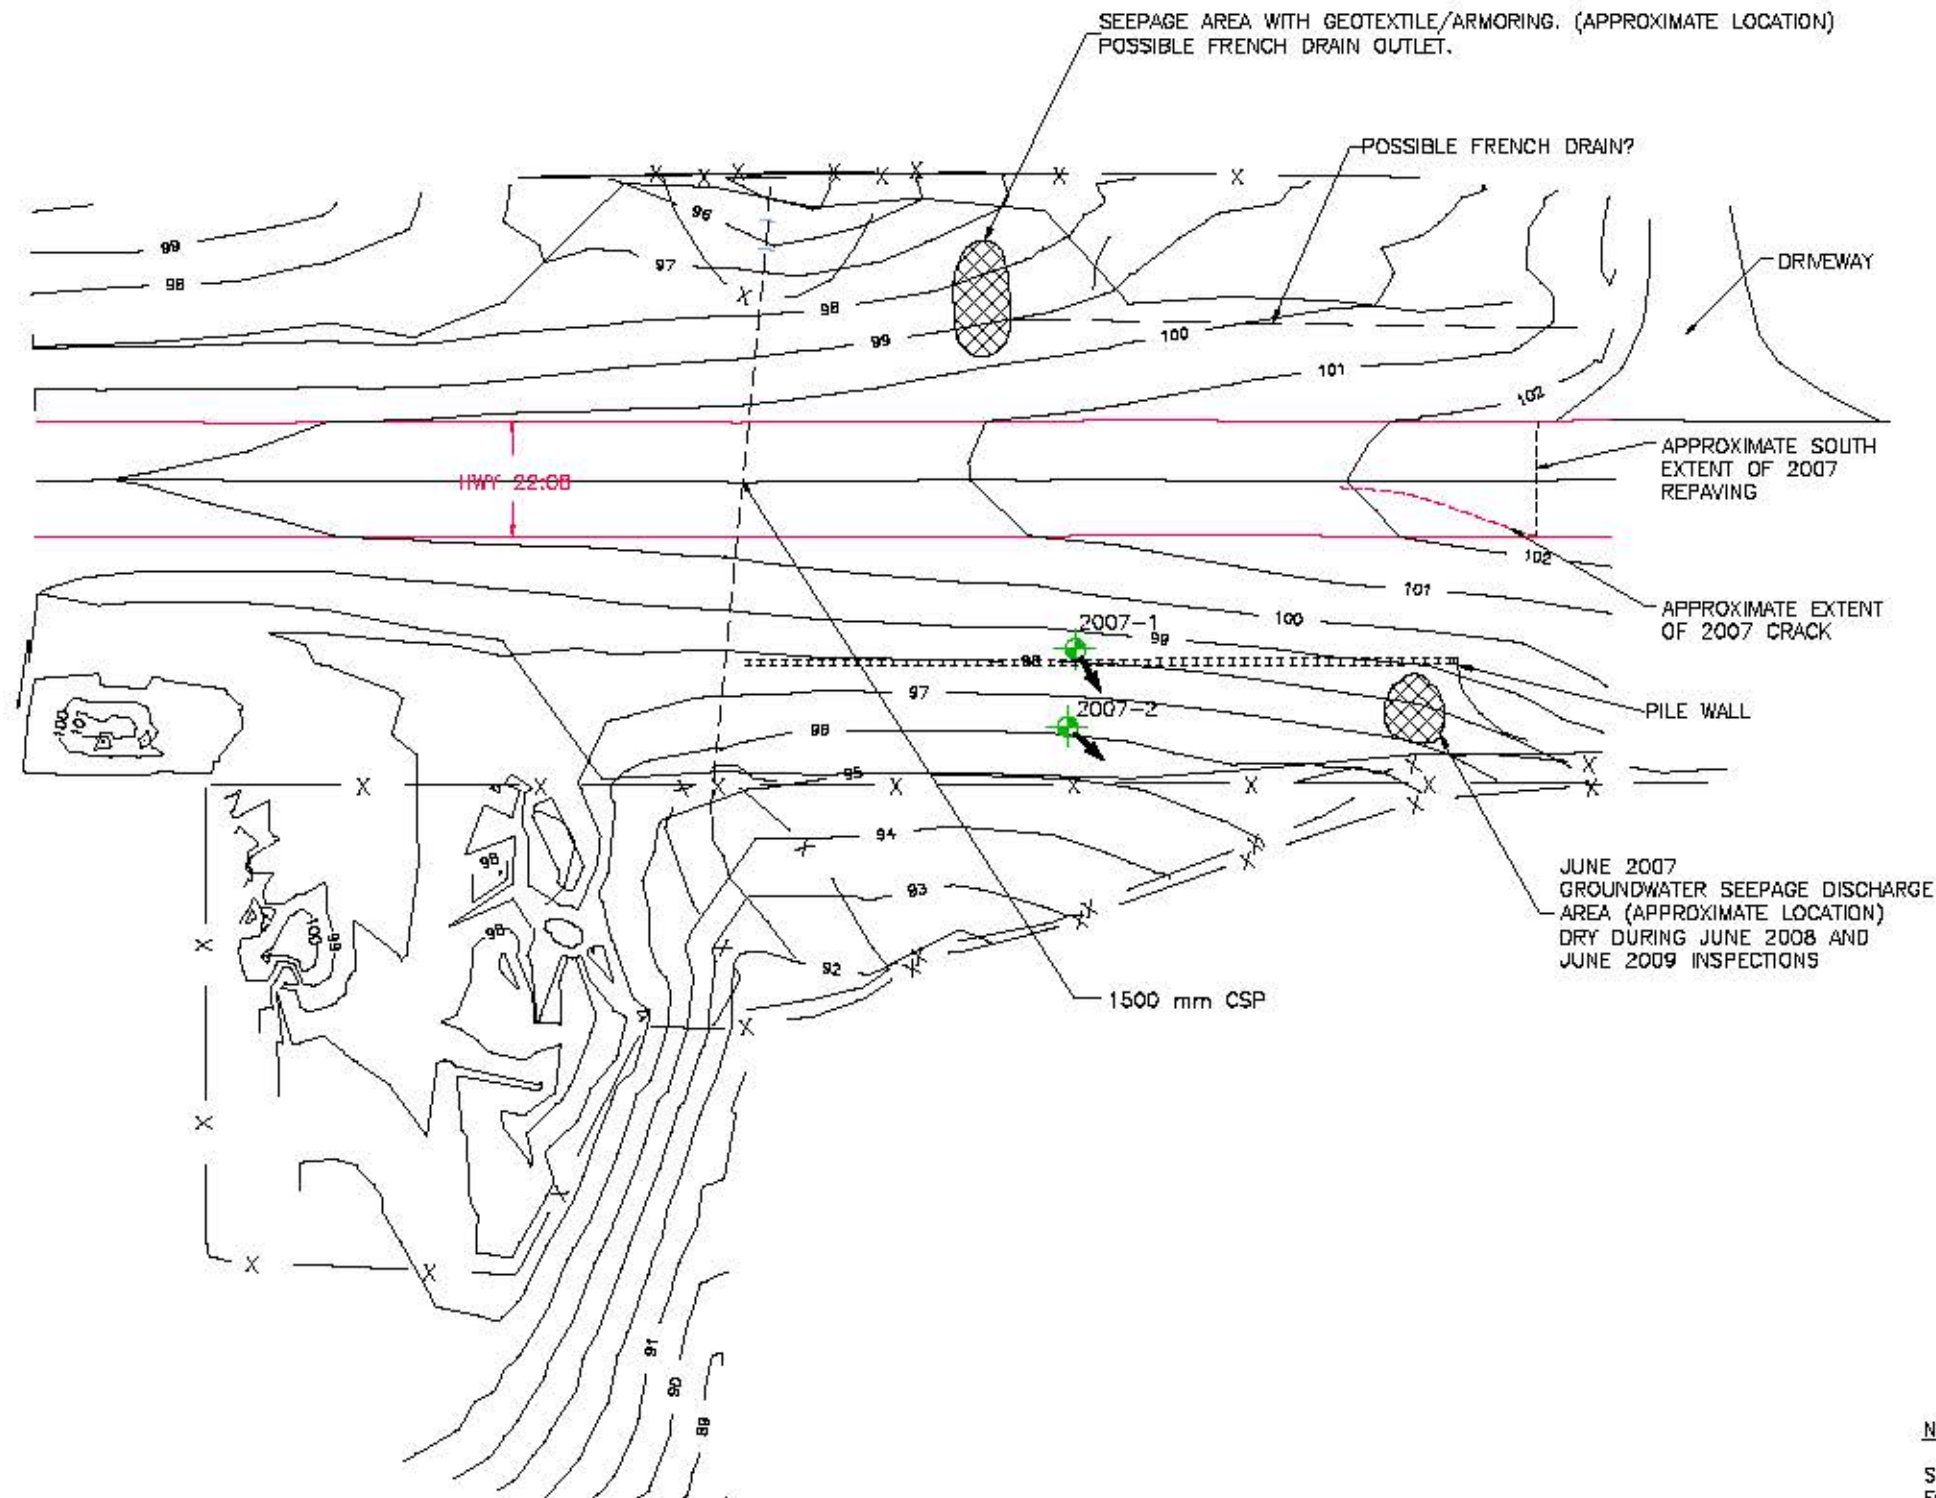
DATE: JULY 2009	JOB No.: CG25309.B	CAD FILE: 25309N22.dwg	FIGURE No.: FIGURE 1	REV: A

- The previously-noted diagonal crack across the southbound lane in the south end of the area that was repaved in 2007 after the repair was still visible. The crack's aperture (5 to 10 mm) and downdrop (0 to 5 mm) of the road surface on the downslope side of the crack had not changed significantly since the 2008 inspection (Photo S16-1). The approximate location of the crack is shown on the attached site plan (Figure 1).

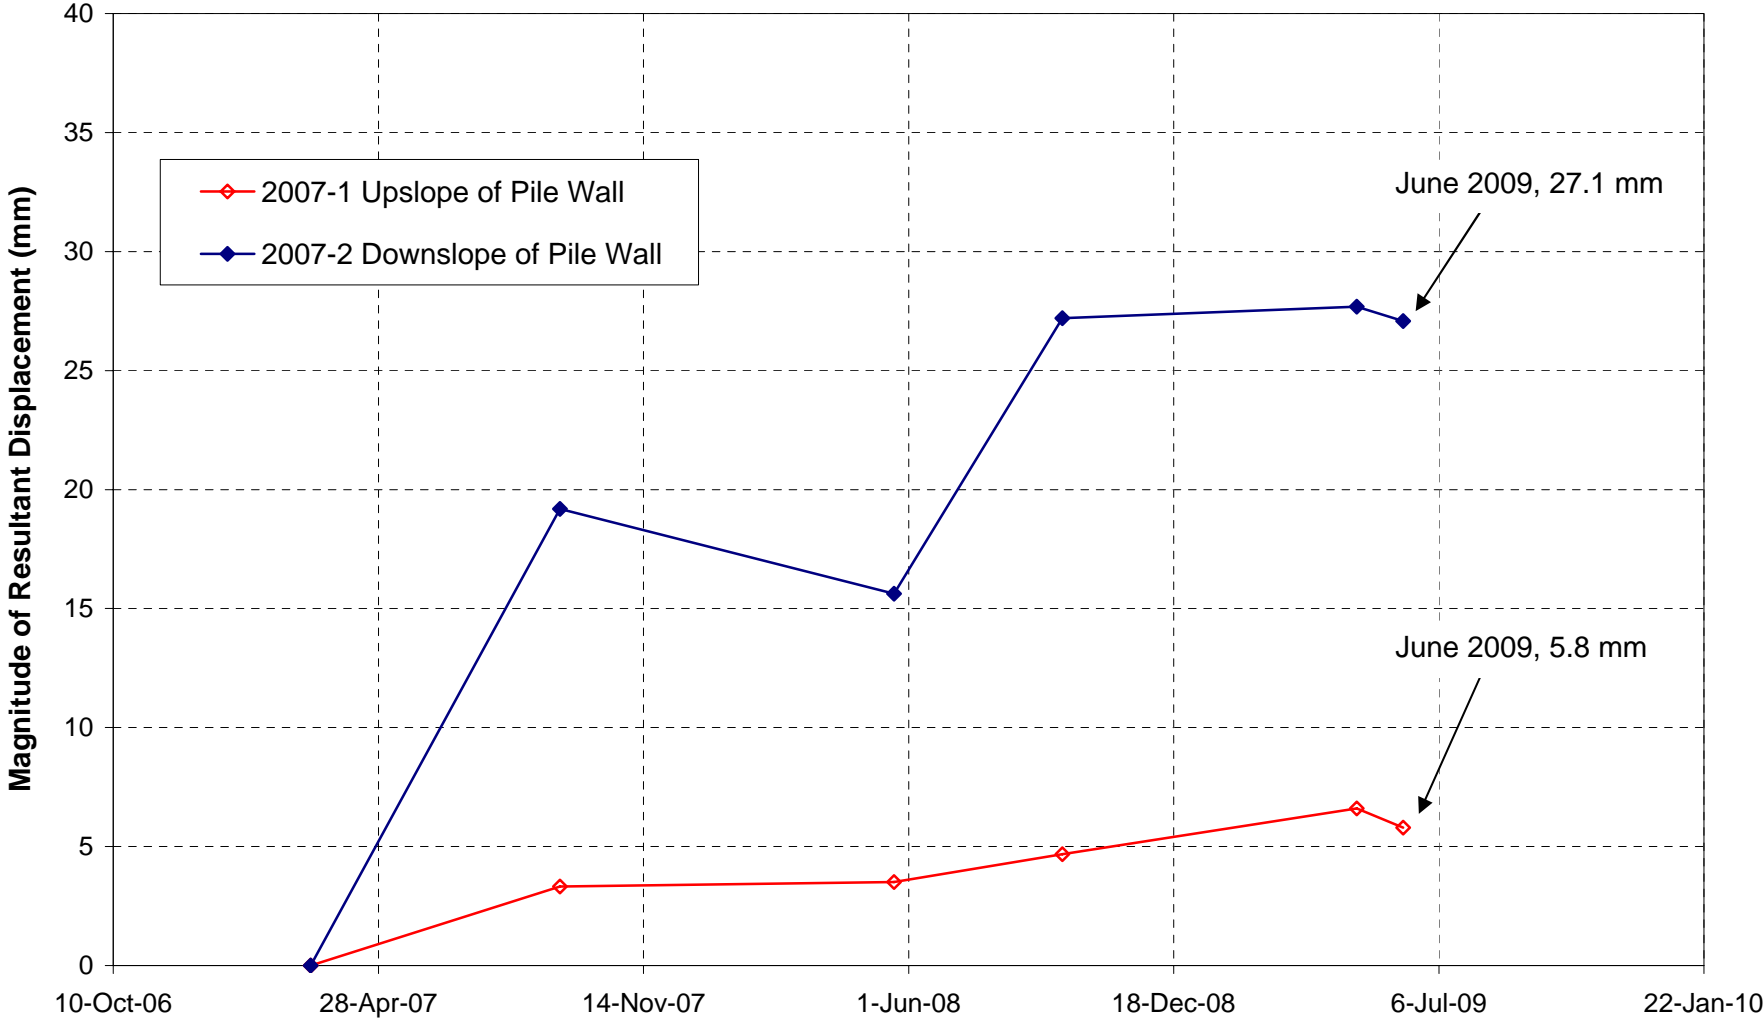
Figure 2

The two SI's were read during the June 2009 inspection as a supplement to the May 2009 readings on the planned spring/fall cycle. Neither of the SI's showed any significant additional movement since the May 2009 readings. An updated displacement vs. time plot for the movement zones identified in both SI's is attached as Figure 2. The data from these two SI's shows continued landslide movement around the elevation of the failure surface for the 2005 landslide, with nominal amounts of movement upslope of the pile wall and roughly four to five times as much movement downslope of the pile wall. Please refer to the report on the Spring 2009 instrument readings² for a more detailed discussion of the interpretation of the data from these two SI's.

AMEC recommends that the SI's be read again in September 2009 as part of the planned semi-annual instrument readings in the Southern Region. The condition of the crack in the road surface can also be checked at that time.

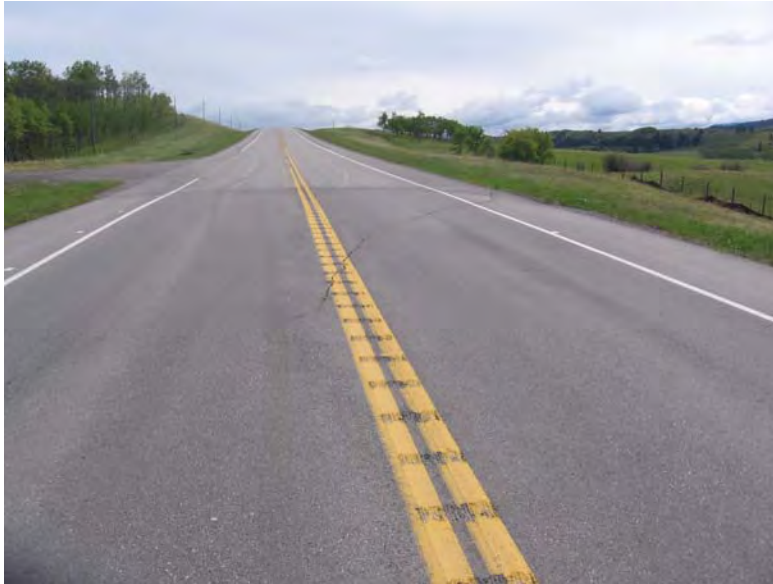
Photo S16-1 (top) – June 2009
Facing south across the southern end of the repair area that was repaved in early 2007. The crack across the southbound lane remains visible, and has not changed significantly since it formed during 2007.

AT's maintenance contractor should seal the crack across the southbound lane at the south end of the repaved area. This was also recommended after the 2008 inspection.

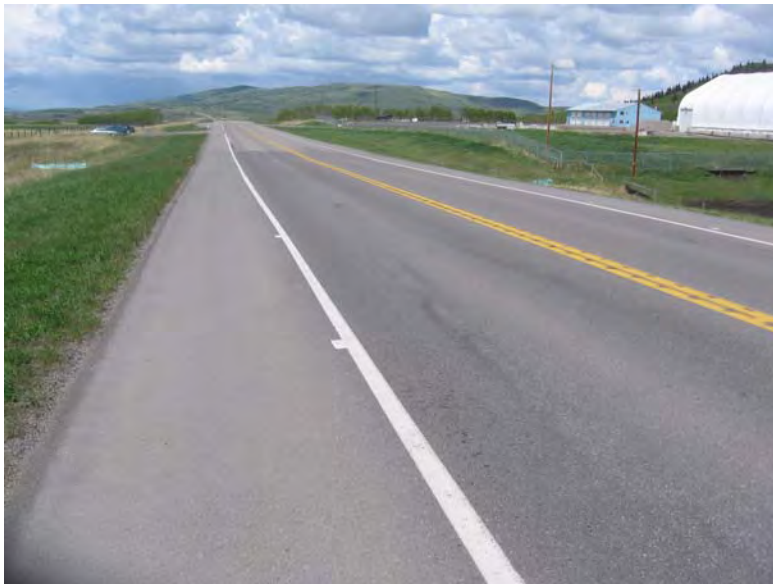
- The remainder of the area that was paved in 2007 continues to show no settlement or cracking (Photo S16-2).
- The exposure of the tops of most of the piles in the pile wall due to settlement of the backfill used to bury the pile wall and reconstruct the west embankment slope that was first noted in the 2008 inspection has not changed significantly. The downdrop of the backfill on the downslope side of the pile wall remains at up to approximately 50 mm and the open tension crack along the downslope side of the pile wall varied in aperture up to approximately 30 mm.

Photo S16-2 (bottom) – June 2009
Facing north across the repair area that was repaved in early 2007. Aside from the crack at the southern end (shown in Photo S16-1) there has been no significant settlement or cracking of the road surface adjacent to the 2006 pile wall repair and trenchless culvert replacement.
