SITE NUMBER AND NAME: S044 Cow Creek Washouts		HIGHWAY & KM: 22:06, 11.745	PREVIOUS INSPECTION DATE: June 15, 2016	INSPECTION DATE: June 1, 2017
LEGAL DESCRIPTION: 04/05-35-008-02 W5M 09-34-008-02 W5M	NAD 83 COORDINATES: UTM Northing Easting 11 5507840 703272		RISK ASSESSMENT: PF: 11 CF: 4 TOTAL: 44	
AVERAGE ANNUAL DAILY TRAFFIC (AADT): 1425 (north), 1440 (south), (Ref No. 60220660)			CONTRACTOR MAINTENANCE AREA (CMA): 26

SUMMARY OF SITE INSTRUMENTATION: None LAST READING DATE: n/a	INSPECTED BY: Chris Gräpel (KCB) Peter Roy (KCB) Ross Dickson (AT) Roger Skirrow (AT) Ammar Zaidi (TA)
PRIMARY SITE ISSUE: Creek erosion adjacent to highway.	
APPROXIMATE DIMENSIONS: Four erosion sites with near vertical erosion scarps 2 to 3 m high, between 10 and 20 m long. The four sites are located along an 800-m length of highway.	
DATE OF ANY REMEDIAL ACTION: Guardrails at Sites B and D installed 3 to 4 years ago.

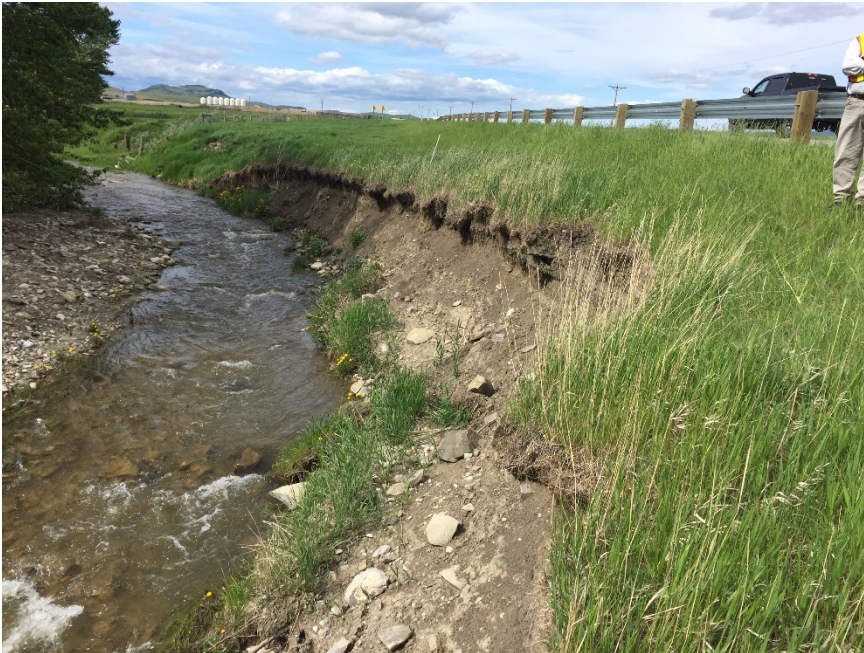
Photo 1 **Site D - edge of scarp 3.2 m from edge of pavement. Gravel bed and scour hole formed and erodible material in cut bank. Photo was taken facing north on June 1, 2017.**

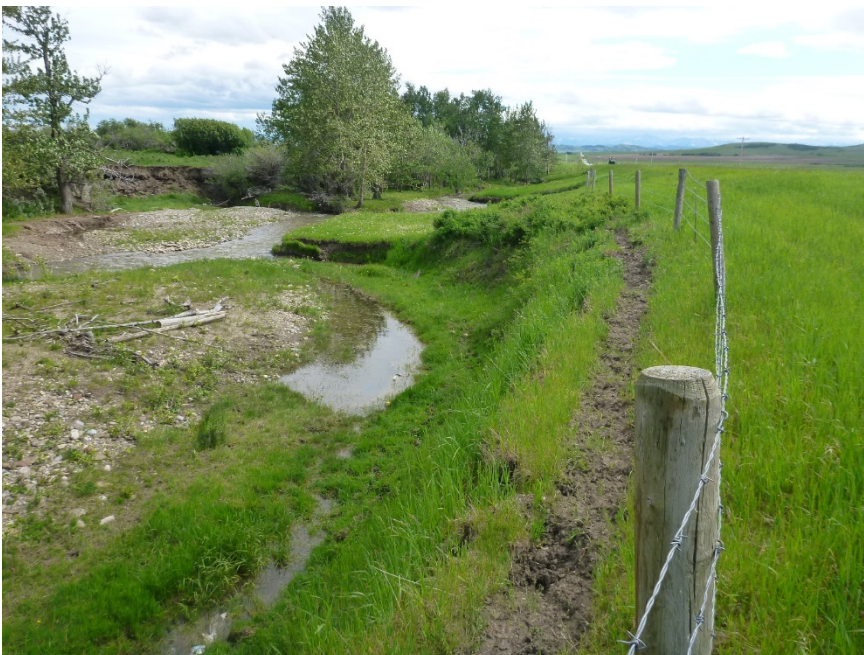
Photo 2 **Site C (north) – Erosion has occurred in a side channel which had some ponded water at the time of inspection. Main channel 15 m to right of side channel. Gravel bed and scour hole formed and erodible material in cut bank. Photo was taken facing south on June 1, 2017.**

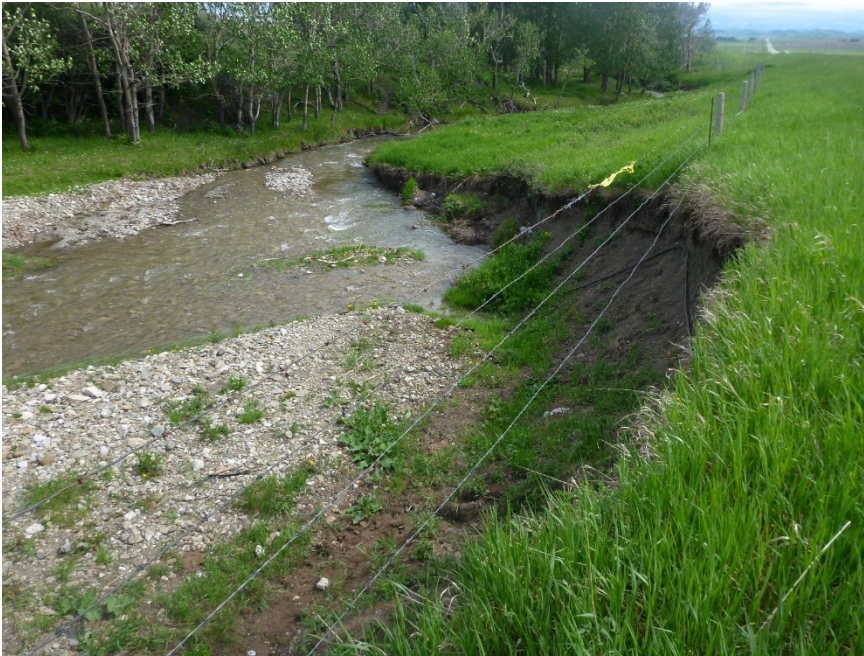
Photo 3 **Site C (south) - erosion scarp undermining fence. Gravel bed and scour hole formed and erodible material in cut bank. Photo was taken facing south on June 1, 2017.**

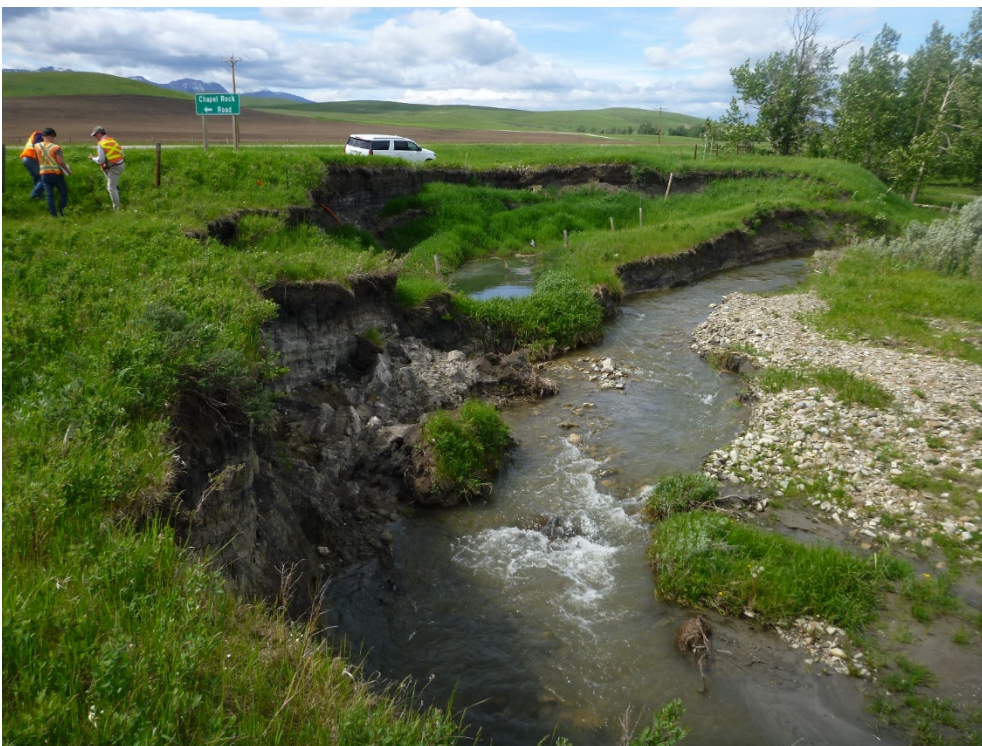
Photo 4 **Site B - erosion scarp undermining fence with retrogressing back scarp instability approaching ditch. Photo was taken facing north west on June 1, 2017.**

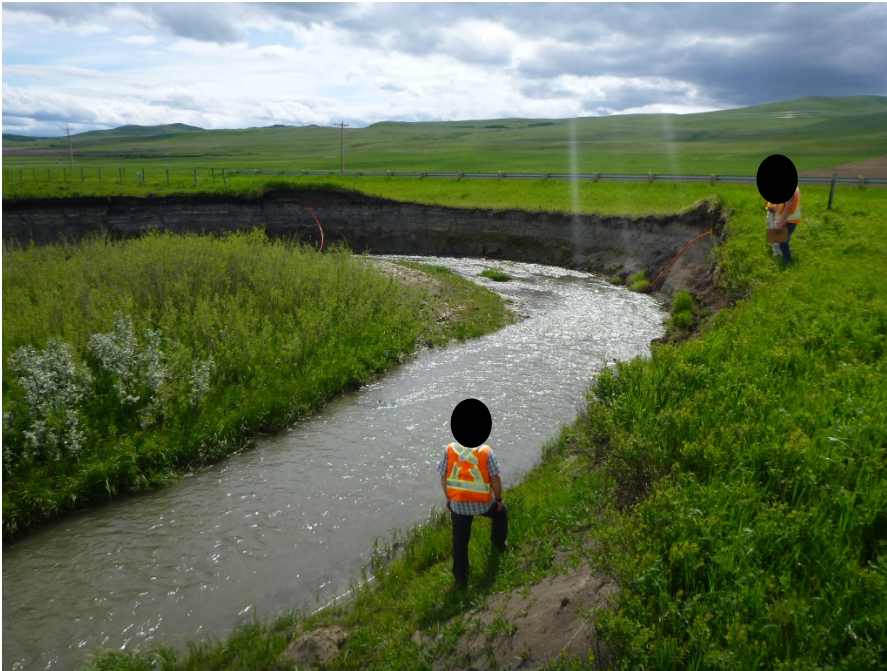
Photo 5 Site A - erosion scarp with retrogressing back scarp instability extending into ditch. Photo was taken facing south west on June 1, 2017.

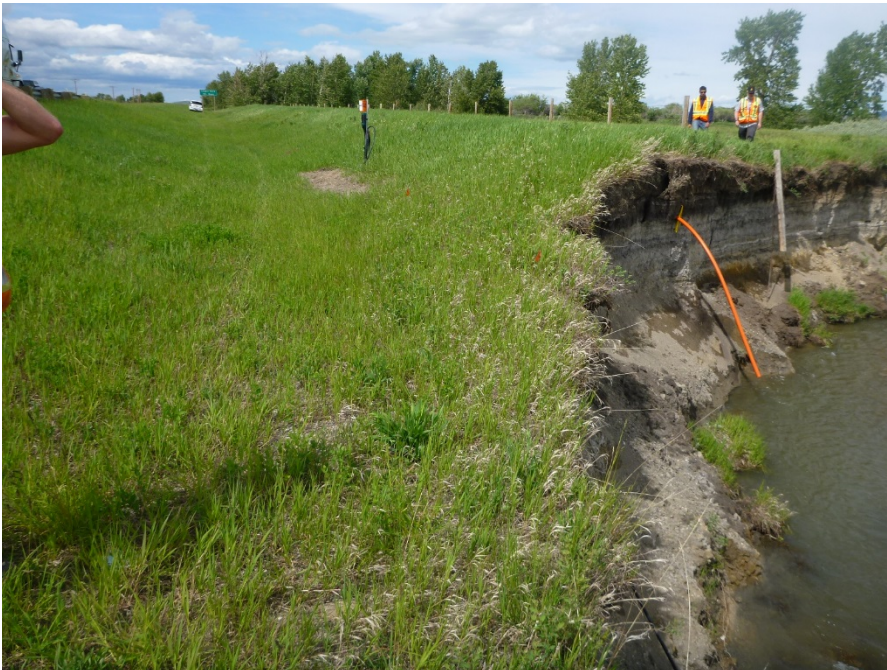
Utility cable exposed at Site A where erosion has retrogressed into ditch.

Photo 5 Site A - erosion scarp undermining fence with retrogressing back scarp instability extending into ditch. Note orange-cased utility cable undermined by erosion. Photo was taken facing north east on June 1, 2017.
