SITE NUMBER AND NAME: <b>S044 Cow Creek Washouts</b>		HIGHWAY & KM: 22:06, 11.745	PREVIOUS INSPECTION DATE: June 1, 2017	INSPECTION DATE: <b>May 2, 2018</b>
LEGAL DESCRIPTION: 04/05-35-008-02 W5M 09-34-008-02 W5M	NAD 83 COORDINATES: UTM Northing Easting 11 5507840 703272		RISK ASSESSMENT: PF: 9 CF: 1 TOTAL: 9	
AVERAGE ANNUAL DAILY TRAFFIC (AADT): 1425 (north), 1440 (south), (Ref No. 60220660)			CONTRACTOR MAINTENANCE AREA (CMA): 26

PROJECT SOUTHERN REGION GEOHAZARD RISK MANAGEMENT PROGRAM		
TITLE Site Plan S044 - Cow Creek Hwy 22:06 km, 11.745		
SCALE 1:4,000	PROJECT No. A05115A03	FIG No. 1

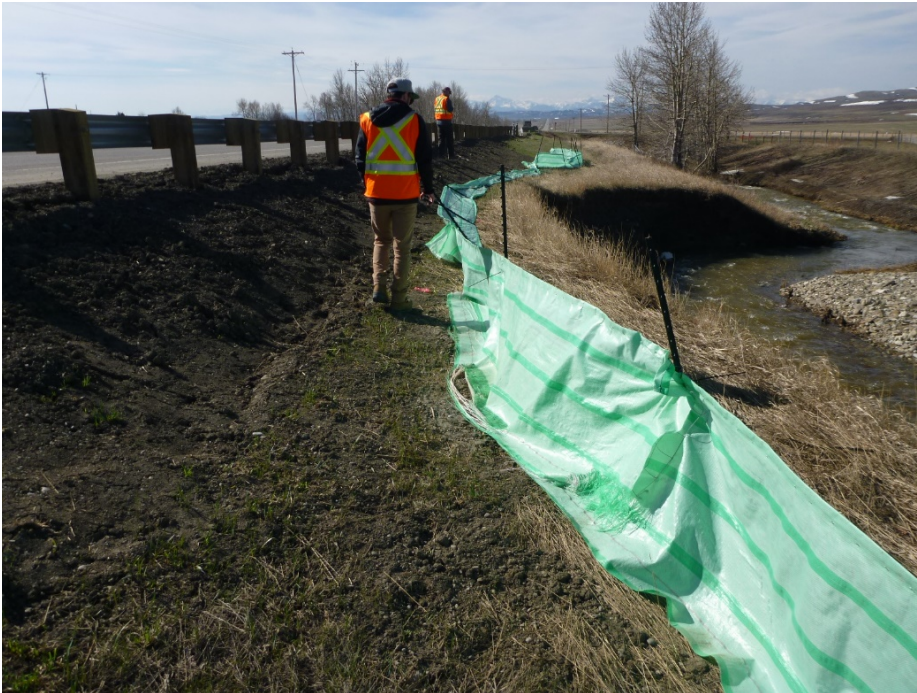
**Photo 1**      **Site D – Sheet pile wall was installed 1.5 m off the highway shoulder. Guard rail replaced. Photo was taken facing south on May 2, 2018.**

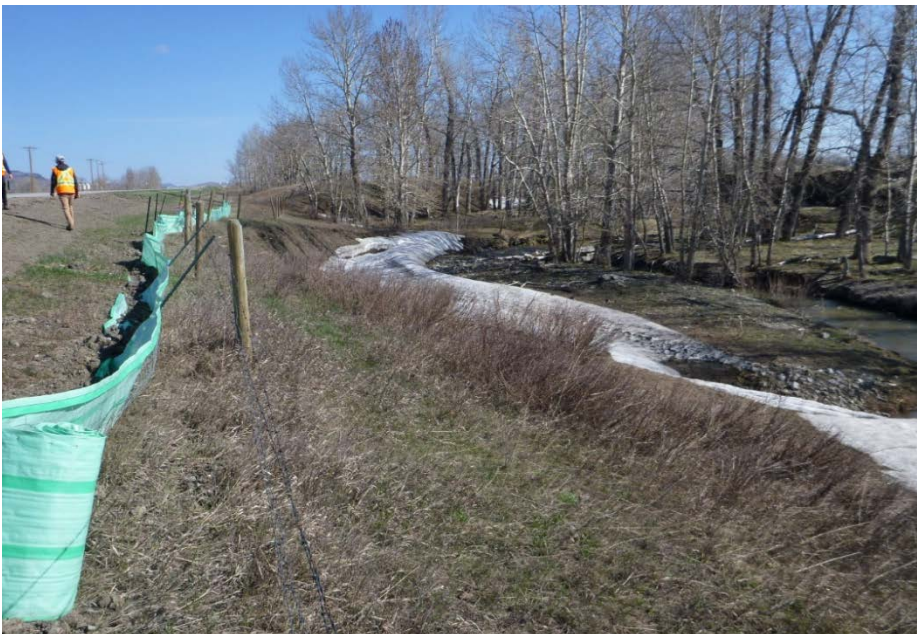
**Photo 2**      **Site C (north) – Erosion has occurred in a side channel which had some ponded water at the time of inspection. Main channel 15 m to right of side channel. Sheet pile wall installed 1.5 m off the highway shoulder. Photo was taken facing north on May 2, 2018.**

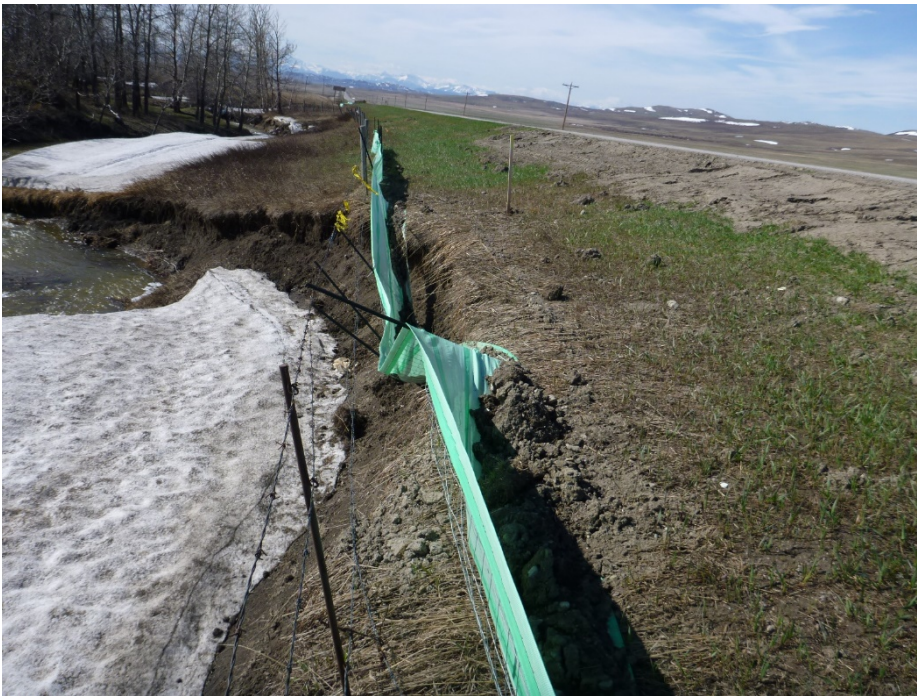
**Photo 3** Site C (south) - Sheet pile wall installed between highway and edge of scarp. Photo was taken facing south on May 2, 2018.

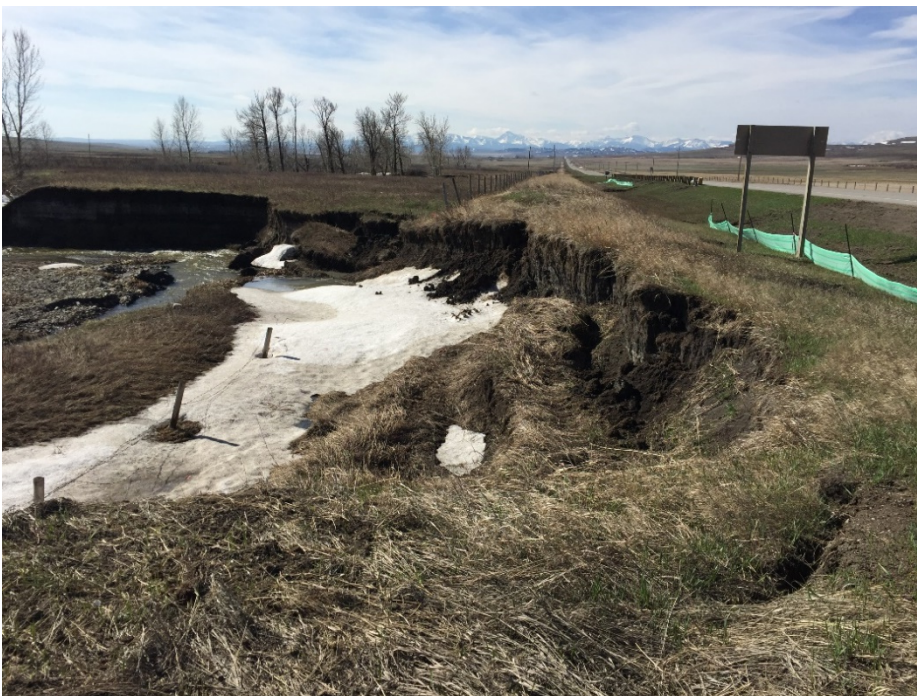
Main scarps from erosion have retrogressed into the ditch at Site A and B, but gully erosion between ditch and creek into creek has not started yet.

**Photo 4** Site B - erosion scarp undermining fence with retrogressing back scarp instability approaching ditch. Sheet pile wall installed 1.5 m off the highway shoulder. Photo was taken facing north west on south on May 2, 2018.

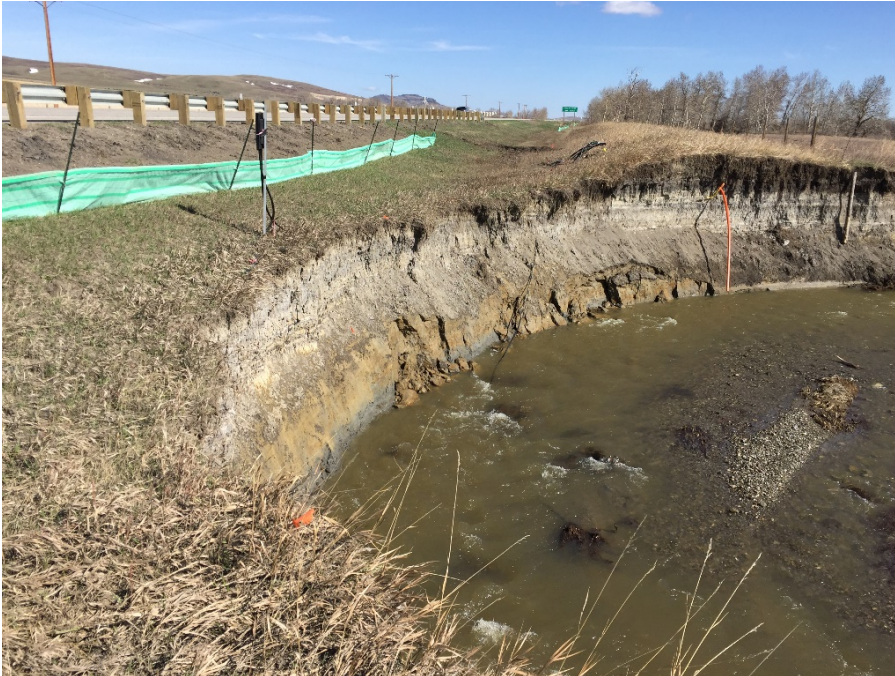
Utility cable exposed at Site A where erosion has retrogressed into ditch.

**Photo 5** Site A - erosion scarp with retrogressing back scarp instability extending into ditch. Sheet pile wall installed 1.5 m off the highway shoulder. Guard rail replaced. Photo was taken facing north on May 2, 2018.

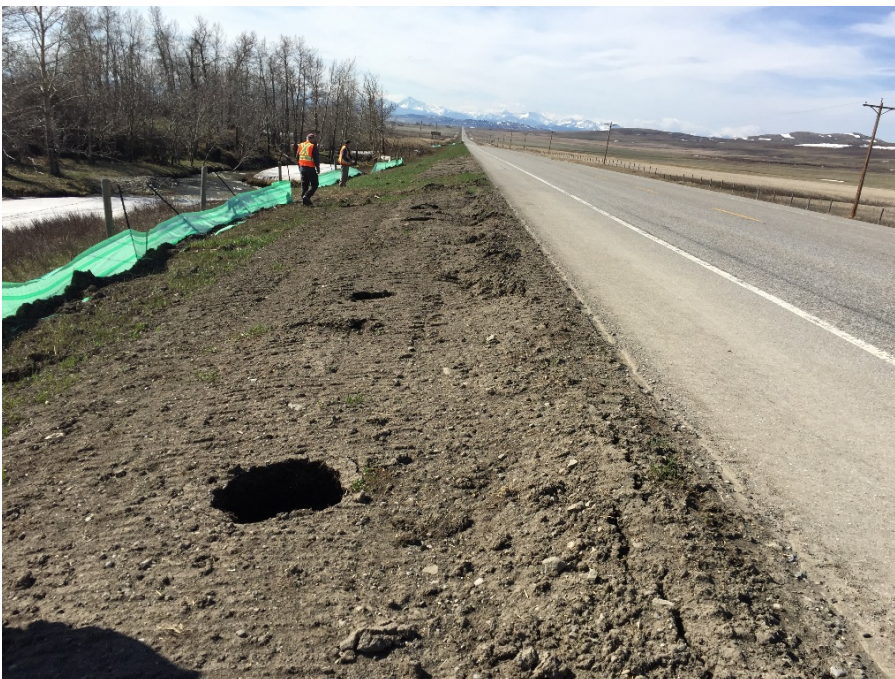
**Photo 6** Sink holes up to 1 m deep where noted across all 4 sites due to the recent construction activities. The contractor who installed the sheet piles were contacted instructed to get these remediated as soon as possible.

The presence of sink holes and excavations for utility locates at the site were communicated to the contractor to get the holes filled as soon as possible. The holes are a hazard to the public who walk at the edge of the highway.
