Site 27 – Rock Glacier Site

PROJECT: HWY 40/HWY 541 GEOHAZARDS REVIEW			
CLIENT: Alberta INFRASTRUCTURE AND TRANSPORTATION		ROCK GLACIER SITE			
DATE:	DECEMBER 2005	JOB No.:	CG25211	CAD FILE:	25211N03.dwg
FIGURE No.:	FIGURE EB	REV.:	A

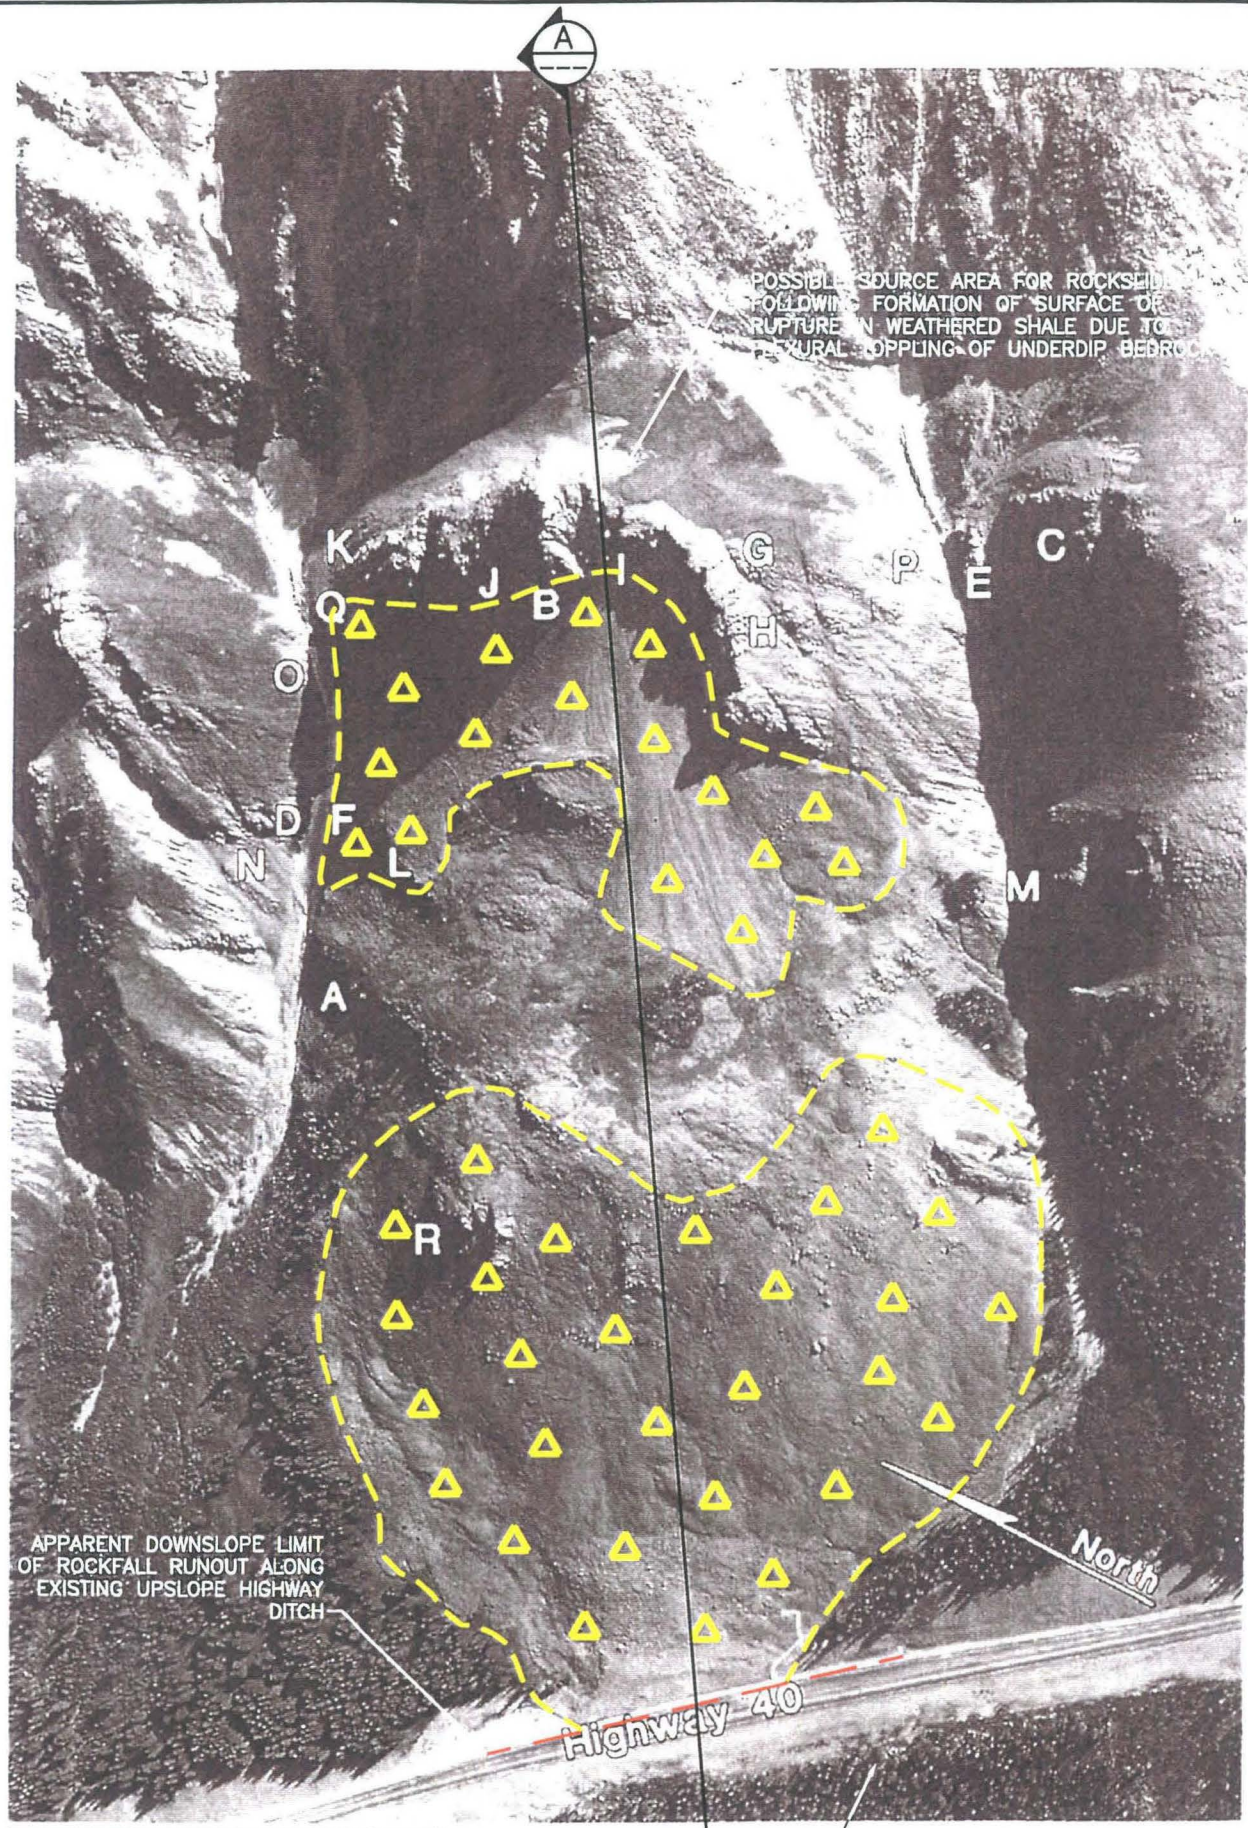
McAfee and Cruden (1996) presented the results of research on landslides at the Rock Glacier site during which hazards from rockfalls, toppling failures and rockslides were identified. A copy of an airphoto of the site from McAfee and Cruden (1996) is attached as Figure E8. This airphoto shows the proximity of the colluvium and bedrock slopes to Highway 40 and has been further annotated as noted in the following discussion.

Notwithstanding the boulders downslope of the highway and the apparent rockfall shadow angle of 31°, the rockfall hazard at the highway is judged to be low based on the lack of evidence or documented reports of rocks rolling onto the road at this site since the current highway was constructed. Also, if large rocks are carried down to the highway by avalanches this would occur when this segment of the highway is closed between December 1st and June 15th of each year and therefore present no risk to motorists.

BOULDERS NOTED DOWNSLOPE OF HIGHWAY - APPARENT ROCKFALL RUNOUT PREDATING THE HIGHWAY (REPORTED IN MCAFFEE AND CRUDEN (1996))

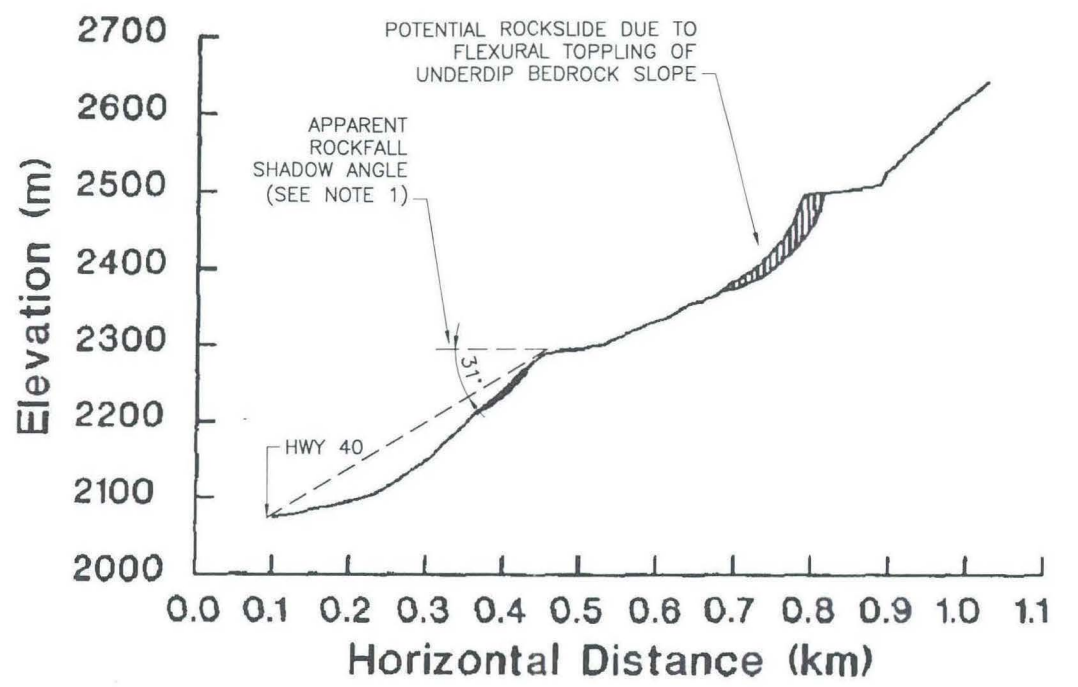
A SECTION

Figure E8 includes a cross-section adapted from McAfee and Cruden (1996) that shows the results of a slope stability analysis for the Rock Glacier site where a potential rockslide with a volume of approximately 50,000 m³ of material was identified. The possible source area for such a slide is marked on the airphoto on Figure E8. Such a rockslide could occur as a series of smaller movements with relatively little risk to the highway, however the hazard of a single, major rockslide event cannot be ruled out on the basis of:

- Probability Factor of 3 based on the low probability of rockslide occurrence.
- Consequence Factor of 2 based on a scenario where a large rockslide originates around 2300 to 2500 m elevation above the highway (see the cross-section on Figure E8) and has a similar runout distance to the possible previous rockslide deposits identified slightly upslope of the highway. Debris from such a rockslide could encroach onto the highway and require heavy equipment to clean up, however the road would likely not be completely blocked.
