## Site 26 – Pocaterra Creek Slope

| PROJECT: HWY 40/HWY 541 GEOHAZARDS REVIEW | | | | |
| TITLE: POCATERRA CREEK SLOPE | | | | |

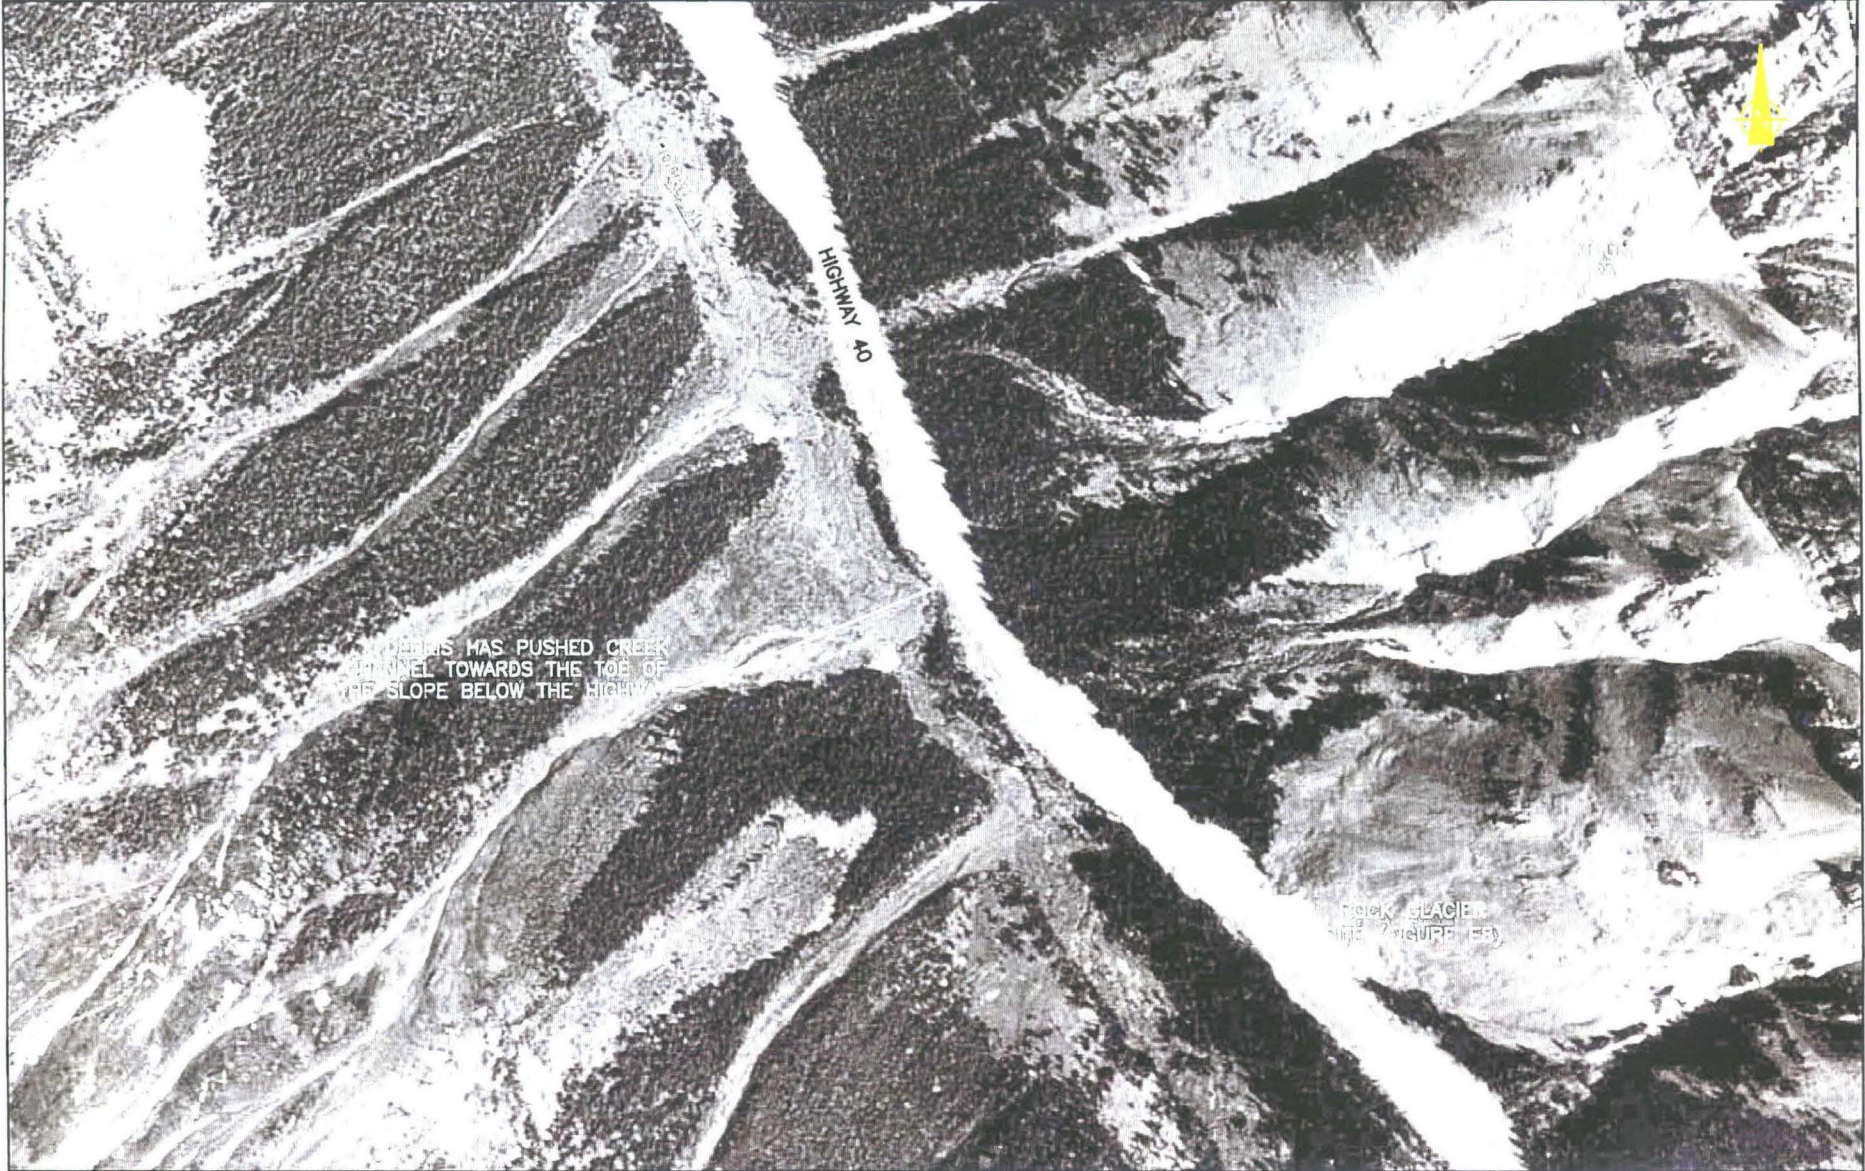
| DATE: DECEMBER 2005 | JOB No.: CG25211 | CAD FILE: 25211N01.dwg | FIGURE No.: FIGURE E7 | REV. A |

The airphoto on Figure E7 shows that debris from an avalanche track/tributary creek channel on the west side of the valley has deflected the channel of Pocaterra Creek to the east (i.e. towards the highway). It appears that the creek channel is eroding the toe of the steep slope below the highway at this location. The creek channel was confirmed to be flowing along the toe of the slope during the field inspection, however the bank erosion did not appear to be significantly destabilizing the slope below the highway. The slope did show signs of shallow soil creep (e.g. curved tree trunks) that appeared to be unrelated to toe erosion at the creek bank. There were no significant slump block scarps or signs of retrogressive instability that could threaten the highway.

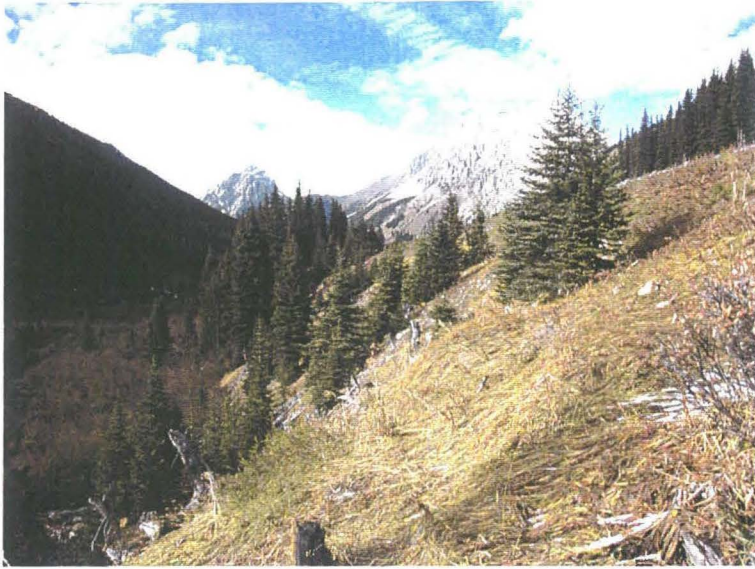
**Photo 1** (top) – Facing north across the slope below the highway. The guardrail along the west side of the highway is visible in the upper right portion of the photo. The slope angle is approximately  $41^{\circ}$  and the crest of the slope is offset approximately 6 m from the guardrail. The vertical height of the slope is approximately 25 m. The toe of the slope is along the east bank of the Pocaterrea Creek channel.

There are signs of shallow soil creep on the slope face but no indications of significant slumping or retrogressive instability that could directly affect the highway.

AMEC recommends that visual inspections of this slope be performed annually in order to:

- Monitor the offset of the crest of the slope from the guardrail,
- Check the condition of the slope face,
- Check the creek erosion conditions at the toe of the slope.

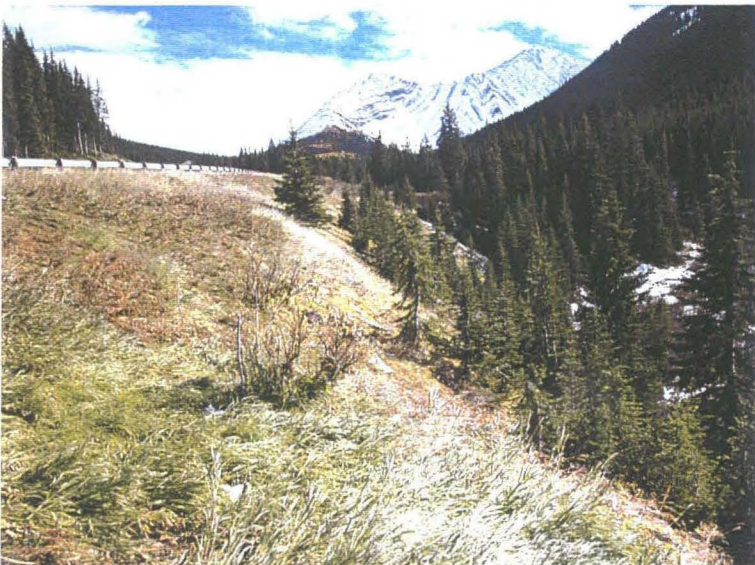
**Photo 2** (bottom) – Facing south across the slope with the relative position of the highway, the slope and the Pocaterrea Creek channel visible.
