## Site 25 – Elbow Pass Cut Slope

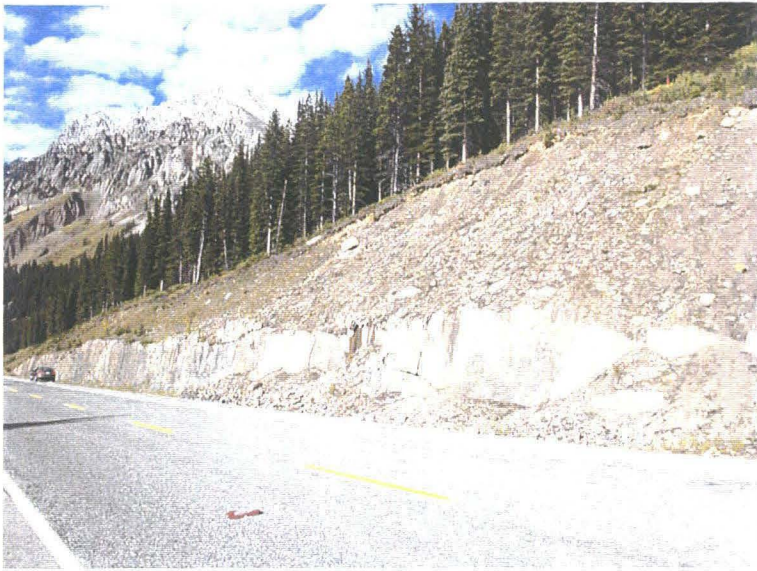
There is a soil and rock cut slope approximately 600 m south of the parking area at the Elbow Pass trailhead (Photo 1). The cut slope has a total height of approximately 6 to 8 m and consists of two distinct components:

- The upper portion of the cut slope exposes rocky soil at an angle of approximately  $42^\circ$  and over a vertical height of approximately 4 to 5 m.
- The lower portion of the cut slope is near-vertical and approximately 2 to 3 m high. The bedrock dips near-vertically and down towards the west, therefore the lower portion of the bedrock exposes the bedding plane.

The majority of the rockfall debris from this cut slope appears to originate from the rocky soil in the upper portion of the cut slope. The size of the rockfall debris varies from gravel to boulders. Some segments of the cut slope had significant volumes of rockfall debris accumulated in the ditch. There was no rockfall debris on the road at the time of the inspection in September 2005, however some of the debris in the ditch was within 1 m of the edge of the pavement (Photo 2).

**Photo 1** (top) – Facing north across the rock cut site to the south of the Elbow Pass hiking trail parking area. The majority of the rockfall debris is generated from the exposed rocky soil in the upper portion of the cut slope.

AMEC recommends that the accumulated rockfall debris be cleared from the ditch in order to restore the full capacity of the ditch. The Consequence Factor could then be reduced to 1 and the corresponding Risk Level reduced to 14 if the ditch capacity is maintained with future clearing as necessary.

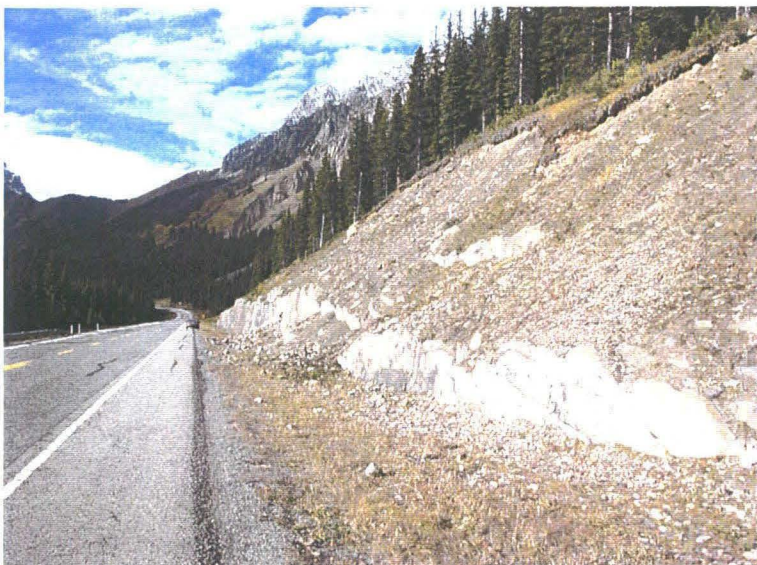
- Probability Factor of 14 based on the visual evidence of many rockfalls (possibly near-ongoing) at this site.
- Consequence Factor of 2 based on the potential for rockfall debris being deposited onto the edge of the northbound lane under the current ditch conditions.

Therefore, the recommended Risk Level for this site is 28.

**Photo 2** (middle) – Facing north along the ditch. The rockfall debris from the cut slope is contained within the ditch. As the volume of debris in the ditch builds up, some of the larger rocks roll closer to the edge of the pavement. At the time of the September 2005 inspection there were some cobble-sized rocks within 1 m of the edge of the pavement.

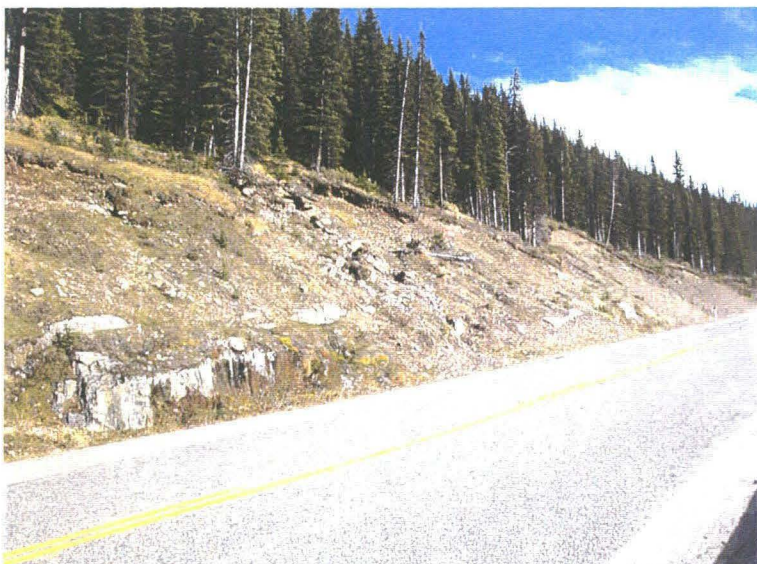
The soil cut slope approximately 630 m south of the parking area at the Elbow Pass trailhead is approximately 8 m high at a slope angle of around 40°. A slump has occurred in the soil slope and nearly blocked the ditch with debris along with almost burying a culvert inlet (Photos 3 and 4). It appears that this slump has been triggered by groundwater seepage in the cut slope and has been occurring on an ongoing basis in recent years.

- Probability Factor of 9 based on the apparent ongoing slumping in the cut slope.
- Consequence Factor of 1 based on the deposition of debris into the ditch but without any immediate impact to driver safety.

Therefore, the recommended Risk Level for this site is 9.

**Photo 3** (middle) – Approximately 30 m south of the area shown in Photos 1 and 2 the cut slope is entirely in soil. At this location, a slump has occurred in the soil slope. The debris from the slump has blocked the ditch and nearly buried a culvert inlet. It appears that this slump has been triggered by groundwater seepage in the cut slope and has been occurring on an ongoing basis in recent years.

It is recommended that the slump debris be cleared from the ditch in order to restore the ditch gradient and keep the culvert inlet open. The debris should be excavated down to the elevation of the culvert inlet. Slump debris should be cleared from the ditch as necessary in the future to keep the ditch and culvert inlet clear.

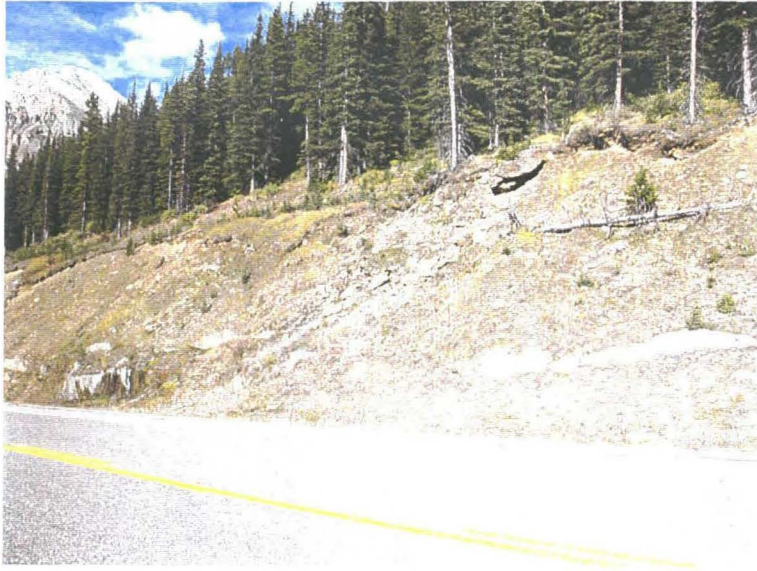
**Photo 4 (top)** – Another view of the cut slope slumping shown in Photo 3.
