Site 24 – Elpoca Mountain Debris Flows

PROJECT: HWY 40/HWY 541 GEOHAZARDS REVIEW

TITLE: ELPOCA MOUNTAIN DEBRIS FLOWS

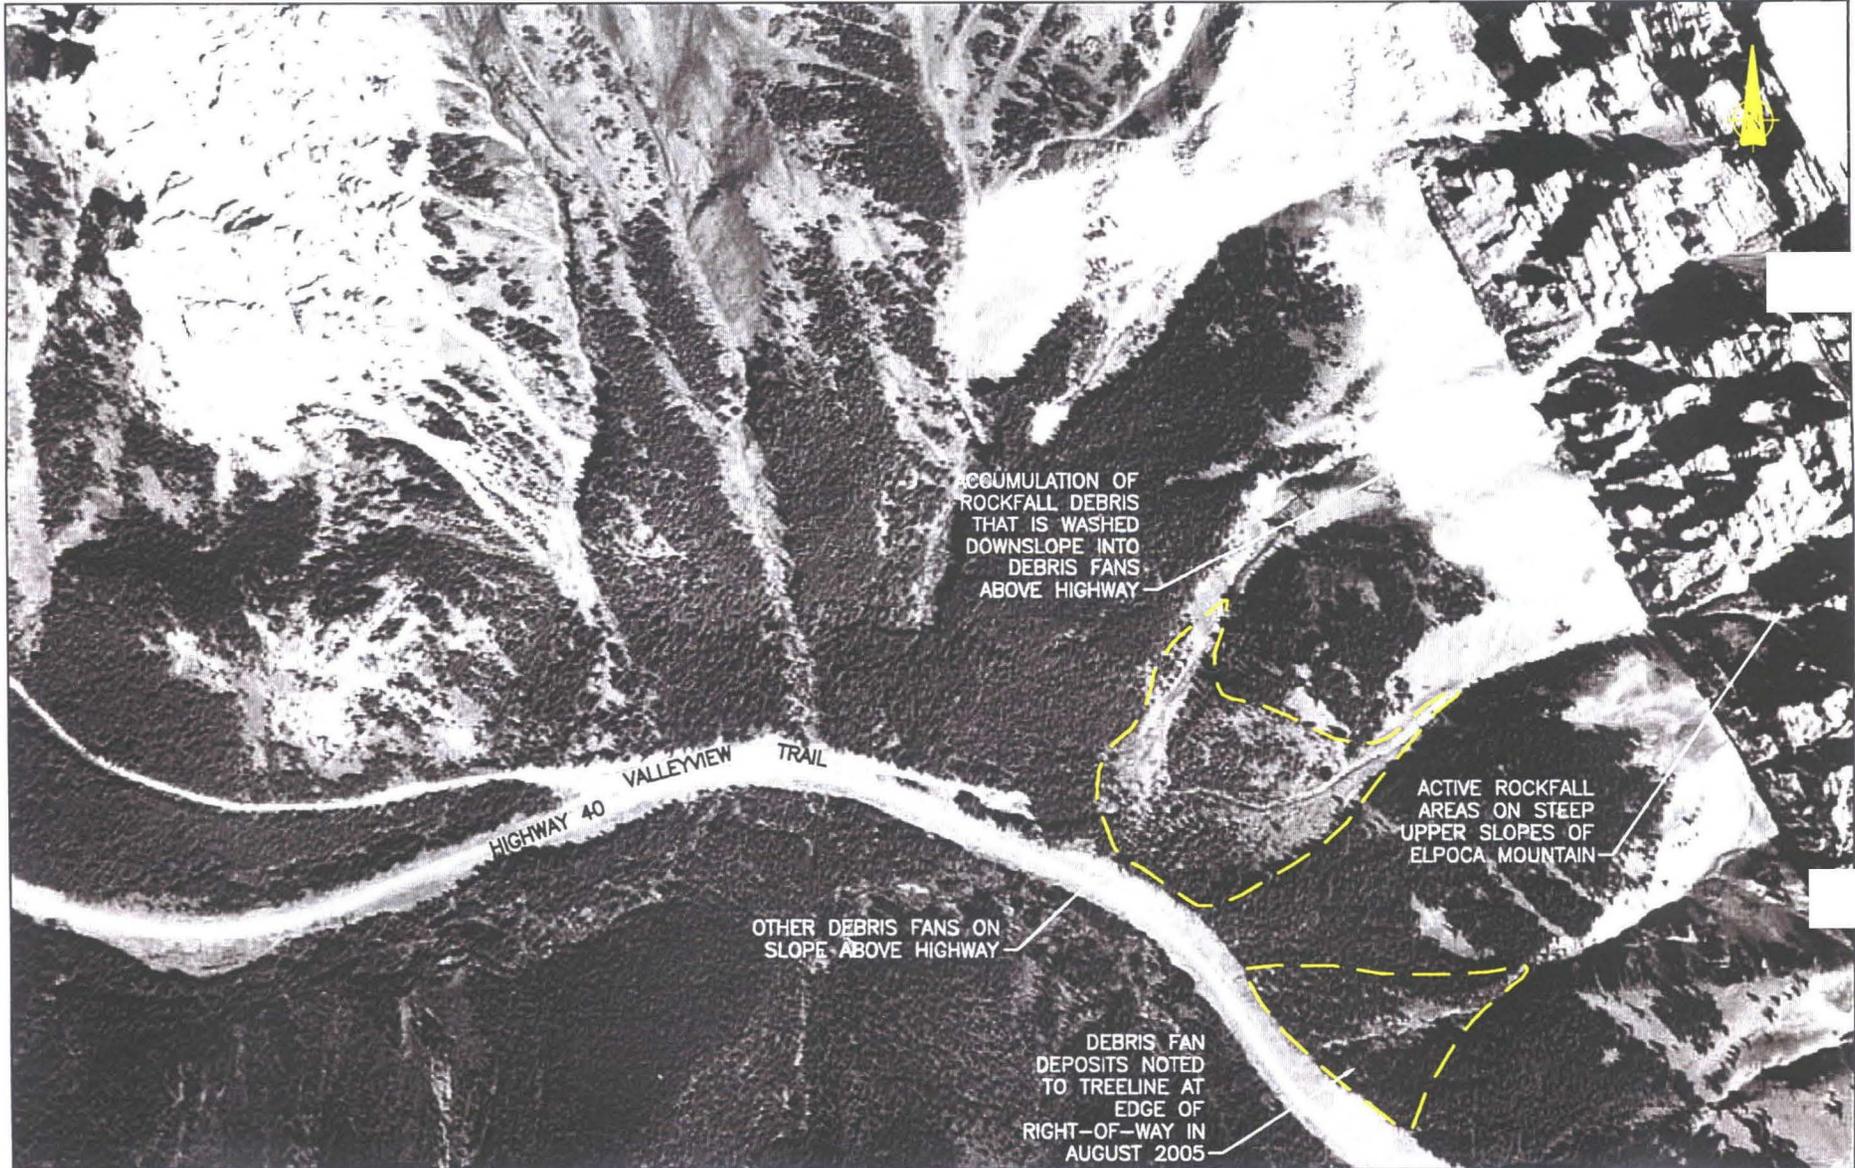
DATE: DECEMBER 2005	JOB No.: CG25211	CAD FILE: 25211N01.dwg	FIGURE No.: FIGURE E6	REV. A
------------------------	---------------------	---------------------------	--------------------------	-----------

The creek channel was traversed for a distance of approximately 300 m upslope of the highway. The debris flow deposits were noted in the treed area above the right-of-way and are not visible from the highway. The approximate extent of the debris flow deposits is shown on Figure E6. The segment of the creek channel between the treeline above the highway and roughly 200 m further upslope was poorly defined within the blanket of debris on the slope. It appeared that the creek channel in this area had been infilled with debris earlier in 2005 and the creek flow went overland across the debris on the slope. The debris blanketing the slope tapers out around the treeline along the east edge of the right-of-way, as shown on Figure E6.

The airphoto on Figure E6 also shows two other debris fans on the slope above the highway and a short distance northwest from the debris fan that was traversed. These debris fans appear to be similar in form to the one shown on Photos 2 to 4 and they do not extend into the cleared highway right-of-way.

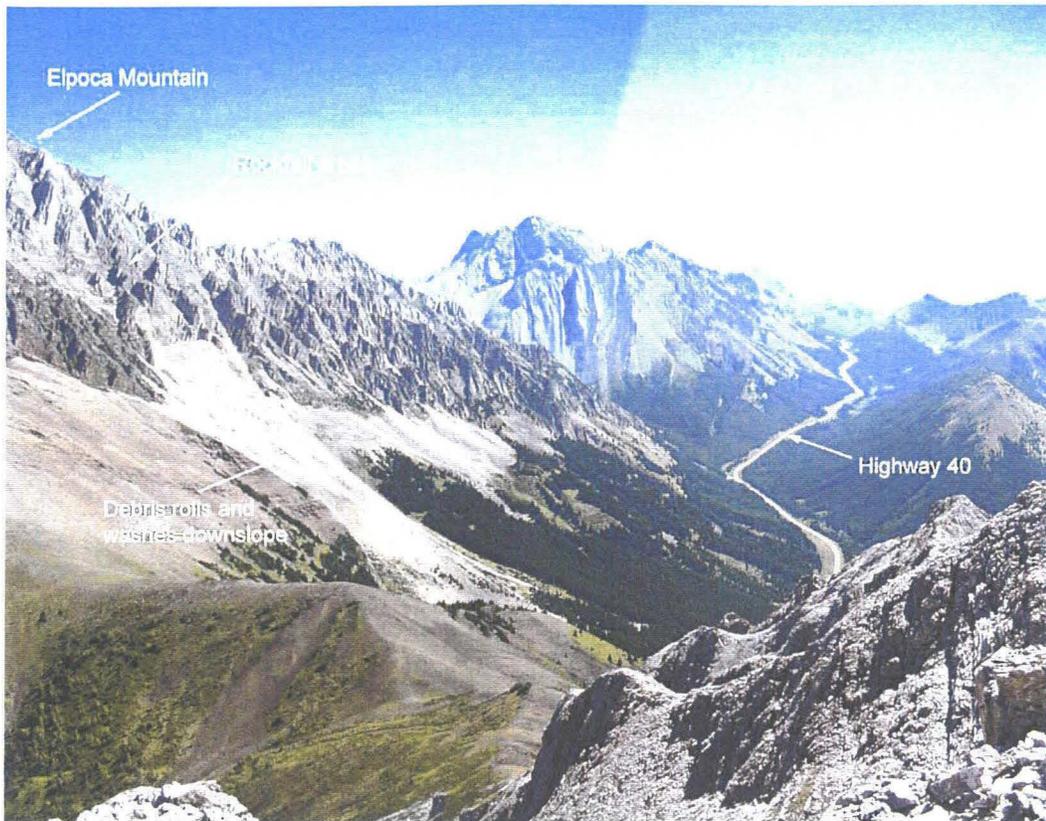
As shown in Photo 1 and on the airphoto in Figure E6, the debris fan on the treed slope above the highway right-of-way is below the steep upper slopes of Mount Elpoca where large volumes of rockfall debris accumulate above the treeline. This rockfall debris gradually moves further downslope over time due to gravity and surface runoff (rain and snowmelt) and contributes to the development of the debris fans above the highway.

Photo 1 (top) – Facing southeast towards the lower west slopes of Elpoca Mountain from the summit of Gap Mountain. This view shows how the rockfall areas on the upper slopes of Elpoca Mountain generate debris that is subsequently transported downslope via surface runoff and tributary creeks and contribute to debris fans in the treed areas further downslope.

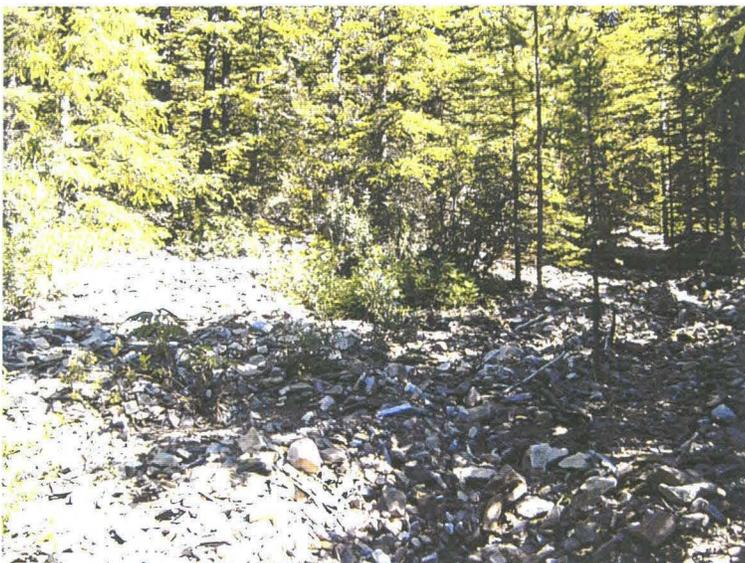
Photo 2 (bottom) – Typical view of braided creek channel and debris flow deposits blanketing the slope approximately 50 m upslope of the cleared highway right-of-way. There is no distinct creek channel in this area (compare with Photo 3 from further upstream) and it appeared that the channel had been filled with debris earlier in 2005 and the creek flow went overland and percolated down into the debris.

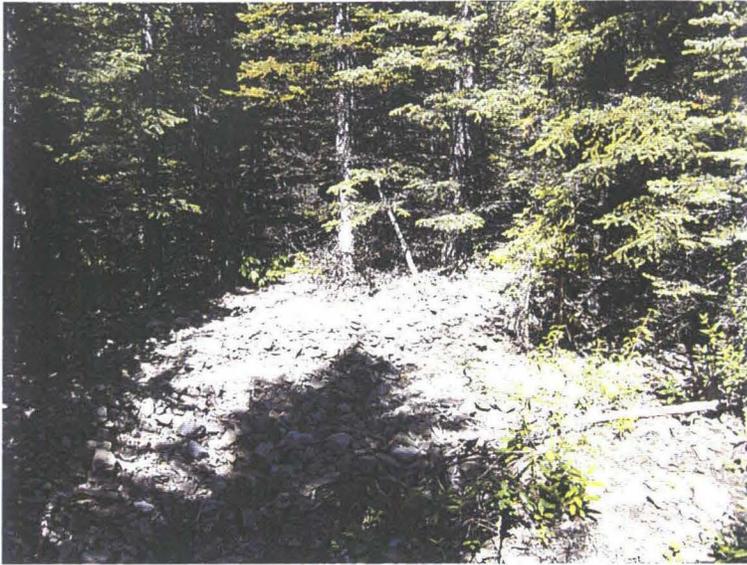
Photo 3 (top) – Another view of the debris flow deposits upslope of the highway right-of-way.

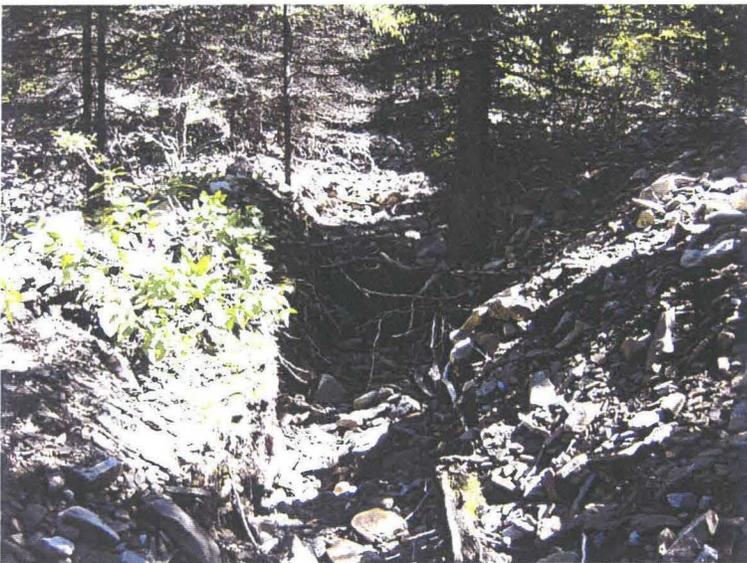
Further upslope (greater than approximately 200 m above the highway) the creek channel was incised approximately 1 to 2 m into the slope. This segment of the channel was dry at the time of the inspection. The channel in this area is surrounded by a broad area (greater than 30 m wide) of cobble to small boulder sized debris blanketing the slope. The slope inclination and creek channel gradient in this area was around 8 to 10°. It appeared that the debris had been deposited during several events in previous years, including a significant amount of “fresh” looking debris judged to be from earlier in 2005.

Photo 4 (bottom) – Incised creek channel, approximately 1 to 2 m deep, located approximately 200 m upslope of the highway right-of-way and within an area of channel overflow debris deposition. This incised channel was not present further downstream (towards the highway) – compare with Photo 2 from further downstream and closer to the highway.
