## Site 23 – Valleyview Trail

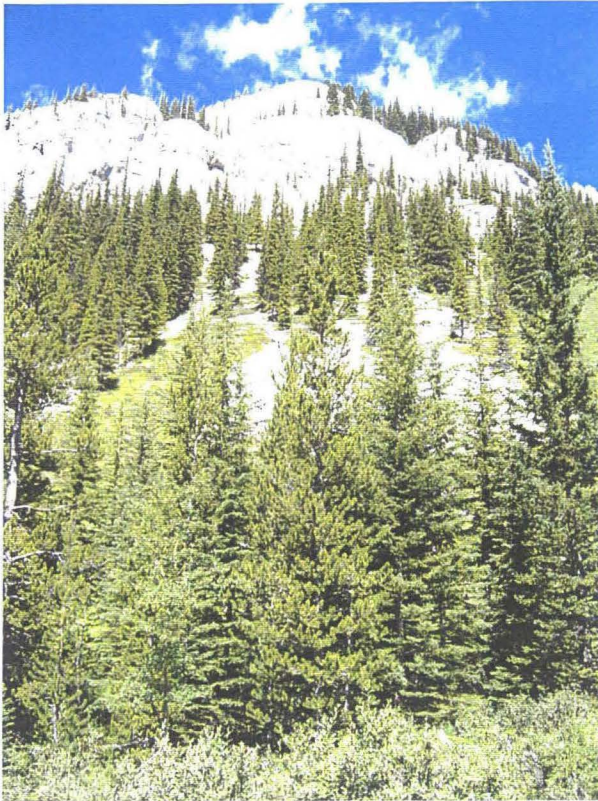
This site consists of a steep colluvium slope above the Valleyview Trail, a side-road parallel to and approximately 100 m upslope of Highway 40 in this area. The source of the colluvium is rockfall from steep slopes on the south ridge of Gap Mountain above the road. As shown on Photo 1, portions of the slope above the road that are blanketed with colluvium remain unvegetated, which suggests that debris may be actively accumulating in these areas and/or the blanket of colluvium is progressively creeping downslope towards the road.

- The road elevation is approximately 3 to 5 m above the natural slope face at the toe of the road embankment sideslope.
- The portion of the slope between the road and the downslope limit of the open colluvium slope is thickly vegetated with mature trees. It is judged that any large rocks rolling down towards the road would be caught amongst the trees.

**Photo 1** (top) – Facing upslope from the Valleyview Trail right-of-way. The open slopes above the road are blanketed with rockfall debris originating from the steep rock slopes on the south ridge of Gap Mountain, visible at the top of the photo. Portions of these slopes remain unvegetated, which suggests that debris may be deposited on an ongoing basis and/or the blanket of debris is creeping downslope over time. There were no signs of debris reaching the Valleyview Trail. The Highway 40 right-of-way below this segment of the Valleyview Trail is approximately 100 m further downslope.

Therefore, the recommended Risk Level for this site along the Valleyview Trail is 12. Given that the Valleyview Trail road embankment essentially acts as a protective berm for Highway 40, the Risk Level for the adjacent segment of Highway 40 is judged to be negligible.

No further work is recommended for this site.
