## Site 22 – Gap Mountain Cut Slope

This site consists of a soil and rock cut slope along the northeast side of the highway approximately 3 km south of the Elpoca Creek crossing. There is a warning sign (“Watch For Fallen Rock”) posted for northbound traffic approaching this site.

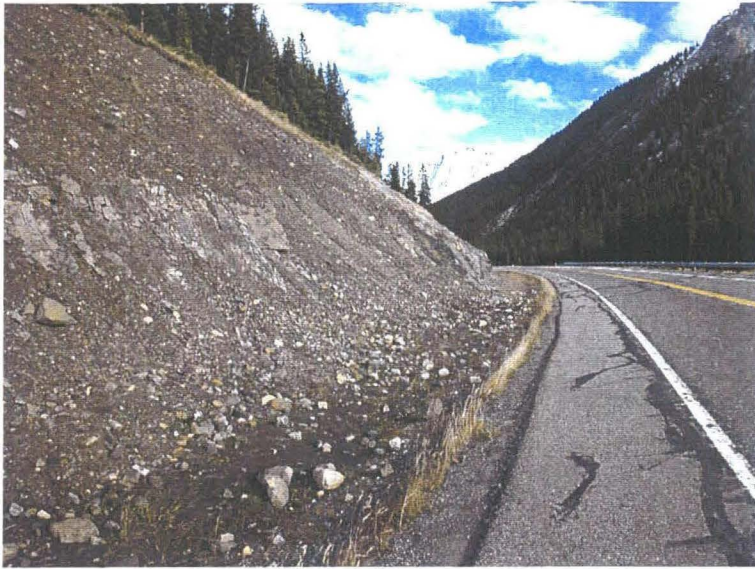
- Northern End: The upper portion of the northern end of the cut slope exposes rocky soil at an angle of about 45°. The lower portion of the cut slope exposes bedrock at an angle of approximately 60°. Gullying of the exposed soil has released cobble to boulder-sized debris which has accumulated as an apron along the toe of the slope and within the ditch. At the time of the inspection, the volume of material in the ditch was such that some debris had rolled down and been deposited within 2 m of the edge of the pavement. There were no signs of damage to the pavement from previous rockfalls. Photos 1 and 2 show views of the northern end of the site.

**Photo 1** (top) – Facing southeast across the site. The northern end of the cut slope (visible in the foreground) exposes rocky soil at an angle of  $45^\circ$  overlying a rock cut at about  $60^\circ$ . Gullying of the exposed soil has released cobble to boulder-sized rocks and an apron of this debris has built up along the toe of this segment of the cut slope. Cobble to boulder-sized material has been deposited within 2 m of the edge of the pavement. The thickness of the exposed soil in the upper portion of the cut slope tapers out towards the southeast. The southeast end of the cut slope (in the background of this photo) exposes intact bedrock at an overall angle of  $45^\circ$  with very little debris in the ditch below.

It is recommended that the accumulated debris be cleared from the ditch. The ditch should also be cleaned as required in the future. This should be treated as an ongoing maintenance issue with cleaning performed as required.

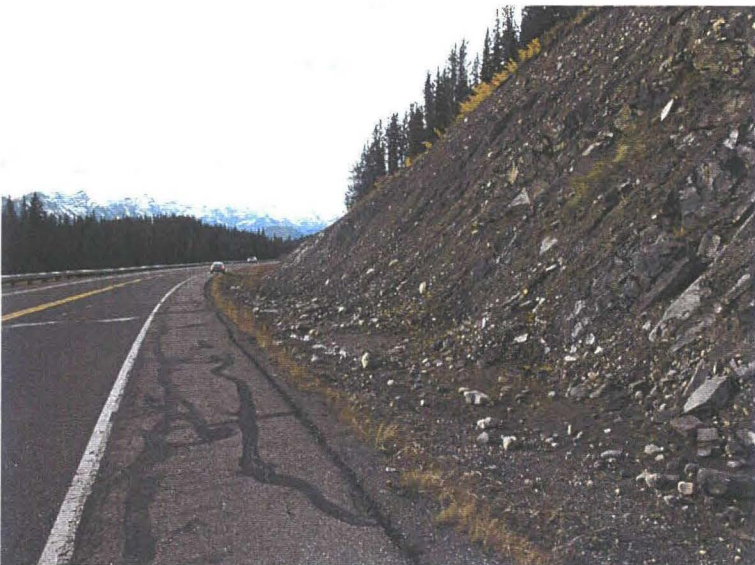
**Photo 2** (middle) – Facing northwest across the northern end of the cut slope. Note the proximity of the debris in the ditch to the edge of the pavement.

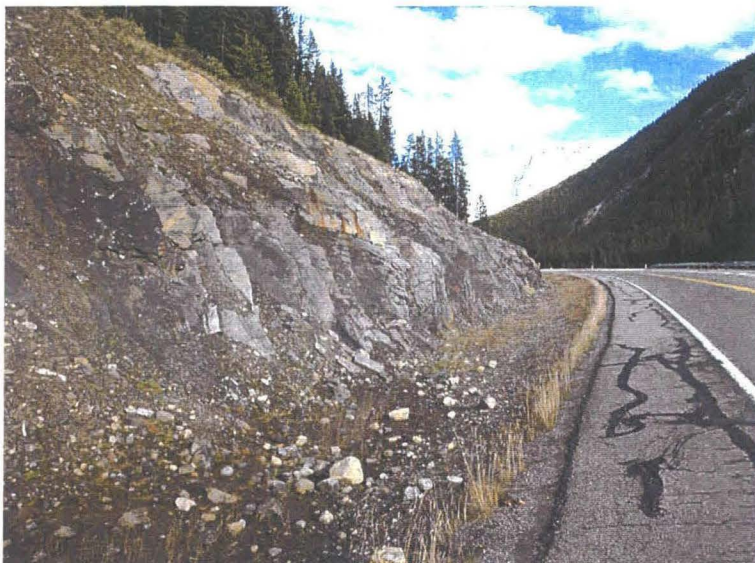
- Southern End: The exposed soil in the upper portion of the cut slope tapers out towards the southeast, such that only rock is exposed in the southern end of the cut slope. The overall slope angle is 45°, with the lowermost 2 to 3 m of the slope at approximately 60°. At the time of the inspection there was very little rockfall debris in the ditch in this area. Photo 3 shows the southern end of the site.

**Photo 3** (bottom) – Closer view of the southern end of the cut slope that exposes rock. The overall cut slope angle is around  $45^\circ$ . The lowermost 2 to 3 m of the cut slope are at approximately  $60^\circ$ . There was very little debris in the ditch below this segment of the cut slope.
