Highway 940 – Km 15 Embankment Slide

The site inspection was performed on September 27, 2008 by Mr. Andrew Bidwell, P.Eng. of AMEC.

Earth & Environmental		PROJECT: HWY 940 GEOHAZARDS REVIEW			
CLIENT: Alberta Transportation		TITLE: Km 15 EMBANKMENT SLIDE NE EMBANKMENT SLOPE CROSS SECTION			
DATE: JANUARY 2009	JOB No.: CG25262	CAD FILE: 25262Z10.dwg	FIGURE No.:	REV. A

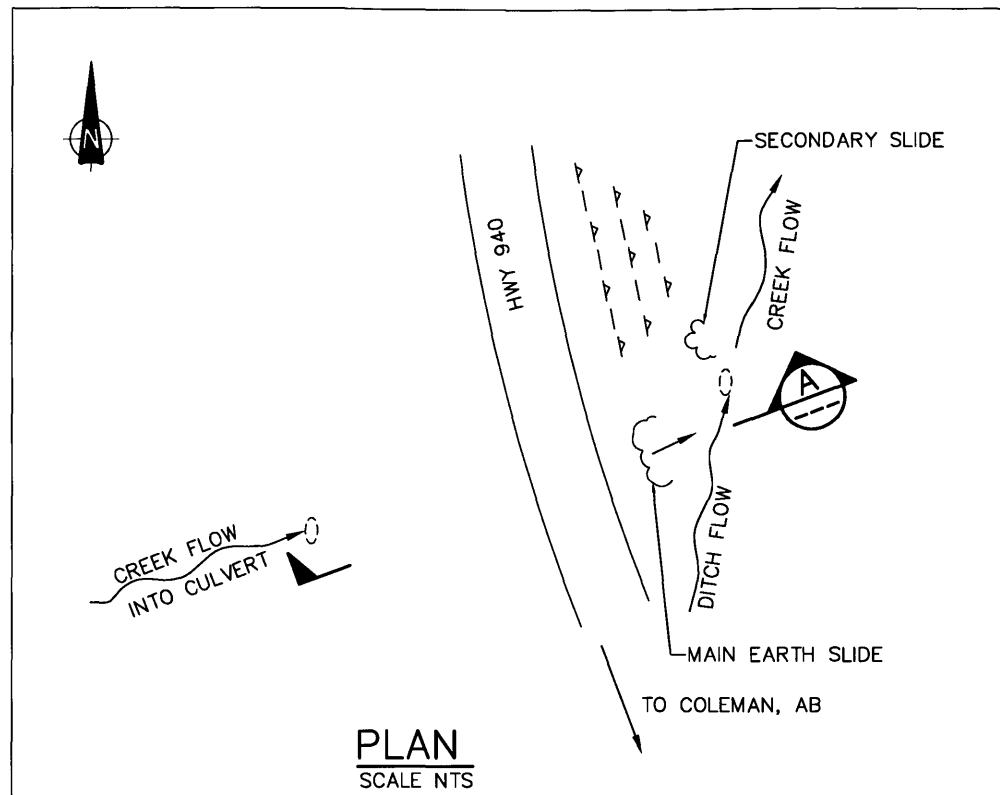
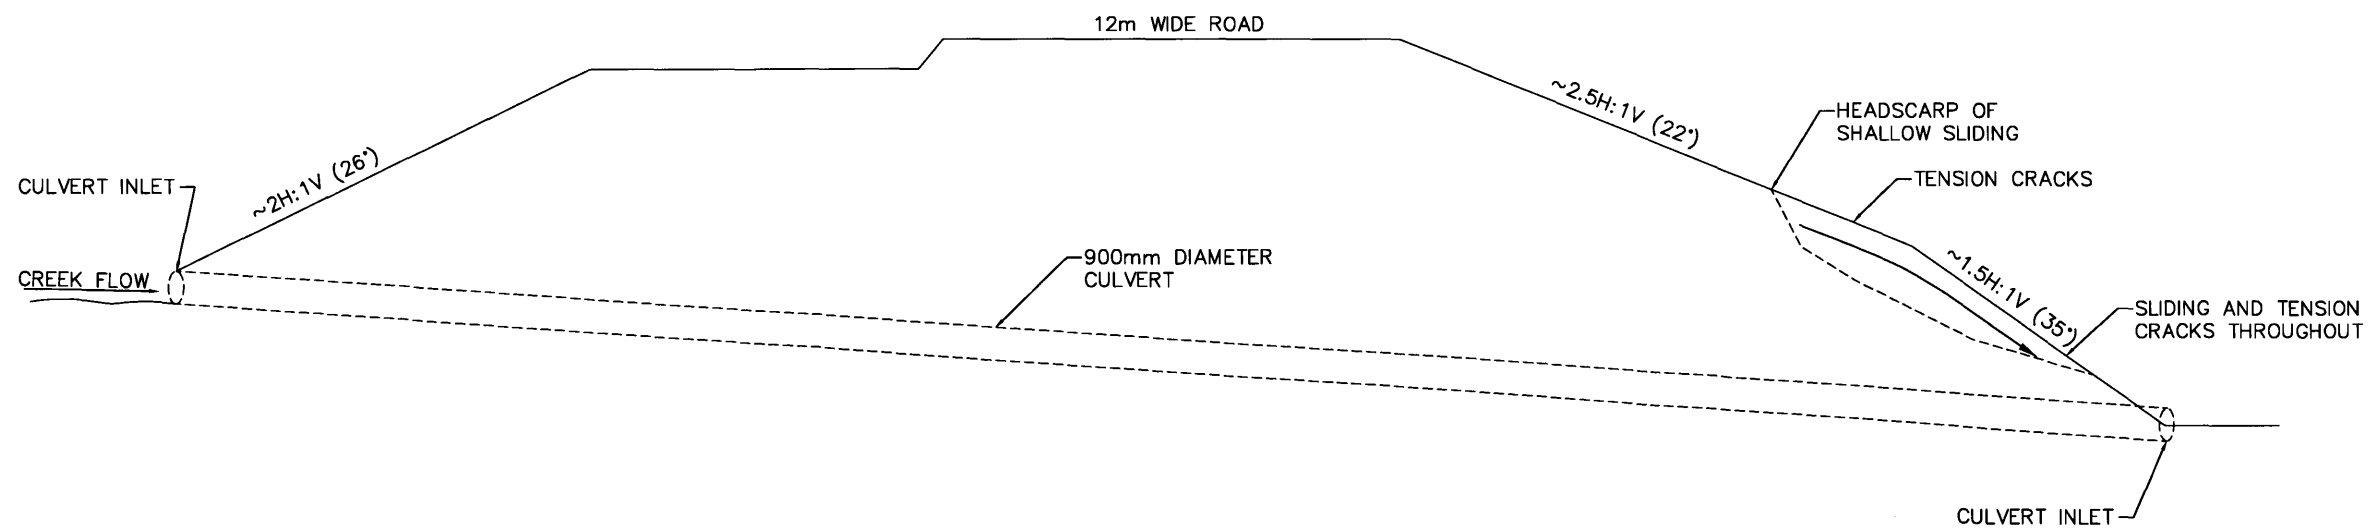
A TYPICAL CROSS SECTION
SCALE APPROX. 1:200

- The creek flow is conveyed from southwest to northeast across the highway alignment by a 900 mm diameter culvert at the base of an approximately 10 m high fill embankment. A cross-section of the embankment is attached.

- As shown on the attached cross-section, there were tension cracks and signs of shallow sliding in the embankment slope face for a distance of approximately 5 m upslope from the slide headscarp. As shown in Photo 940-6, there were also tension cracks extending laterally to the north of the slide that could be traced across the mid and lower portions of the embankment slope, as shown on the attached site sketch.
- There was also a secondary slide in the toe of the embankment slope and immediately to the north of the culvert outlet, as shown in Photo 940-7. This slide appeared to also be due to ditch erosion, but had not retrogressed as far upslope as the main earth slide described above.

As shown on the attached cross-section, there is ample room to shift the road to the southwest if required if the northeast edge of the road eventually becomes undermined. Therefore, if the northeast edge of the road were to eventually start to become undermined, the consequences should be easily manageable.

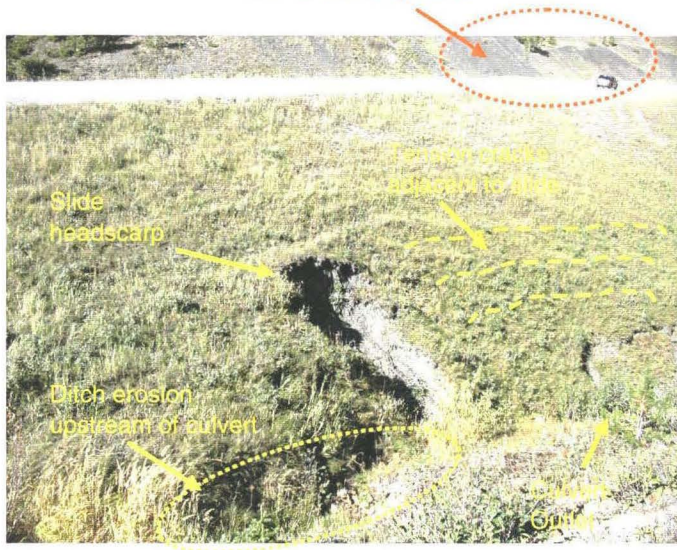
- There is an earth slide in the east embankment face, upstream of the culvert outlet. The slide is in the mid-slope area, roughly 3 to 4 m wide at the headscarp and with a depth of movement in the order of 1 to 1.5 m. The headscarp of the slide exposes embankment fill soil ranging from fines to gravel sized particles. Photos 940-6 and 940-7 show the slide.

It is also possible that the area with tension cracking adjacent to the north side of the existing slide, as shown in Photo 940-6, will begin to slide. If the instability spreads like this, this would threaten to eventually undermine a longer segment of the northeast edge of the road.

Photo 940-6 (top) – Facing northwest toward the slide area on the embankment slope. The slide appears to have been triggered by ditch erosion along the toe of the embankment slope. Tension cracks were visible in the embankment slope adjacent to the active slide, and that area may further destabilize in the future.

It is recommended that the current ditch erosion and resulting sliding and tension cracking in the downstream embankment face be mitigated rather than deferring any repair work until if and when the instability retrogresses upslope and begins to directly undermine the northeast edge of the road. The effort required to repair the current erosion and instability would be much less than a future repair of a larger area.

1. The segment of the east road ditch along the toe of the embankment slope should be lined with a geosynthetic product in order to minimize erosion of the exposed soils and promote vegetation growth along the ditch sideslopes. This could be supplemented with a series of rock check dams (using locally available rock) along the ditch to limit the velocity of the ditch flow. The check dam concept is illustrated on the attached copy of AT's Best Management Practice #7 for Erosion and Sediment Control along highways.
2. The headscarp of the existing slide should be graded down slightly from its near-vertical inclination (e.g. a laborer with a shovel should trim back the oversteepened scarp). The exposed soils in the headscarp and slide area

should then be covered with a seeded erosion control product secured to the slope face or hydroseeded.

3. The tension cracks in the embankment slope face should be backfilled with clay material (or even bentonite chips), shoveled into place by laborers and tamped/compacted in order to minimize the infiltration of surface runoff into the open cracks. The sealed cracks should then be covered with topsoil and hydroseeded.

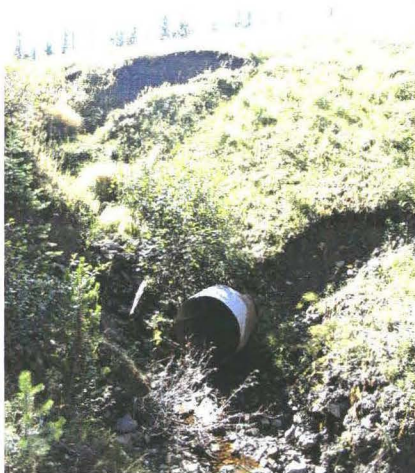
Photo 940-7 (middle) – Facing upstream along the ditch, showing the position of the existing slide relative to the culvert outlet. Also note the secondary earth slide at the toe of the embankment slope and immediately north/downstream of the culvert outlet (lower right corner of this photo).

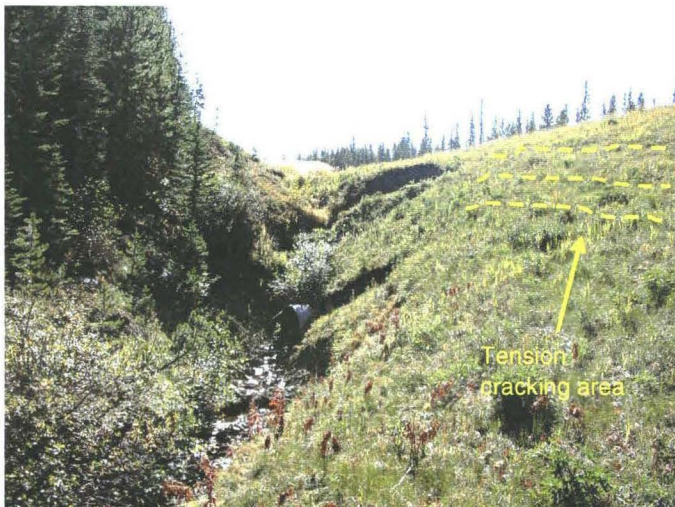
- It appears that the slide has been triggered by erosion of the toe of the embankment slope along the east road ditch. The segment of the east ditch along the downstream toe of the embankment is being downcut and the

sidewalls locally undermined by erosion along the base of the ditch. This segment of the ditch connects the upland area south of the creek valley and the creek channel downstream of the embankment, and therefore has a significant gradient. The erosion appears to be due to ditch flow from the upland area south of the embankment picking up velocity along this segment of the ditch.

Photo 940-8 (bottom) – Wider view facing upstream along the ditch. Note the erosion along the ditch relative to the location of the slide in the embankment slope face and the tension cracking area.
