Highway 940 – Km 15 Cut Slope

The site inspection was performed on September 27, 2008 by Mr. Andrew Bidwell, P.Eng. of AMEC.

Hwy 940 – Km 15 Cut Slope

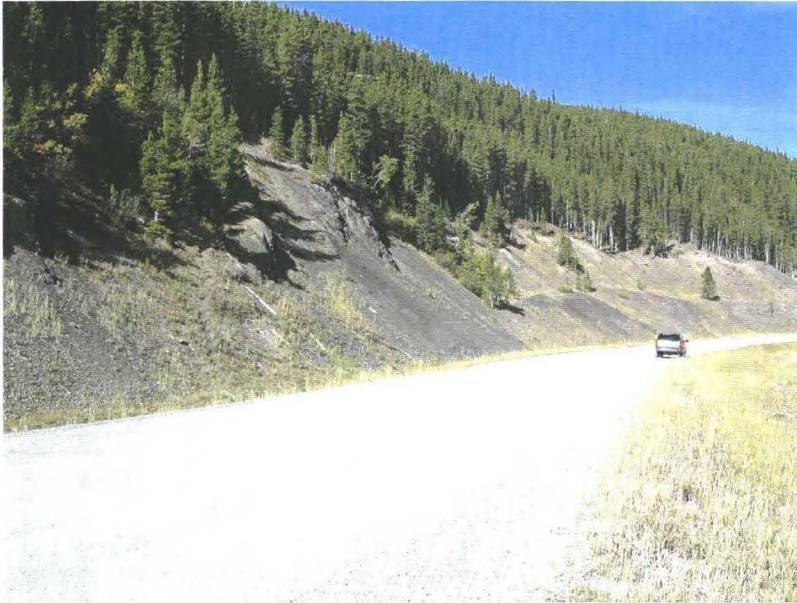
- Photos 940-9 and 940-10 show general views of the cut slope. The maximum cut slope height is in the order of 12 to 14 m.
 - The upper portion of the slope has some bedrock exposures at 45 to 60° inclination, consisting of dark grey shale and siltstone with a dip direction roughly parallel to the road alignment. The remainder of the upper portion of the slope is covered with gravel-sized debris from the bedrock exposures.

Photo 940-9 (top) – Facing northbound across the Km 15 Cut Slope site.

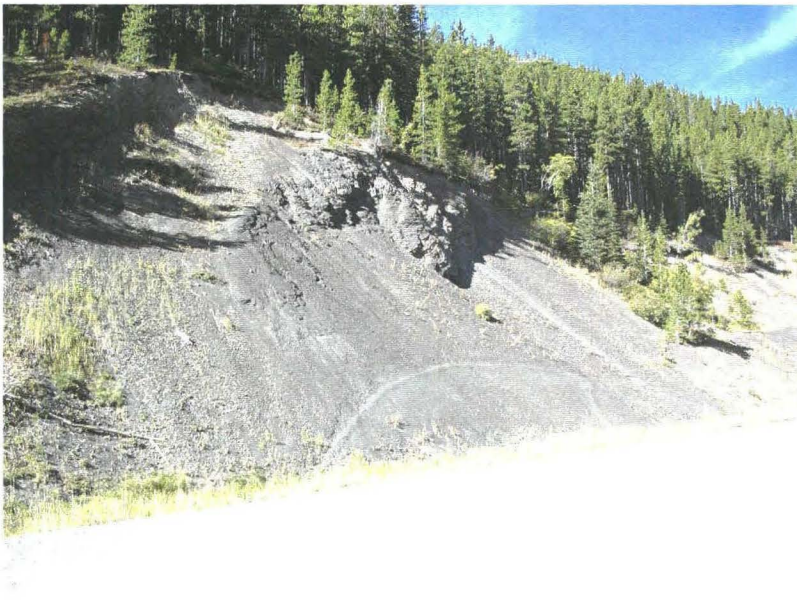
Photo 940-10 (bottom) – Closer view of the Km 15 Cut Slope site. Note the bedrock exposed in the upper portion of the cut slope, and the apron of debris covering the lower portion of the cut slope.

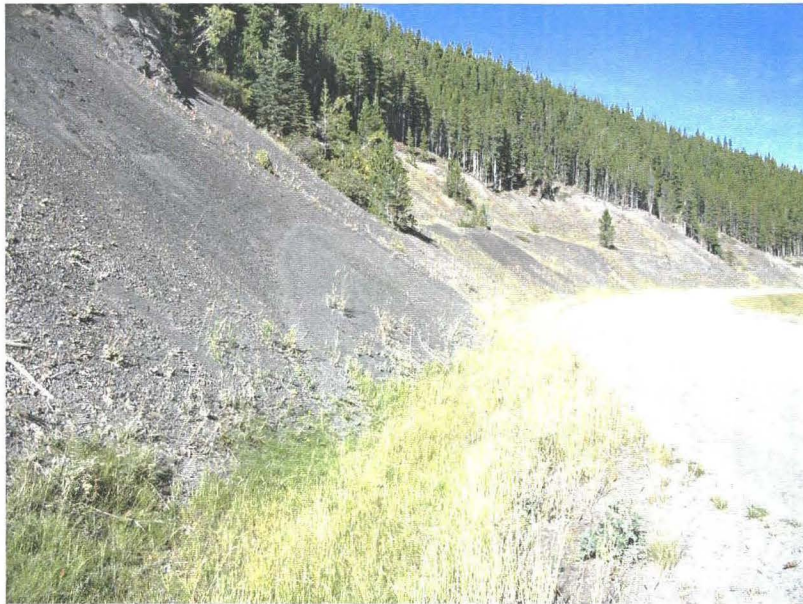
- The lower portion of the slope is covered with an apron of the same gravel-sized debris at a 36° slope.
- As shown in Photos 940-11 and 940-12, the toe of the debris apron has encroached into the base of the west road ditch. The remaining ditch width varies down to a minimum of approximately 1 m. The ditch depth relative to the road surface is less than 0.5 m.

The existing ditch width and depth does not meet the ditch sizing guidelines shown on the rockfall catch ditch design chart on Figure C1 in Appendix C. However, it does not appear that there is a significant rockfall hazard risk to the road at this site because the debris from the bedrock exposures in the upper portion of the cut slope accumulates at the angle of repose across the lower portion of the slope and only a very small number of gravel-sized pieces of debris roll as far as the road. Furthermore, the road at this site is gravel surfaced and the minor amounts of gravel-sized debris that reach the road do not change the conditions on the road significantly.

Photo 940-11 (top) – Facing northbound along the ditch, with debris encroaching into the ditch base visible.

No work is recommended for this site. The ongoing erosion of the cut slope does not appear to be impacting the road surface. The width and/or depth of the existing, undersized ditch could be increased to meet the sizing criteria shown on the chart in Figure C1 in Appendix C, however it is judged that this would not significantly reduce the already low Risk Level for this site.

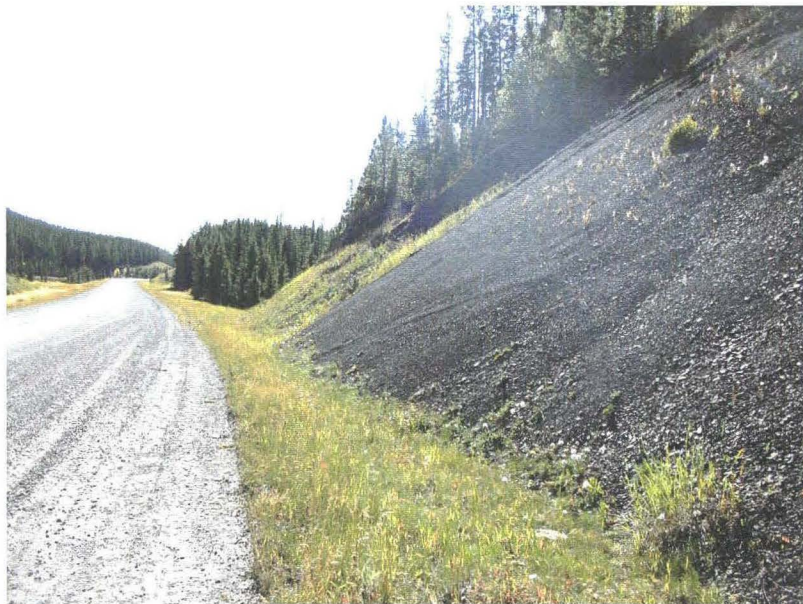
- The debris was consistently gravel-sized. There were only a few cobble-sized pieces visible across the entire debris apron. At the time of the inspection, there were only a few pieces of the debris from the cut slope that had rolled out beyond the toe of the debris apron and onto the road surface.

Photo 940-12 (bottom) – Facing southbound along the ditch, with debris encroaching into the ditch base visible. At the time of the inspection, only a few of the gravel-sized pieces of debris had rolled beyond the ditch and onto the road surface.
