Highway 940 – Km 16.5 Cut Slope

Hwy 940 – Km 16.5 Cut Slope

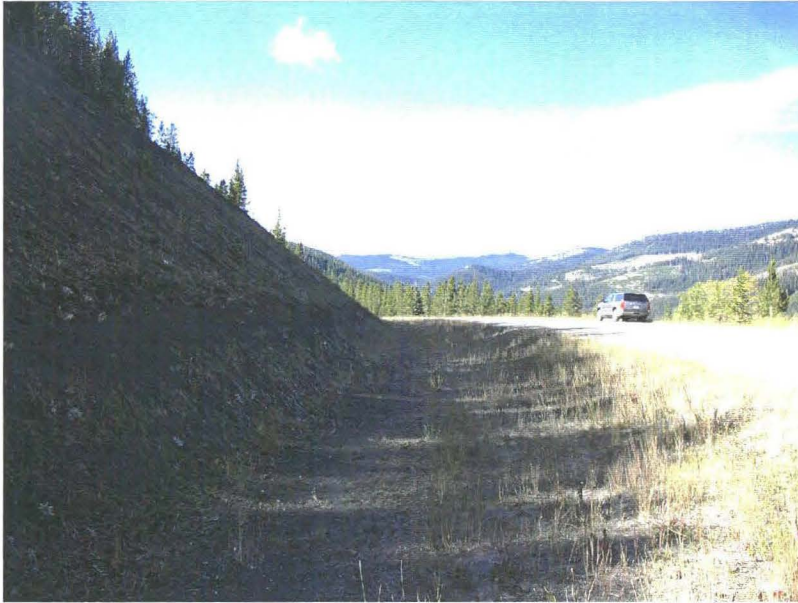
- There is a rock cut slope along the south (upslope) side of the road at this site. Photos 940-13 and 940-14 show the cut slope. The cut slope is in the order of 100 m long and exposes weak bedrock that weathers into both gravel-sized pieces of dark grey shale and fine grained soil that wash down into the upslope road ditch.

- Eroded material from the cut slope was visible along the ditch. No debris had reached the road surface at the time of the inspection.

Photo 940-13 (top) – Facing northbound along the ditch adjacent to the cut slope. The shadow on the cut slope mostly obscures the weak bedrock that is exposed in the cut. This bedrock weathers into gravel-sized pieces of dark grey shale and fine grained soil.

No work is recommended for this site. The accumulated debris may need to be cleaned out from the ditch at some point in the future, however the accumulation of debris to date has not significantly reduced the ditch capacity and it is judged that this can be handled during the course of routine road maintenance for this area.

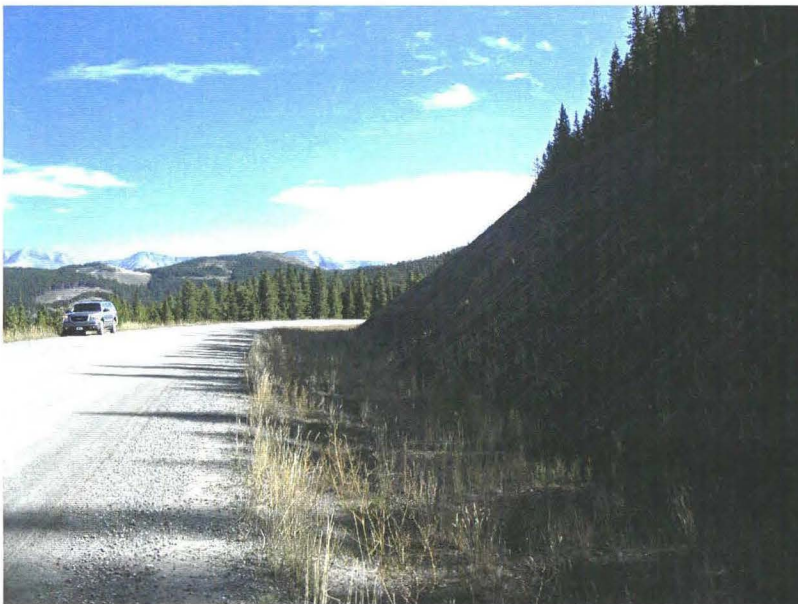
Photo 940-14 (bottom) – Facing southbound along the ditch adjacent to the cut slope.
