Highway 940 – Km 20.2 Cut Slope

The site inspection was performed on September 27, 2008 by Mr. Andrew Bidwell, P.Eng. of AMEC.

April 2009

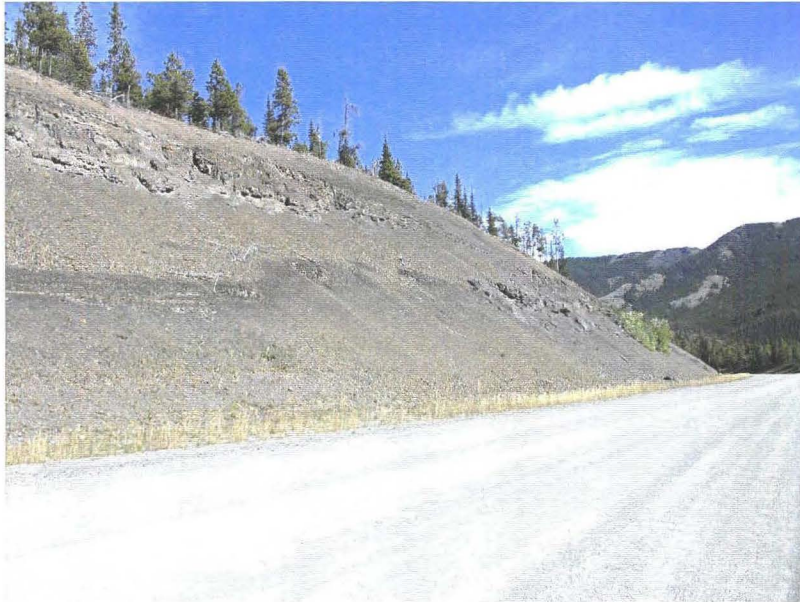
- There is a rock cut slope along the west side of the road at this site. The cut slope is in the order of 12 to 15 m maximum height at a 33° crest-to-toe angle. Photos 940-15 and 940-16 show general views of the cut slope.
- The upper portion of the cut slope is near-vertical. There is a talus apron extending downslope below the near-vertical areas. The talus apron is confined to a mid-slope bench in the cut slope.
- The road ditch along the toe of the cut slope is typically 3 to 4 m wide and less than 1 m deep. Photos 940-17 and 940-18 show the road ditch with debris accumulation into the upslope side of the ditch.
- The cut slope exposes shale to sandstone rock. The bedding orientation is near-horizontal and possibly dipping very gently into the cut slope.

Photo 940-15 (top) – Facing northbound across the Km 20.2 Cut Slope site. The mid-slope bench retains debris from the near-vertical uppermost portion of the rock cut.

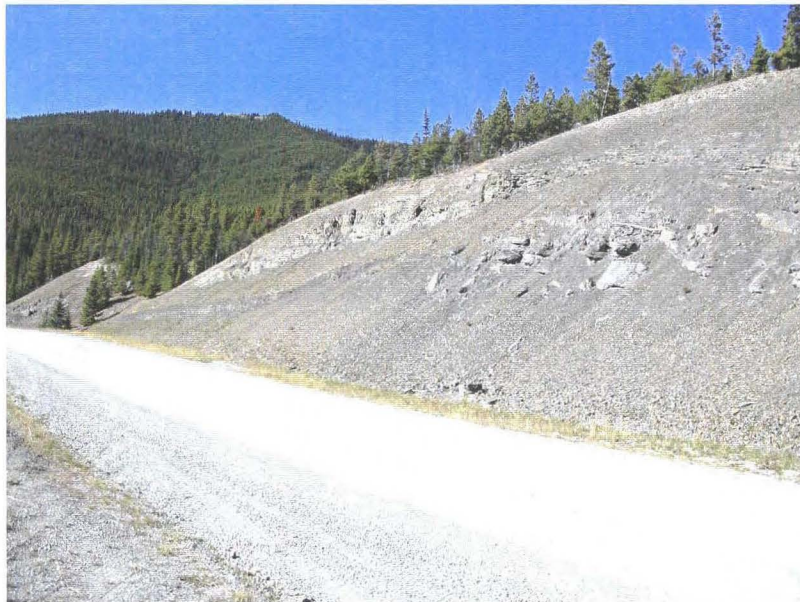
Photo 940-16 (bottom) – Facing southbound across the Km 20.2 Cut Slope site.

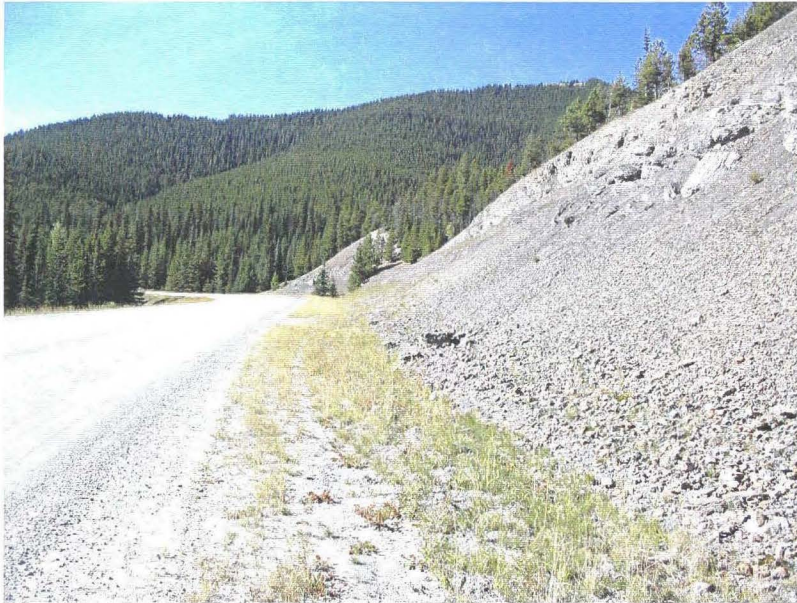
The cut slope angle of 33° is gentle enough to prevent debris from erosion of the cut slope from falling and bouncing down towards the road. The existing ditch appears to be sufficient to contain eroded material that does roll and slide downslope.

Photo 940-17 (top) – Facing southbound along the ditch at the Km 20.2 Cut Slope site. Note the debris accumulation into the upslope side of the ditch.

No work is recommended for this site. The accumulated debris may need to be cleaned out from the ditch at some point in the future, however the accumulation of debris to date has not significantly reduced the ditch capacity and it is judged that this can be handled during the course of routine road maintenance for this area.

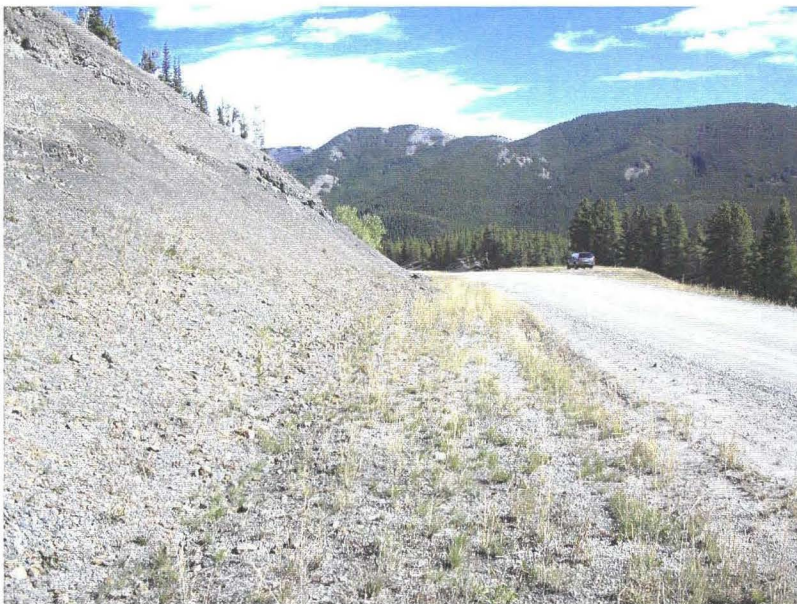
Photo 940-18 (bottom) – Facing southbound along the ditch at the Km 20.2 Cut Slope site. Note the debris accumulation into the upslope side of the ditch.
