Highway 940 – Km 20.8 Ditch Erosion

The site inspection was performed on September 27, 2008 by Mr. Andrew Bidwell, P.Eng. of AMEC.

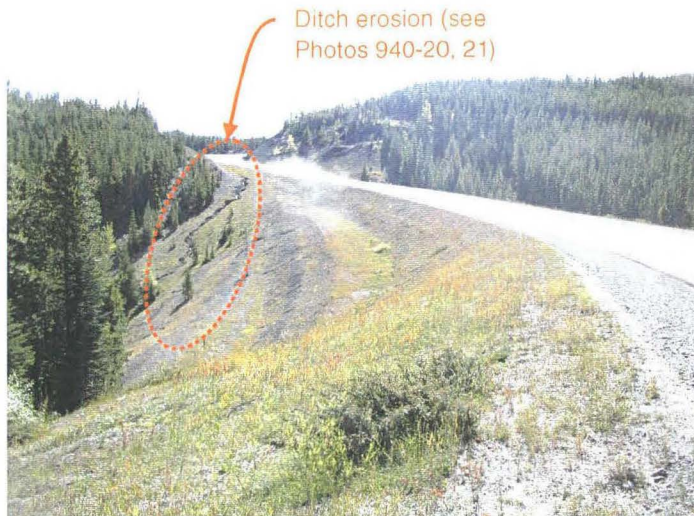
- The site is located at the south side of a large fill embankment across a northeastwards flowing, unnamed tributary of Vicary Creek. The embankment is greater than 10 m high with benched sideslopes and slope angles of 26° between benches. Photo 940-19 shows a general view of the embankment.

- There was significant erosion visible along both ditches at the south end of the embankment. As shown on Photos 940-19 and 940-22, these segments of the ditches are between the upland area south of the creek valley and the unnamed creek channel. The eroded segments along the ditches are incised up to 2 to 3 m and appear to have bottomed-out on relatively erosion resistant bedrock. The width between the crests of the ditch sideslopes along the eroded segments is up to 3 to 4 m.

Photo 940-19 (top) – Facing southbound across the downstream embankment slope. Note the benched embankment slope. Also note the erosion visible along the segment of the east road ditch between the upland area south of the creek valley and the creek channel.

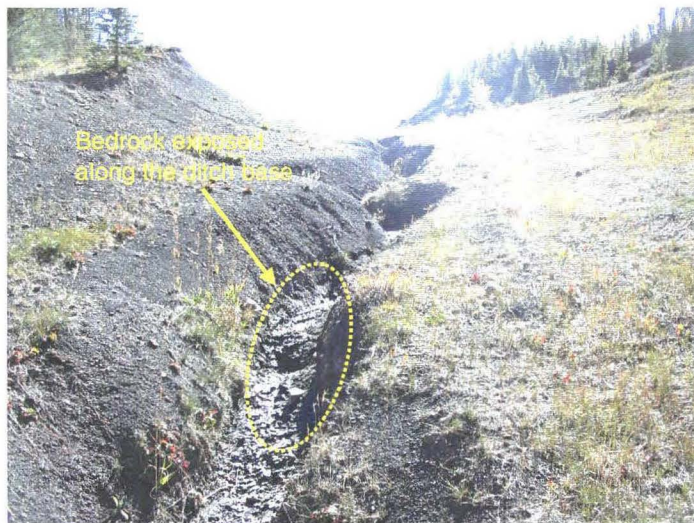
- Photos 940-20 and 940-21 shows views of the erosion along the east ditch.
 - Photo 940-23 shows the erosion along the west ditch.

The erosion in the ditches at the south end of the embankment is occurring where the ditch gradient increases and the ditch flow increases in velocity. The erosion to date poses little risk to the highway. The potential for further downcutting and ditch sidewall destabilization resulting in ditch widening appears to be limited by the bedrock exposed along the ditch bases. This reduces the likelihood of the road embankment sideslope becoming destabilized and possibly eventually undermining the highway itself, however this cannot be entirely ruled out.

Photo 940-20 (middle) – Facing upstream along the eroded segment of the east road ditch. Further downcutting along this segment of the ditch appears to be limited by the bedrock exposed along the base of the ditch.

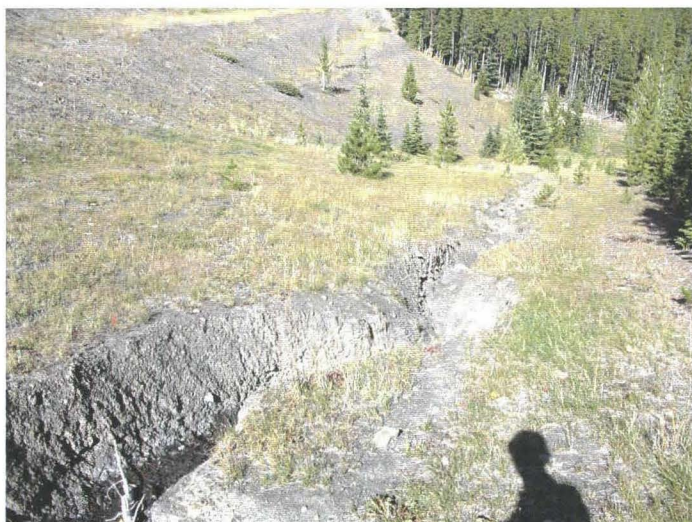
Photo 940-21 (bottom) – Facing downstream along the eroded segment of the east road ditch (same area as shown in Photo 940-20).

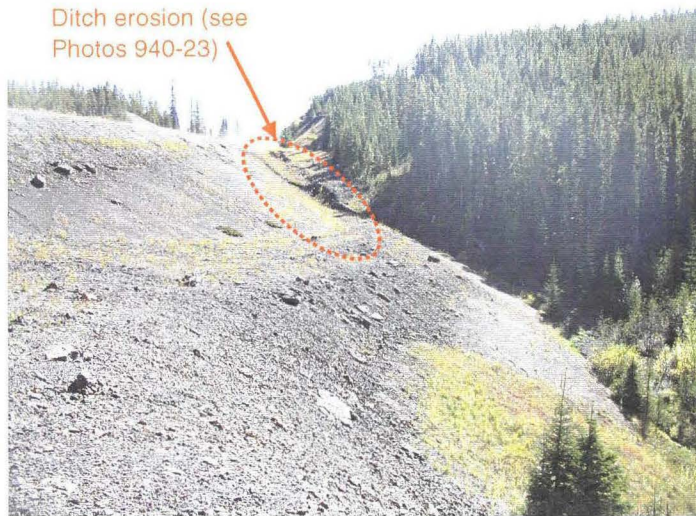
Photo 940-22 (top) – Facing southbound across the upstream embankment slope, with erosion visible along the segment of the west road ditch between the upland area to the south of the creek valley and the creek channel.

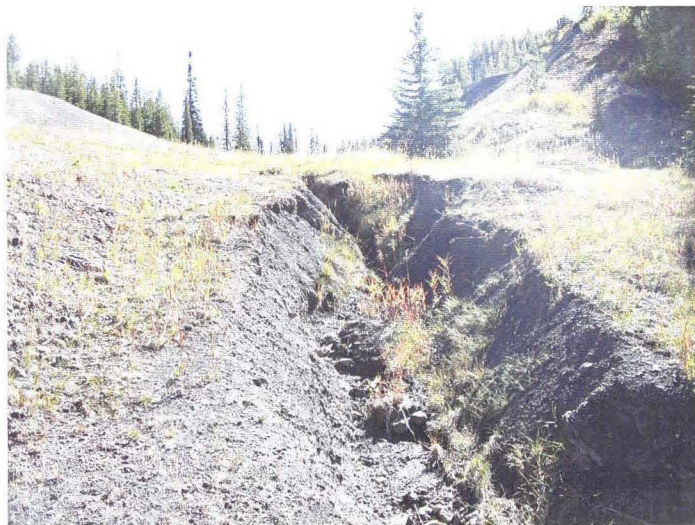
Photo 940-23 (bottom) – Facing upstream along the eroded segment of the west road ditch. Bedrock was discontinuously exposed along this segment of the ditch (covered in places with gravelly deposits from ditch flow).
