Highway 940 – Km 26.1 Cut Slope

Hwy 940 – Km 26.1 Cut Slope

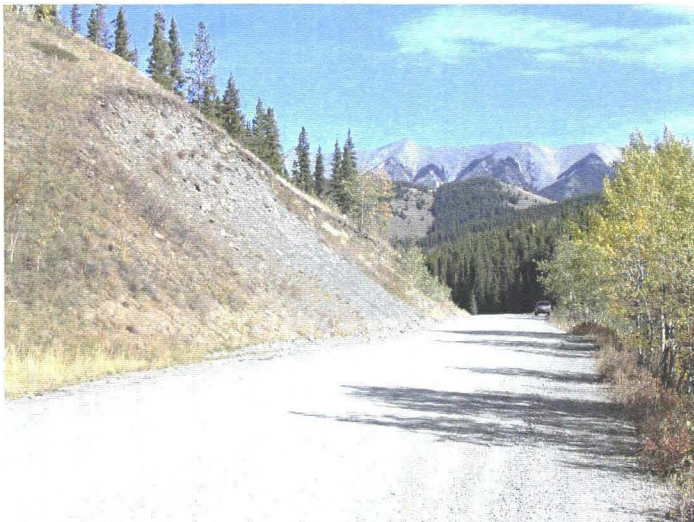
- There is an 8 to 10 m high cut slope at 36 to 38° inclination along an approximately 40 to 50 m segment of the north/upslope side of the highway at this site. The cut slope exposes rocky soil, with up to boulder-sized rocks visible. Photo 940-27 shows a general view of the cut slope.

Photo 940-27 (top) – Facing east/northbound across the cut slope at the Km 26.1 site.

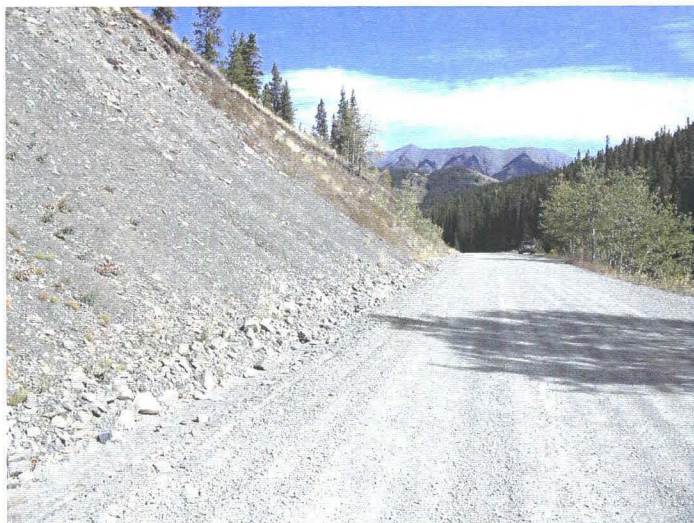
There is a potential for large rocks to erode and ravel out from the cut slope and then slide or roll into the traffic lanes of the highway, particularly with the lack of a ditch along the toe of the cut slope to contain any such rocks. None of the rocks from the slope were in the traffic lanes at the time of the site inspection, however it is possible that they do roll onto the road at other times and are later pushed to the edge of the road by maintenance crews.

Photo 940-28 (middle) – Closer view facing east/northbound. Note the lack of a ditch and the accumulation of material eroded from the cut slope along the upslope side of the road.

A small ditch/swale should be excavated along the north side of the road to ensure that rocks sliding or rolling down the cut slope are contained within the ditch and do not roll into the traffic lanes. Such a ditch would also reduce the reliance on ongoing and timely clearing of the accumulated rocks from along the edge of the road.

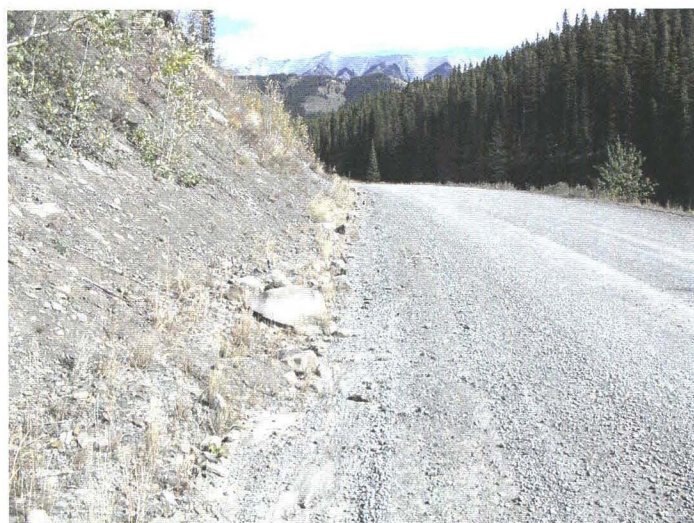
- There is no ditch along the north side of the road. Rocks that have eroded out from the cut slope have slid and/or rolled downslope and come to rest along the north/upslope edge of the road. As shown in Photo 940-29, up to boulder-sized rocks were present along the edge of the road at the time of the site inspection.

Photo 940-29 (bottom) – A boulder-sized rock that has been eroded from the cut slope and come to rest along the edge of the highway.

The accumulation of cobble to boulder-sized rocks along the north edge of the road should be removed. Future accumulations of such rocks should also be removed in order to keep the amount of rocks along the edge of the road at a practical minimum.
