Highway 940 – Km 14 Ditch Erosion Site

The site inspection was performed on September 27, 2008 by Mr. Andrew Bidwell, P.Eng. of AMEC.

PROJECT:		HWY 940 GEOHAZARDS REVIEW							
TITLE:		Km 14 DITCH EROSION SITE							
DATE:	JANUARY 2009	JOB No.:	CG25262	CAD FILE:	25262Z06.dwg	FIGURE No.:		REV.	A

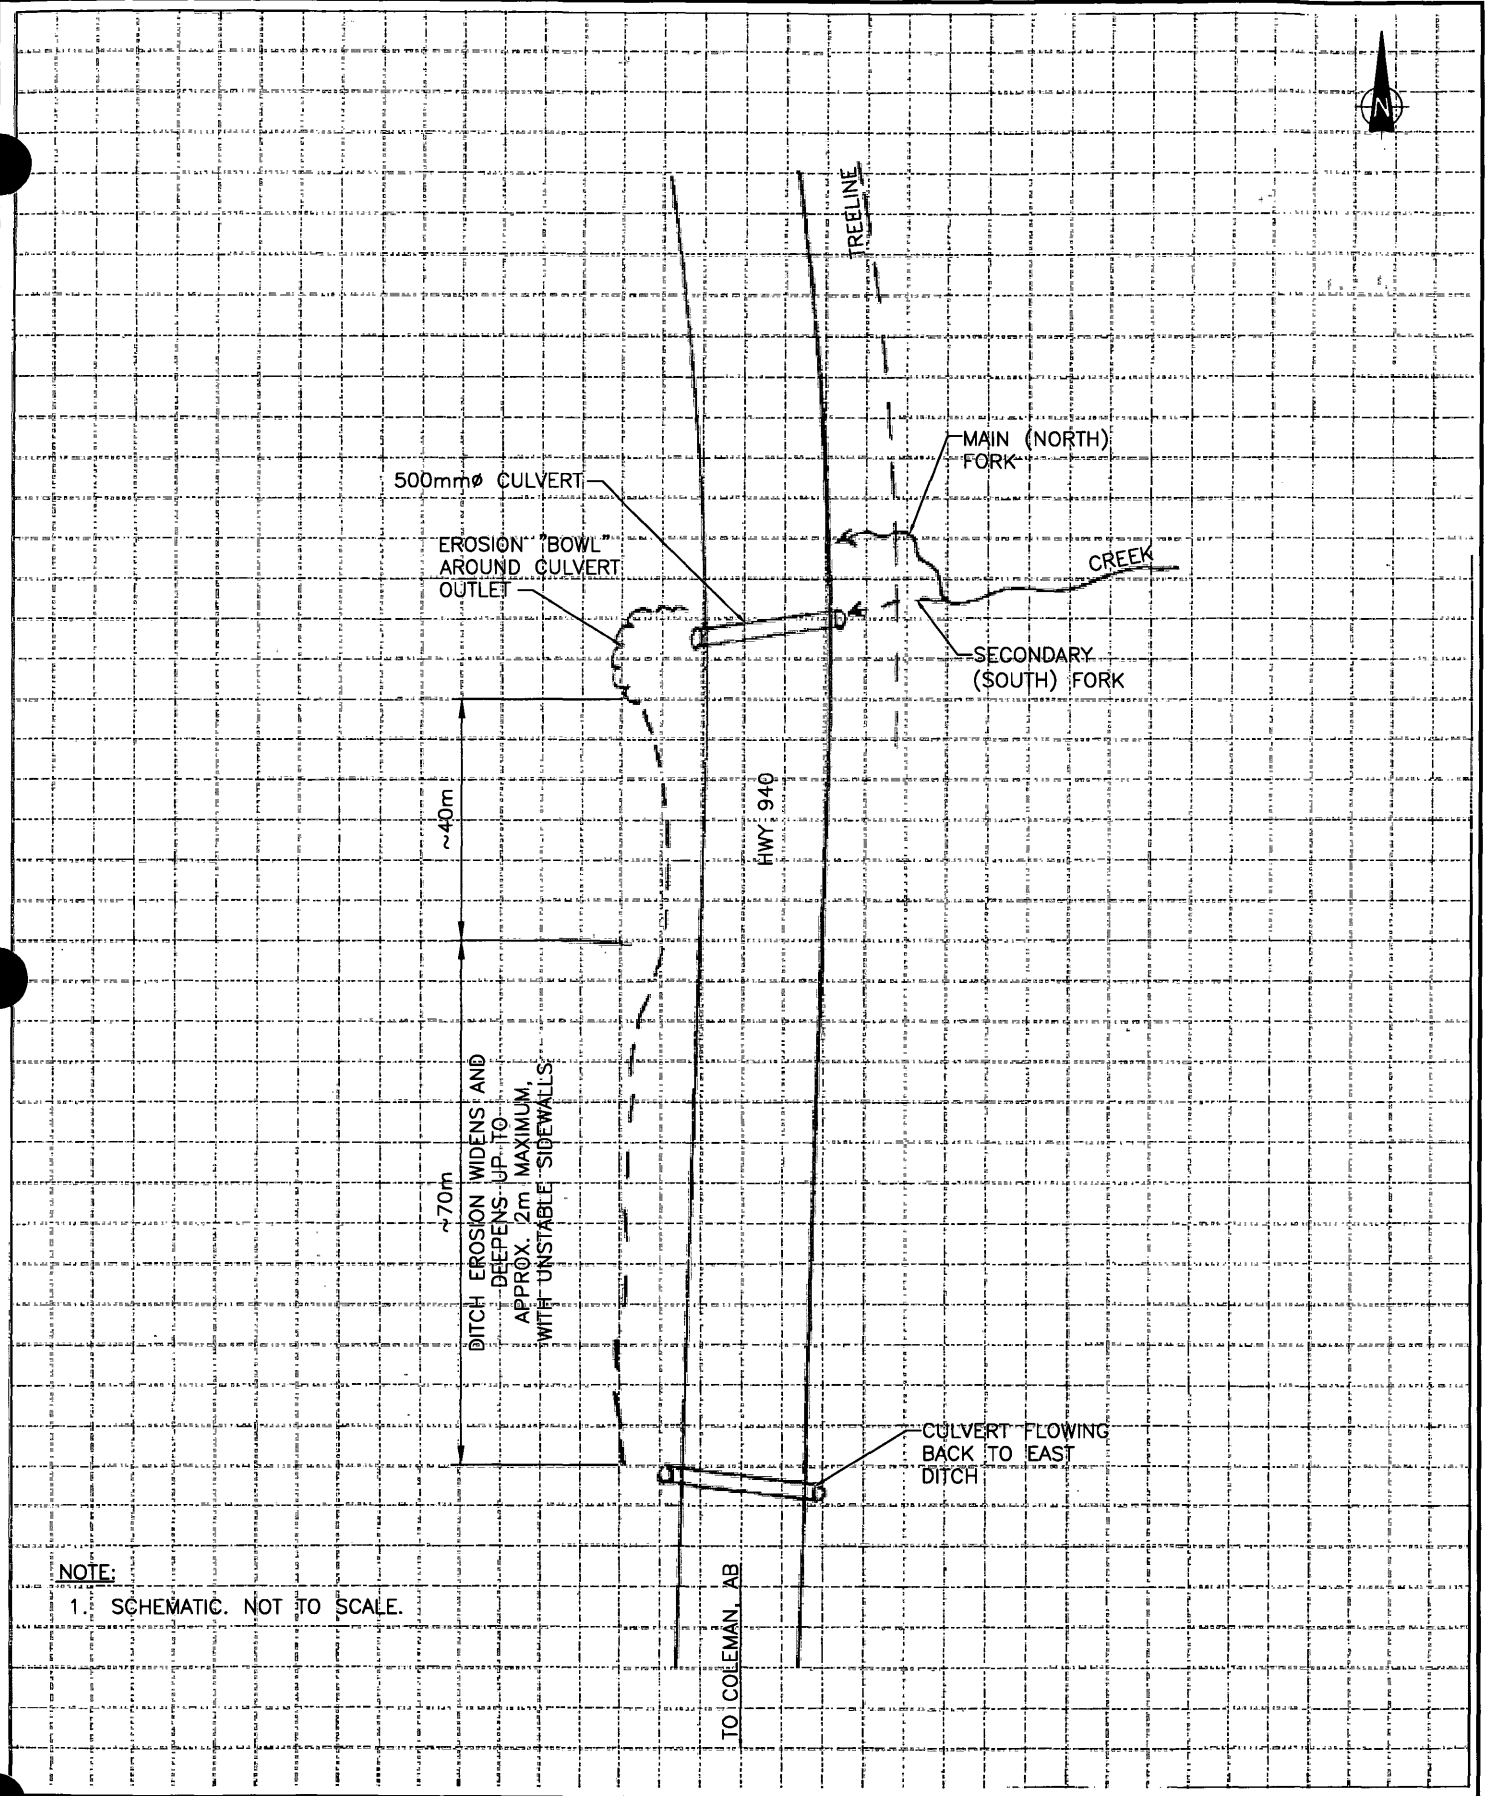
- The attached site sketch shows the layout of the site and the relative locations of the site features described below.
- There is significant erosion and downcutting along an approximately 110 m segment of the west road ditch. The northern limit of the erosion is around the outlet of a 500 mm diameter culvert, as shown in Photos 940-1 and 940-2. The erosion extends southwards (downstream) along the ditch. The southern limit of the erosion is around the inlet of another culvert to the south that carries the west ditch drainage back over to the east ditch, as shown on the attached site sketch.

- There is a minor, seasonal creek channel flowing down the treed slope above (east) of the road and the 500 mm diameter culvert is positioned to carry the flow from this channel across the road alignment. As shown on the attached site plan sketch, there is a fork in the creek channel a short distance upslope of the road. The main fork curves to the north and is intercepted by the east road ditch approximately 10 m north (upstream) of the culvert inlet (see Photo 940-4). The secondary fork continues downslope more or less flowing directly towards the culvert inlet (see Photo 940-5). It appears that the creek flows through the main (north) fork except during peak flow periods when a portion enters the secondary (south) fork.

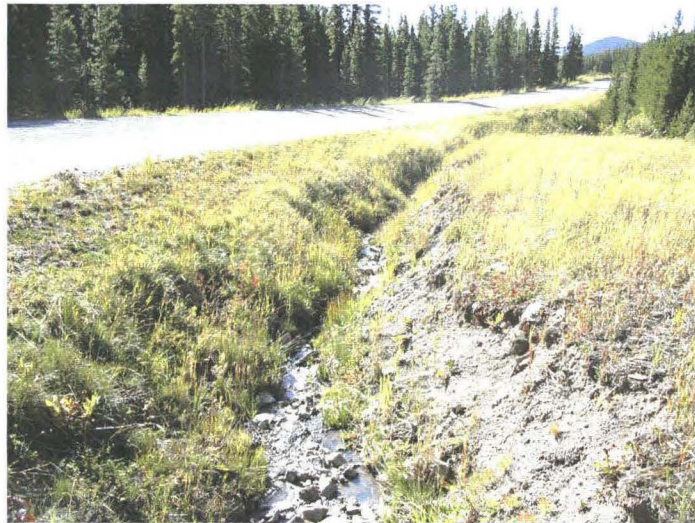
- The ditch erosion widens and deepens to approximately 2 m maximum depth starting around 40 m south from the outlet of the north culvert. Photo 940-2 shows this segment of the ditch. Fine grained, clayey soils are exposed in the ditch base and sidewalls in this area. There are numerous slump failures along the ditch sidewalls in this area. At the time of the inspection, the west edge of the road had not been directly undermined by the slumping in the ditch sidewalls.

There is a risk that the west edge of the road will become directly undermined by the slumping in the sidewalls of the west road ditch if the erosion and downcutting along the ditch downstream of the culvert outlet continues and possibly worsens in the future. However, the road has not been damaged to date.

1. Excavate the destabilized material along the ditch sidewalls and then reconstruct the ditch base and sidewalls with compacted backfill to a suitable cross-section (i.e. a suitable ditch depth relative to the road surface and sideslopes at inclinations that will remain stable over the long term). Line the reconstructed ditch with a geosynthetic product in order to protect from erosion under future peak flows.

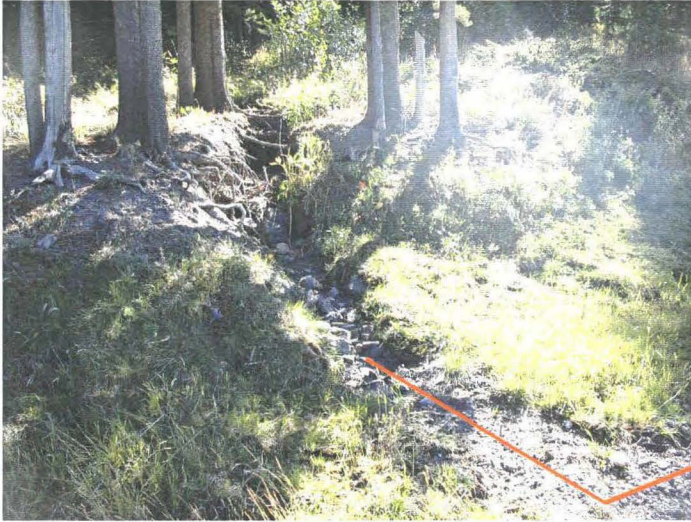
Photo 940-4 (top) – Main (north) fork of the seasonal creek in the slope above the highway. The main fork discharges into the east road ditch approximately 10 m upstream/ northbound of the culvert inlet.

In addition to the above, a second culvert could be installed approximately 10 m northbound of the existing culvert and aligned with the main (north) fork of the creek channel. This would distribute flow input to the west ditch between the two culverts and may help to mitigate the erosion “bowl” at the existing culvert outlet (as shown in Photo 940-1). However, this is not recommended because it does not appear that the east ditch has been overflowing during peak creek flows. Furthermore, the second culvert would not mitigate the erosion and downcutting of the west ditch downstream of the existing culvert outlet, because the total volume of flow in the west ditch would not change.

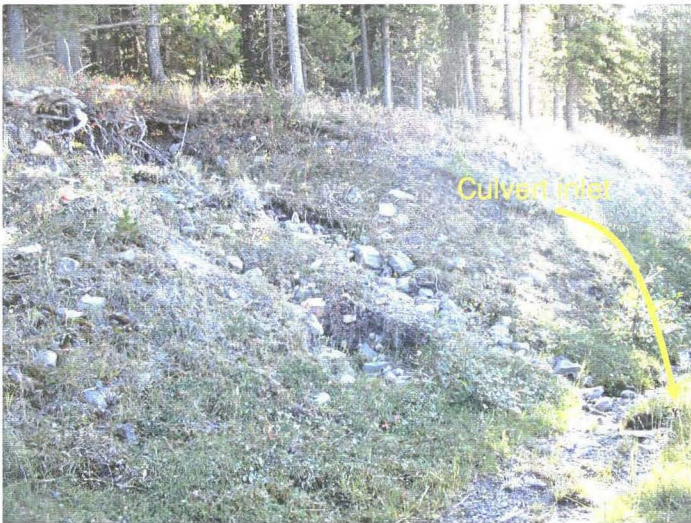
Photo 940-5 (bottom) – Secondary (south) fork of the seasonal creek in the slope above the highway, draining directly towards the culvert inlet.
