August 28, 2009

CG25309.B

**Re: Southern Region Geohazard Assessment Program  
Highway 940, KM 25.9  
June 10, 2009 Inspection Report**

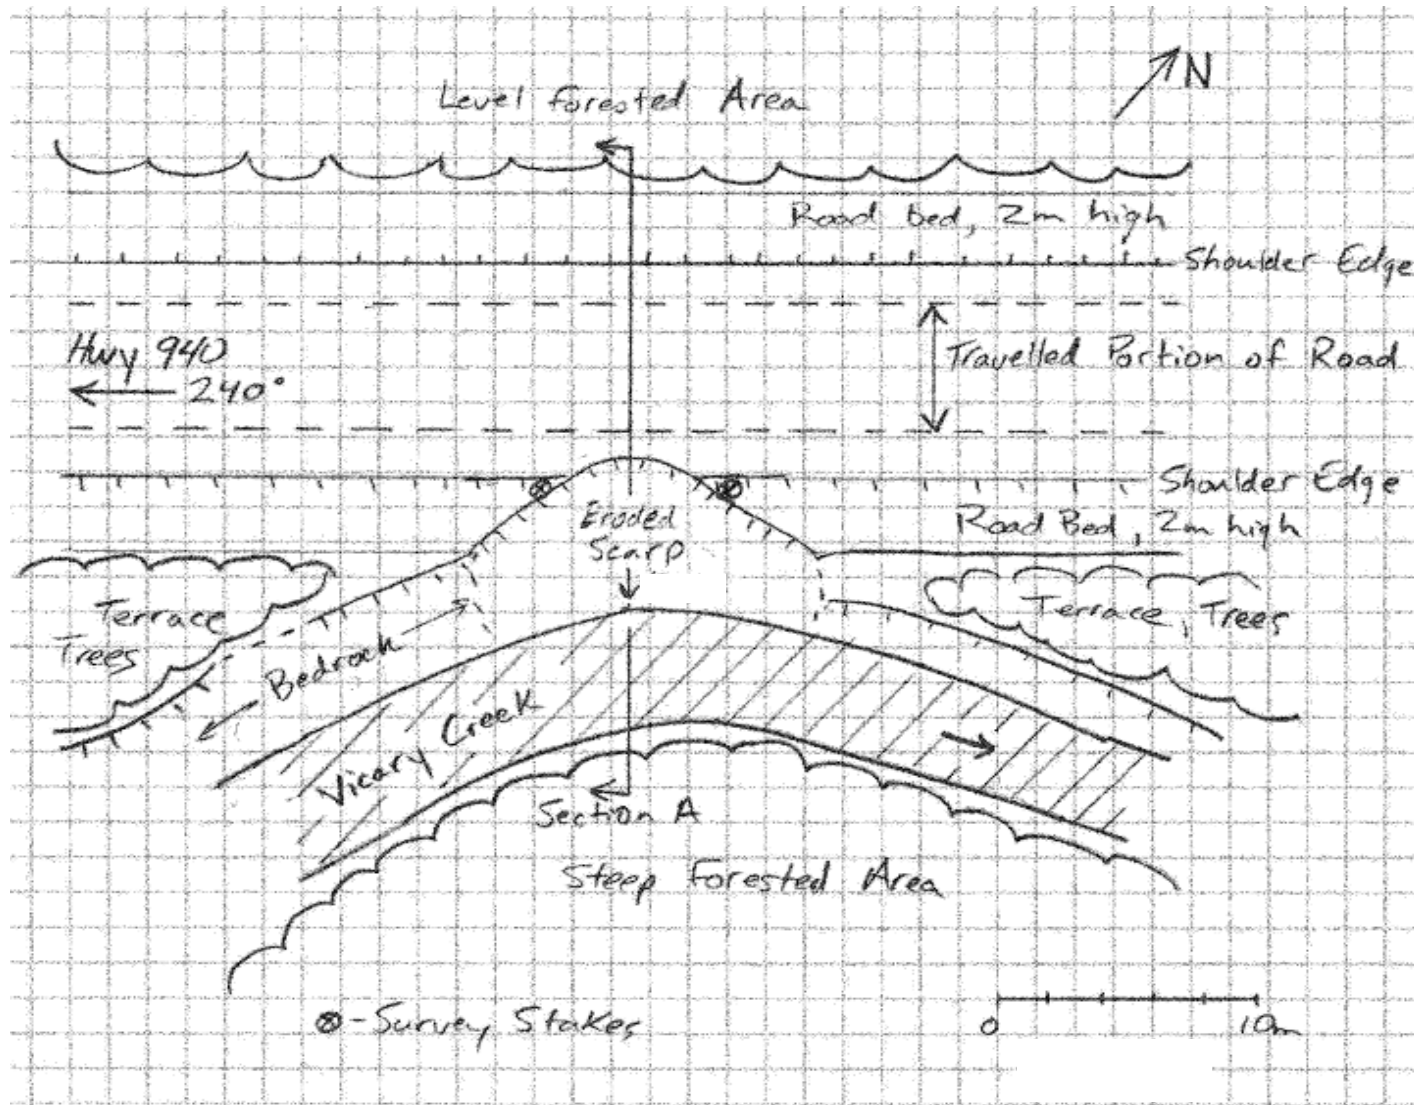
Client	Alberta Transportation		Figure 1	
Project	Southern Region Geohazard Assessment		Date:	Revision
	Hwy 940 - KM 25.9		Jul-09	
	Site Plan		Job No.	CG25309.B
			File No.:

- Two survey stakes were installed at the upslope extent of the gully for future monitoring (as shown in Photo 1 and on Figure 1).
- There is a swale in the road surface along and parallel to the downslope edge of the road and extending approximately 5 m southbound from the head of the gully. This swale directs surface runoff into the head of the gully. Photos 1 to 3 show the position of the swale relative to the head of the gully.

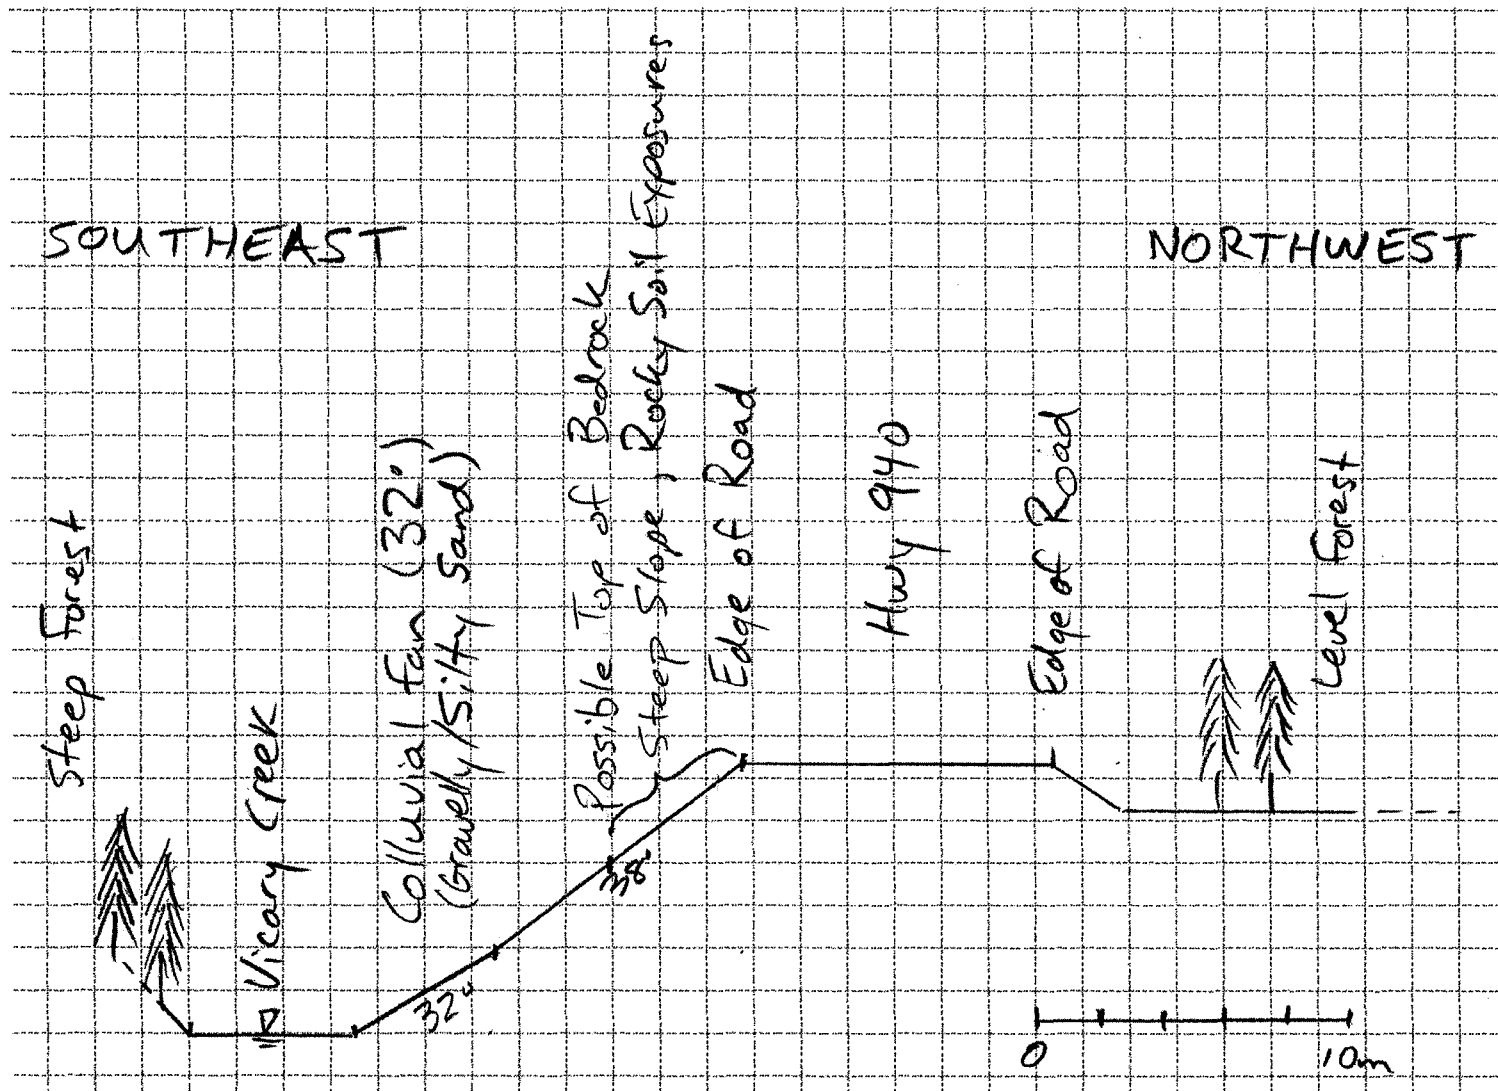
Client	Alberta Transportation		Figure 2	
Project	Southern Region Geohazard Assessment		Date:	Revision
	Hwy 940 - KM 25.9		Jul-09	
	Cross Section A		Job No.	CG25309.B
			File No.:

- The erosion gully has formed in a 38 to 40° inclination slope of exposed bedrock and rocky soil above the left creek bank, as shown in Photo 4. The slope is approximately 10 m high. The upper half of the slope exposes rocky soil that appears to be either a glacial till with up to boulder-sized rocks or perhaps the weathered and broken up surface of the underlying bedrock. The lower half of the slope and the left creek bank expose intact bedrock that is covered in places with colluvium and slope wash from above.

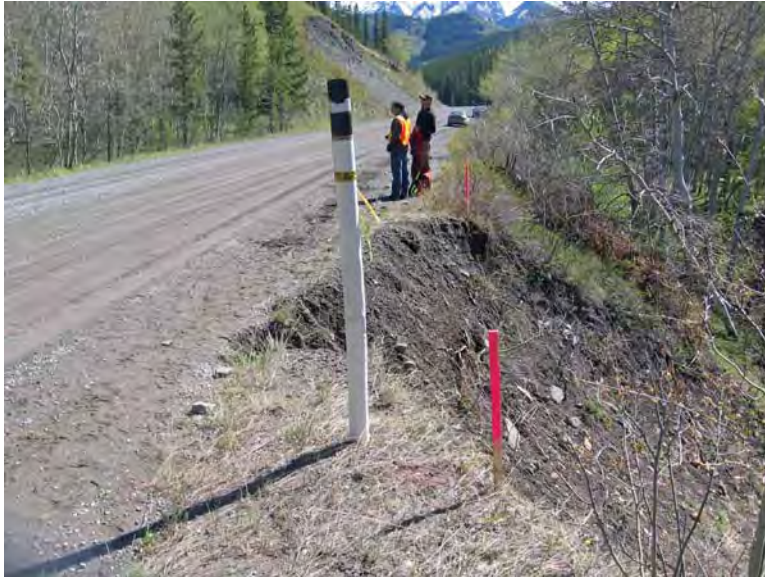
**Photo 1 – June 2009**

- The head of the gully will retrogress further into the northbound lane of the road over time. If left unchecked, the erosion will likely continue until the gully headwall and sideslopes eventually reach a marginally stable angle for the rocky soil in the order of 34 to 36°, which would result in the loss of at least the northbound lane of the road and leave the remaining road width in a marginally stable condition.

Looking northeast along the edge of the road. Erosion gully has encroached onto the shoulder and is within 1 m of the tire tracks on the road surface. Stakes mark the June 2009 upslope extent of the gully for future comparison.

1. Reducing the rate of gully erosion by directing surface runoff from the road surface away from the gully area. The road surface should be graded to shed surface runoff towards the upslope side of the road (and maintained to remain that way in the future).
2. Installing a guardrail along the downslope side of the road to keep traffic away from the undermined edge of the existing road. This will result in a nominal reduction of the road width from the existing 10 to 11 m width, however should be feasible for a secondary, unpaved highway of this nature.

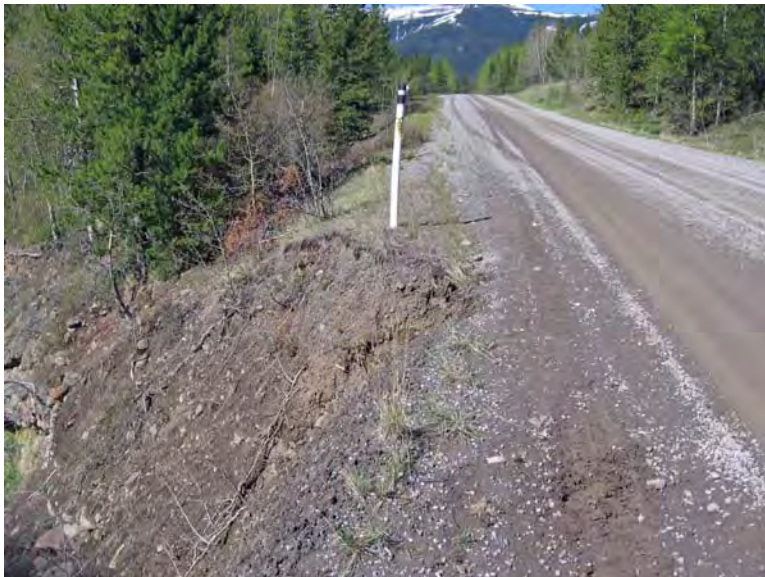
**Photo 2 – June 2009**

- The primary cause of the gully erosion appears to be the surface runoff from the road being directed into the head of the gully by the swale along the downslope edge of the road. Creek erosion along the toe of the slope below the road is judged to have little influence on the rate of gully erosion, because the creek bank consists of exposed bedrock that erodes slowly to a near-vertical bank of intact bedrock and/or is self armoring with boulder-sized blocks of bedrock that have broken away from the bank due to exposure and weathering.

Looking southwest along the edge of the road (prior to the installation of the reference stakes visible in Photo 1). Surface runoff from the road is channelled into the head of the gully.

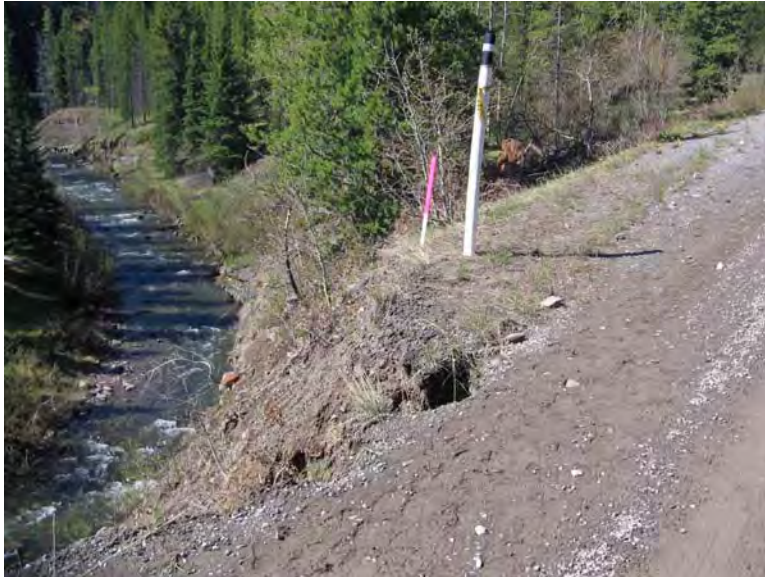
**Photo 3 – June 2009**  
Another view of the erosion gully encroaching onto the road surface.

- An erosion gully in the slope above the left creek bank is encroaching into an approximately 9 m wide segment of the downslope (southeast) edge of the road. This location is marked with a delineator post with some old (i.e. weathered and tattered) "Danger" flagging tied to it. As shown in Photo 3, at the time of the site inspection the gully had encroached approximately 0.1 to 0.2 m into the downslope edge of the road. The gully encroachment into the road was approximately the same as the 2008 inspection.

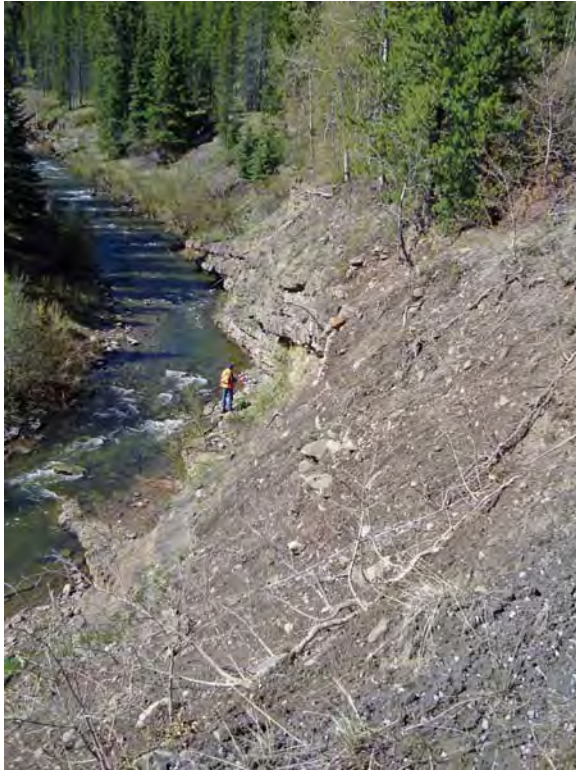
**Photo 5 – June 2009**

- The sandstone bedrock exposed upstream of the gully strikes at 30/210° and dips at 10 to 20° towards the northwest (i.e. the dip direction is downwards away from the creek channel at this site).

Bedrock exposure upstream  
from the erosion gully with  
bedrock striking at 30/210° and  
dipping at 10 to 20° towards  
the northwest.
