### **Sites 33, 34 and 35 – Mount Armstrong Viewpoint Cut Slope and Retaining Walls**

The Mount Armstrong viewpoint is located approximately 2 km west of the junction between Highways 40, 541 and 940 at Highwood House. There is an approximately 200 m long pullout lane on the downslope (south) side of the two lane highway at this site. This site was inspected in September 2005 and three areas with potential hazards were noted.

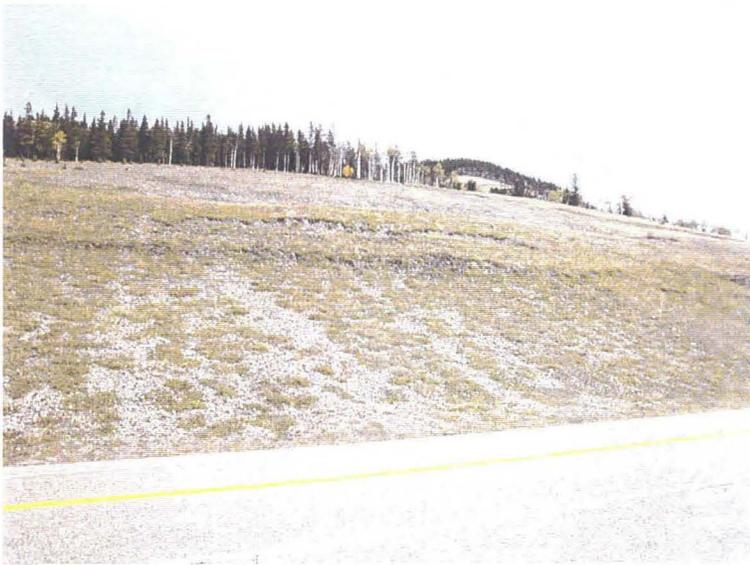
The cut slope above the highway is approximately 25 to 30 m in height at a crest-to-toe angle of around 21°. There are numerous arcuate slump scarps in the cut slope with vertical downdrops typically ranging between 0.5 and 1.5 m. Photos 1 to 4 show various views of this slope. In general, the slump scarps on the lower half of the slope are more well-defined in the slope profile than the scarps further upslope. Many of the slump scarps coincide with areas of seepage discharge on the slope. The natural slope face above the crest of the cut slope has an inclination of approximately 10°. The slump scarps visible on the cut slope face did not extend upslope of the crest of the cut.

It is not clear when the slump blocks first formed. It is judged that they have been present for many years. None of the slump blocks appear to have undergone significant movement in recent years, however it is possible that there may be ongoing movement at low rates.

The slumping does not appear to have affected the upslope ditch or northbound lane of the highway.

**Photo 1** (top) – Cut slope above the highway. Total height estimated to be 25 to 30 m and the crest-to-toe slope angle is approximately 21°. There are numerous arcuate slump scarps in the cut slope with vertical dropdowns typically ranging between 0.5 and 1.5 m. The slump scarps often coincide with areas of seepage discharge on the slope. There appears to be little to no impact to the ditch or northbound lane of the highway from the slumping.

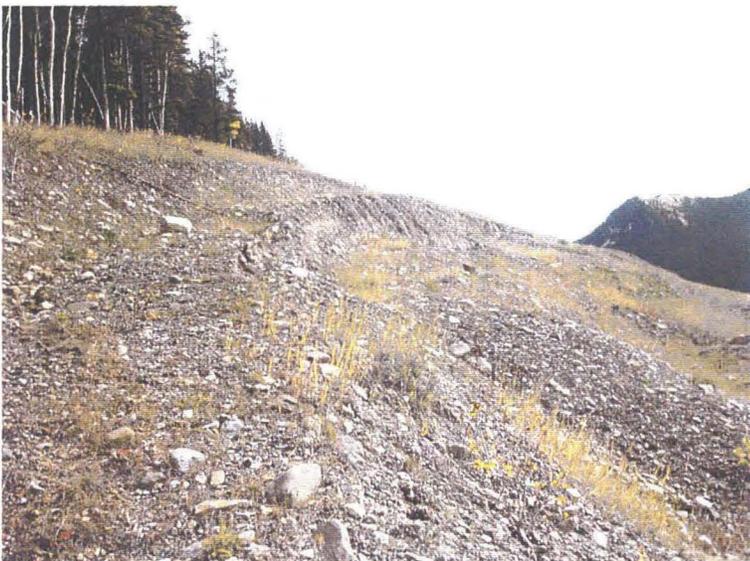
**Photo 2** (middle) – Facing east along one of the visible slump scarps near the crest of the cut slope above the road. The slump scarp and vertical dropdown of the slump block is well-defined in the slope profile, however the overall visual appearance does not indicate recent significant movement of the slump block.

The natural slope above the cut slope (in the trees off the left background of this photo) has an inclination of approximately 10° and appeared to be stable.

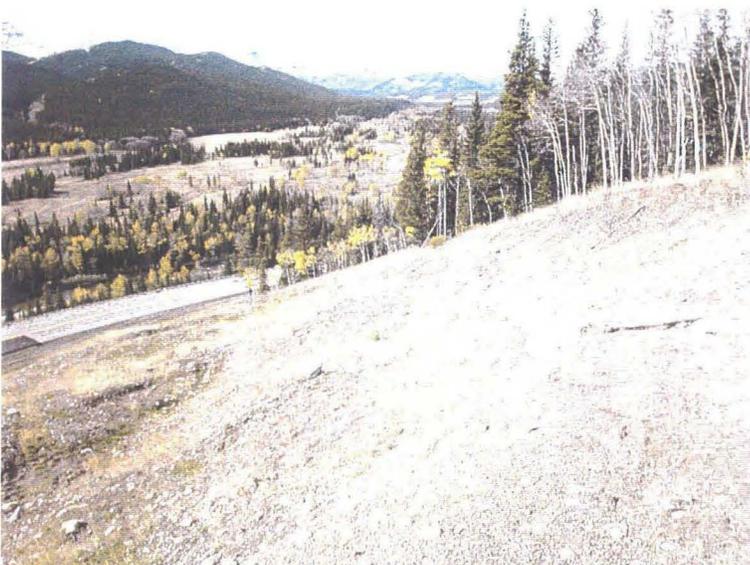
**Photo 3** (bottom) – Facing west across the area shown in Photo 2, illustrating the relative position of the slump scarps in the upper portion of the cut slope and the highway.

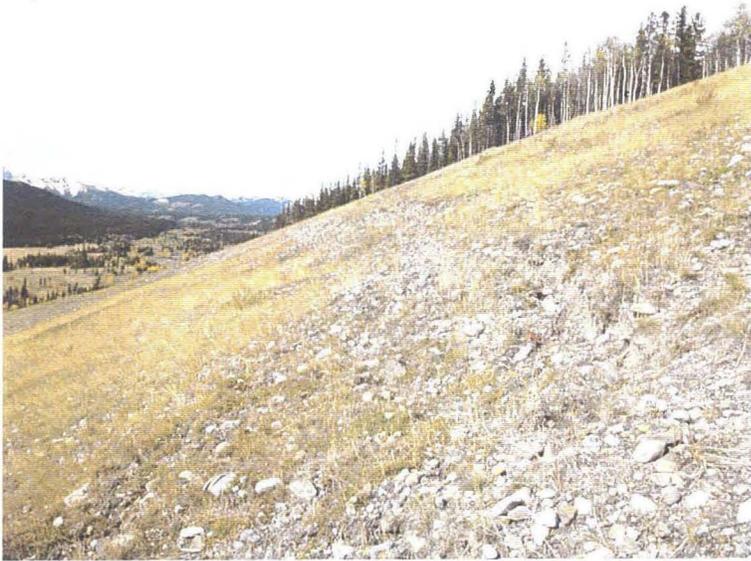
**Photo 4** (top) – Facing west across the lower to middle portions of the cut slope above the highway. A slump scarp is visible in the right foreground of the photo. A number of similar scarps were noted at various locations on the cut slope, however they generally did not appear to have experienced significant movement in recent years.

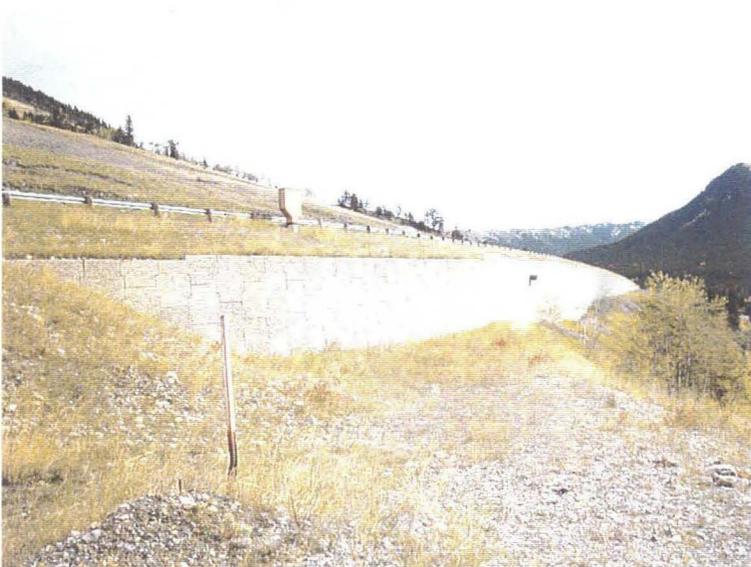
There is a vertical retaining wall below the highway, roughly centered around the Mount Armstrong viewpoint sign on the south side of the highway (Photo 5). The length of the wall is approximately 220 m. The maximum height of the retaining wall is approximately 9 to 10.5 m. The wall appears to be a "reinforced earth" style wall with a series of metal retaining straps connected to the concrete face panels and extending into the backfill behind the wall. The wall itself appears to be in good condition, with no visual signs of significant deformation or movement.

**Photo 5** (middle) – Facing east across the retaining wall along the downslope edge of the highway. The red/brown signpost along the guardrail is the “Mount Armstrong Viewpoint” sign along the highway. The maximum height of the retaining wall is approximately 9 to 10.5 m. The wall appears to be in good condition, however there is a steep slope in close proximity to the base of the wall at the eastern end of the wall (right background of this photo) – see Photos 6 and 7.

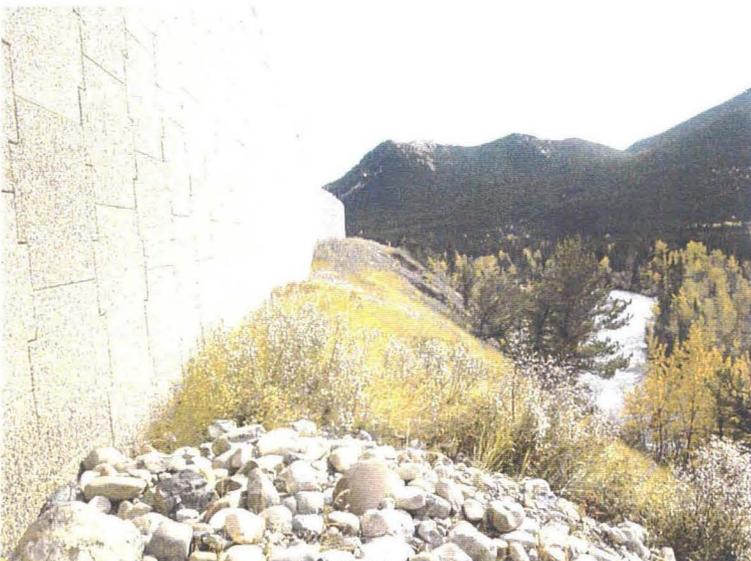
The east end of the wall is above a steep (approximately 36°) slope between the highway and the Highwood River (Photos 6 and 7). The toe of this slope is exposed to erosion along the river channel, and there are also several erosion gullies in the slope face that have formed due to surface runoff. It was not possible to safely access the gullies to check if there was bedrock exposed in the gully walls. The gully head slopes are close to the toe of the retaining wall in several locations, with a minimum offset from the toe of the wall in the order to 3 m. Some short lengths of metal strips of the type used in retaining wall backfill were exposed in one of these gully headwalls, however it is not clear if these strips were waste material from when the wall was constructed or were perhaps buried in an attempt to stabilize the soil around the head of the gully.

**Photo 6** (bottom) – Facing east along the toe of the retaining wall below the highway. The natural slope below the eastern portion of the wall is steep (approximately 36°) and the heads of several erosion gullies in this slope were within 3 m of the toe of the wall. The toe of this slope is exposed to erosion by the Highwood River, as shown in Photo 7.

1. Check the design and construction records for the wall to see if the steep slope adjacent to the east toe of the wall was accounted for in the design. If not, check how this might affect the stability of the wall.
2. Future visual inspections of the slope crest along the toe of the east end of the retaining wall to monitor for retrogression of the erosion gullies and potential destabilization of the wall.

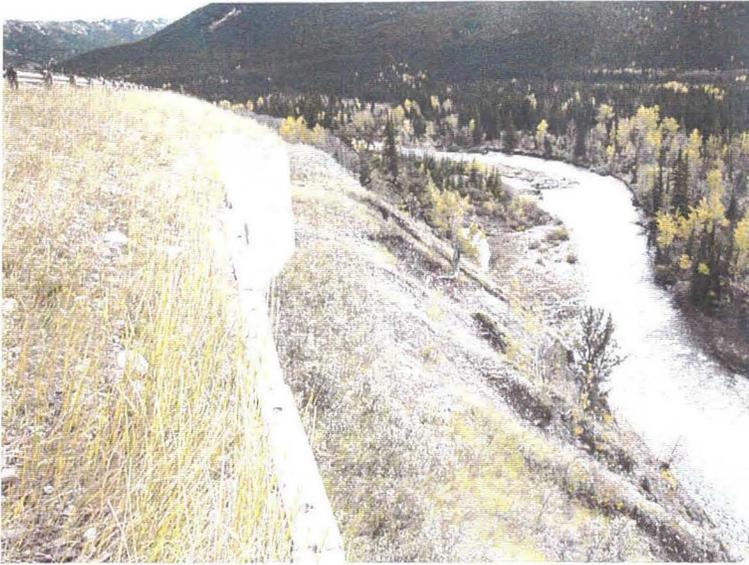
**Photo 7 (top)** – Eastern end of the retaining wall below the Mount Armstrong viewpoint. This view illustrates the relative position of the erosion gullies in the steep slope below the wall and the toe of the wall. The minimum offset between the toe of the wall and the head of one of the erosion gullies was approximately 3 m. Some short lengths of metal strips used in retaining wall backfill were exposed in one of these gully heads, however it is not clear if these strips were waste material from when the wall was constructed or if they had been placed in an attempt to stabilize the soil around the head of the gully.

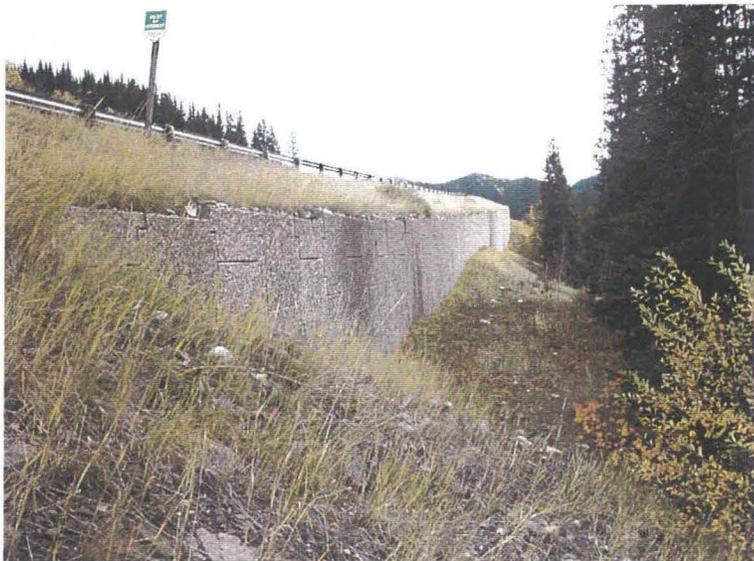
The vertical retaining wall to the west of the viewpoint sign has a maximum height of approximately 6 to 7.5 m. The length of the wall is approximately 60 m. Photo 8 shows an overall view of this wall, which also appears to be a “reinforced earth” style of retaining wall with a series of metal retaining straps connected to the concrete face panels and extending into the backfill behind the wall.

The eastern end of the wall face appears to be tilting downslope. This may be an optical illusion, however if the downslope tilt is real it may have occurred during or shortly after construction when the retaining strips for the wall were first loaded or it could indicate post-construction movement of the wall face.

**Photo 8 (bottom)** – Facing east along a second retaining wall below the highway, approximately 300 m west of the Mount Armstrong viewpoint sign along the highway. The maximum vertical height of this wall was approximately 6 to 7.5 m. This wall had a distinct visual appearance of tilting outwards, especially at the east end.

1. After this segment of the highway re-opens in June 2006, using a plumb bob to determine if the wall face is off vertical, and if so measure the horizontal offset of the top of the wall relative to the toe. This survey could be repeated in the fall of 2006 in order to check if the tilt is increasing.
