August 28, 2009

CG25309.B

**Re: Southern Region Geohazard Assessment Program
Highway 40, Mount Armstrong Viewpoint Retaining Wall
June 2009 Inspection Report**

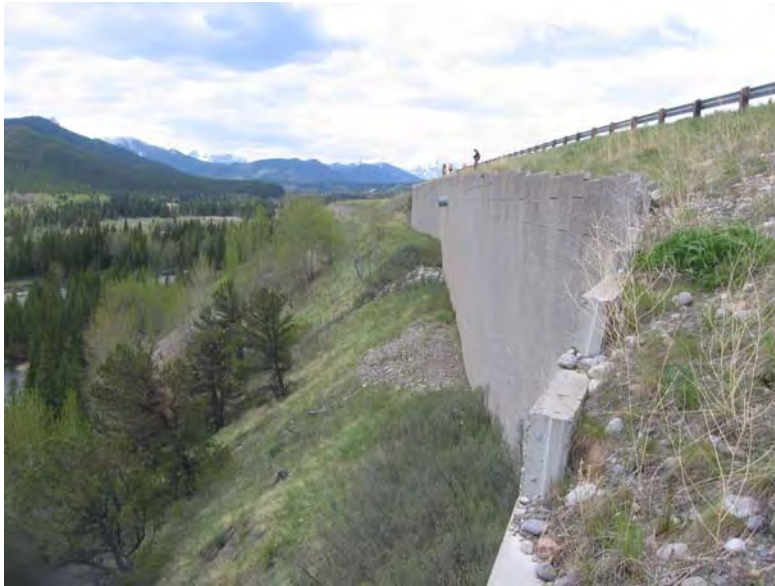
Photo 1 (top) – June 2009

- There were no significant changes to the slope and gullies below and adjacent to the toe of the wall since the 2005 inspection. The gully at the east end of the wall was still in the same proximity to the toe of the wall, without any signs of fresh retrogression towards the wall. Photos 1 to 3, attached, show views of the site from the June 2009 inspection.

Facing westbound across the wall face, showing the relative position of the highway, wall and steep slope below the wall.

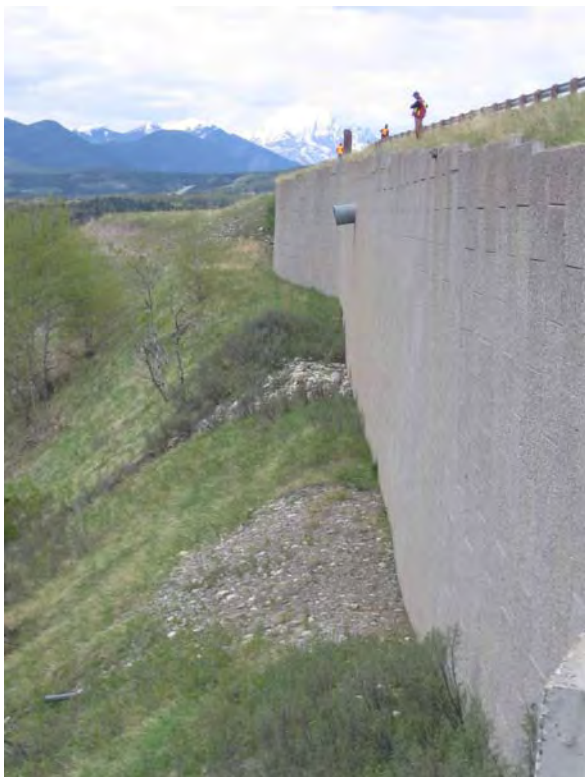
Photo 2 (bottom) – June 2009

- The wall continued to appear vertical and in good condition. There was no cracking or settlement in the paved area adjacent to the crest of the wall that would suggest deformation or destabilization of the wall since the 2005 inspection.

Closer view, facing westbound, across the wall face below the highway.

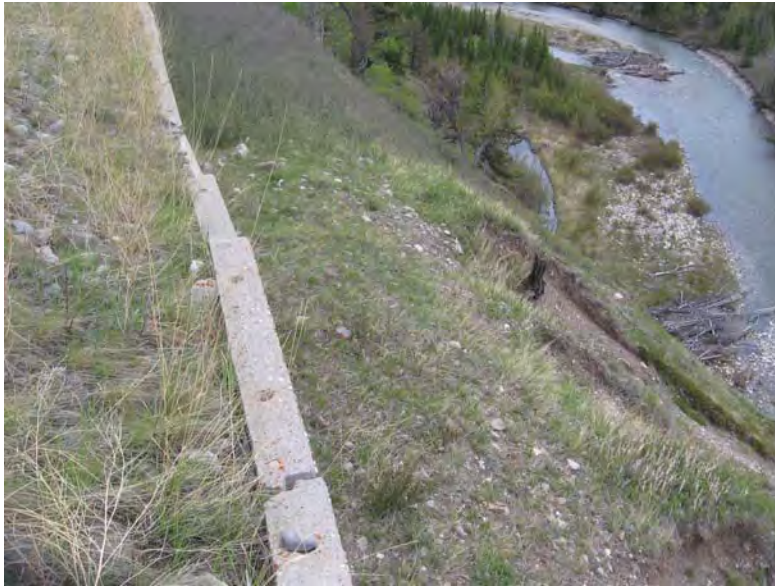
Photo 3 – June 2009

Facing down from the crest of the wall, towards some of the erosion gullies in the slope below the wall. Note the position of the Highwood River channel visible in the right background.
