### **Sites 33, 34 and 35 – Mount Armstrong Viewpoint Cut Slope and Retaining Walls**

The Mount Armstrong viewpoint is located approximately 2 km west of the junction between Highways 40, 541 and 940 at Highwood House. There is an approximately 200 m long pullout lane on the downslope (south) side of the two lane highway at this site. This site was inspected in September 2005 and three areas with potential hazards were noted.

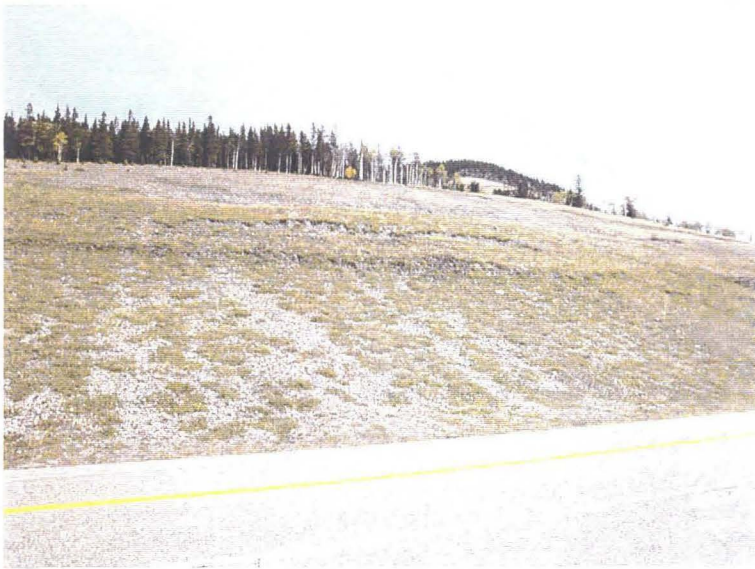
The cut slope above the highway is approximately 25 to 30 m in height at a crest-to-toe angle of around 21°. There are numerous arcuate slump scarps in the cut slope with vertical downdrops typically ranging between 0.5 and 1.5 m. Photos 1 to 4 show various views of this slope. In general, the slump scarps on the lower half of the slope are more well-defined in the slope profile than the scarps further upslope. Many of the slump scarps coincide with areas of seepage discharge on the slope. The natural slope face above the crest of the cut slope has an inclination of approximately 10°. The slump scarps visible on the cut slope face did not extend upslope of the crest of the cut.

It is not clear when the slump blocks first formed. It is judged that they have been present for many years. None of the slump blocks appear to have undergone significant movement in recent years, however it is possible that there may be ongoing movement at low rates.

The slumping does not appear to have affected the upslope ditch or northbound lane of the highway.

- Probability Factor of 6 based on the presence of well-defined slump scarps in the slope profile but uncertainty regarding the level of activity and movement rate.
- Consequence Factor of 2 based on a scenario where one of the slump blocks on the lower portion of the slope moved and filled the ditch with debris that encroached into the northbound lane of the highway. The highway would not have to be closed, although the pullout lane along the downslope edge of the highway might need to be used to maintain two-way traffic under a reduced speed limit until the debris was cleared.

Therefore, the recommended Risk Level for this site is 12.

**Photo 1** (top) – Cut slope above the highway. Total height estimated to be 25 to 30 m and the crest-to-toe slope angle is approximately 21°. There are numerous arcuate slump scarps in the cut slope with vertical dropdowns typically ranging between 0.5 and 1.5 m. The slump scarps often coincide with areas of seepage discharge on the slope. There appears to be little to no impact to the ditch or northbound lane of the highway from the slumping.

1. A follow-up site inspection in July 2006 in order to check the slope conditions and further estimate whether or not the slump blocks are actively moving and verify

the applicable Risk Level. Note that this portion of the highway is closed between December 1<sup>st</sup> and June 15<sup>th</sup> of each year. It may be possible to reduce the Probability Factor if future observations of the cut slope suggest that the slump blocks are not actively moving.

2. Given the recommended Consequence Factor, additional geotechnical characterization and more involved monitoring of the slumping are not judged to be warranted at this time. However, if it is judged after future inspections that the slump blocks are actively moving and quantitative monitoring of the movement is required, then the installation of simple surface extensometers spanning the slump scarps could be considered as a reasonably effective and economical alternative to slope inclinometers (SI's). The simple extensometers could consist of metal rods hammered into the ground on either side of a slump scarp. Follow-up readings are taken by using a tape measure to measure the distance between these reference points. Changes in the distance over time can be used to estimate any lateral deformation that is occurring, notwithstanding any disturbance to the reference points and the level of precision achieved while using the tape measure.

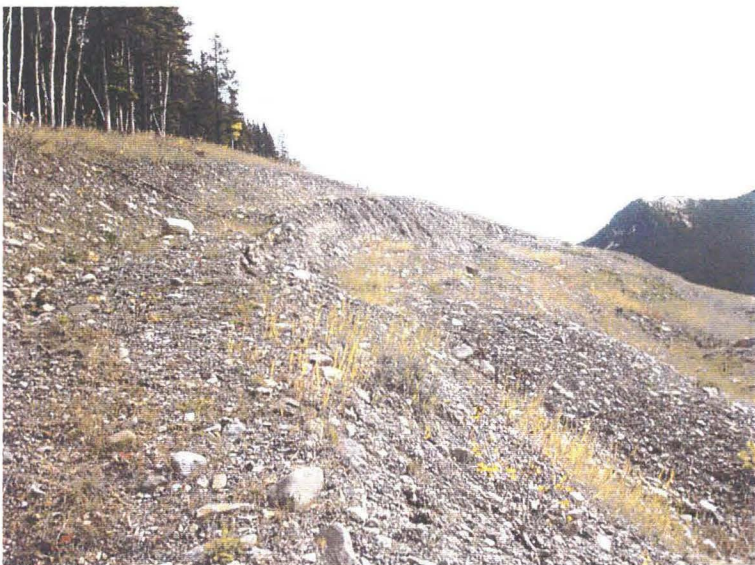
**Photo 2** (middle) – Facing east along one of the visible slump scarps near the crest of the cut slope above the road. The slump scarp and vertical dropdown of the slump block is well-defined in the slope profile, however the overall visual appearance does not indicate recent significant movement of the slump block.

The natural slope above the cut slope (in the trees off the left background of this photo) has an inclination of approximately 10° and appeared to be stable.

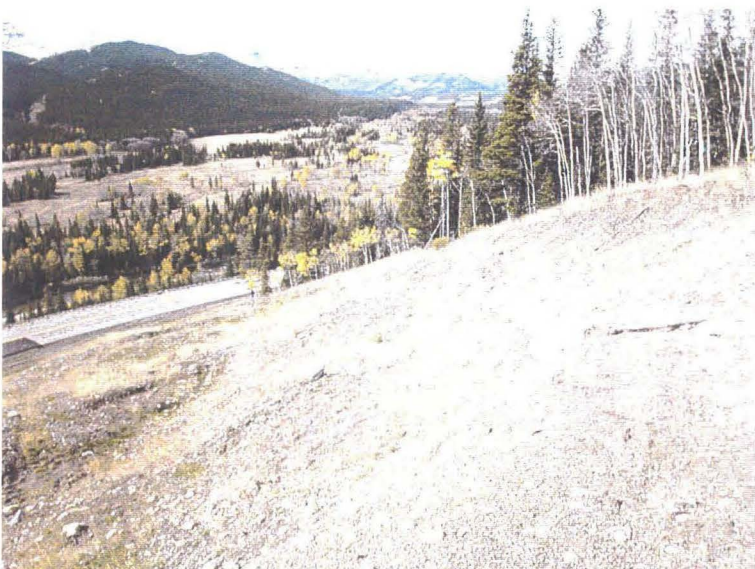
**Photo 3** (bottom) – Facing west across the area shown in Photo 2, illustrating the relative position of the slump scarps in the upper portion of the cut slope and the highway.
