Sites 33, 34 and 35 – Mount Armstrong Viewpoint Cut Slope and Retaining Walls

The Mount Armstrong viewpoint is located approximately 2 km west of the junction between Highways 40, 541 and 940 at Highwood House. There is an approximately 200 m long pullout lane on the downslope (south) side of the two lane highway at this site. This site was inspected in September 2005 and three areas with potential hazards were noted.

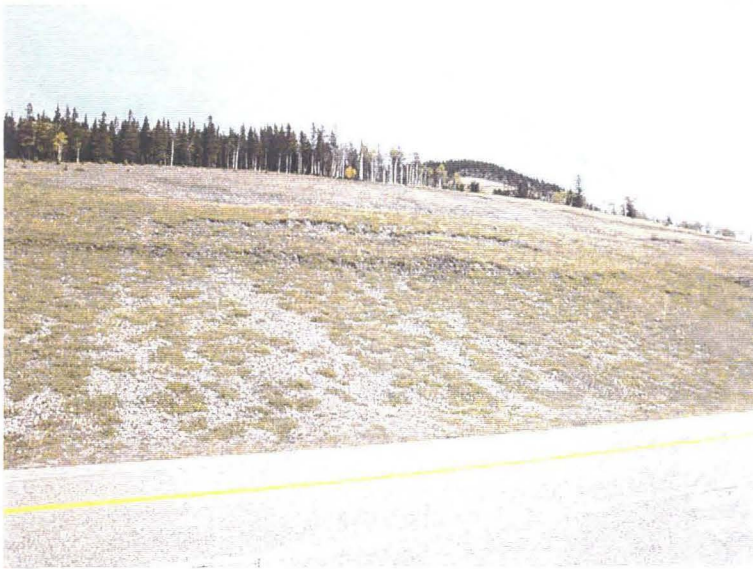
The cut slope above the highway is approximately 25 to 30 m in height at a crest-to-toe angle of around 21°. There are numerous arcuate slump scarps in the cut slope with vertical downdrops typically ranging between 0.5 and 1.5 m. Photos 1 to 4 show various views of this slope. In general, the slump scarps on the lower half of the slope are more well-defined in the slope profile than the scarps further upslope. Many of the slump scarps coincide with areas of seepage discharge on the slope. The natural slope face above the crest of the cut slope has an inclination of approximately 10°. The slump scarps visible on the cut slope face did not extend upslope of the crest of the cut.

It is not clear when the slump blocks first formed. It is judged that they have been present for many years. None of the slump blocks appear to have undergone significant movement in recent years, however it is possible that there may be ongoing movement at low rates.

Photo 1 (top) – Cut slope above the highway. Total height estimated to be 25 to 30 m and the crest-to-toe slope angle is approximately 21°. There are numerous arcuate slump scarps in the cut slope with vertical dropdowns typically ranging between 0.5 and 1.5 m. The slump scarps often coincide with areas of seepage discharge on the slope. There appears to be little to no impact to the ditch or northbound lane of the highway from the slumping.

1. A follow-up site inspection in July 2006 in order to check the slope conditions and further estimate whether or not the slump blocks are actively moving and verify

the applicable Risk Level. Note that this portion of the highway is closed between December 1st and June 15th of each year. It may be possible to reduce the Probability Factor if future observations of the cut slope suggest that the slump blocks are not actively moving.

2. Given the recommended Consequence Factor, additional geotechnical characterization and more involved monitoring of the slumping are not judged to be warranted at this time. However, if it is judged after future inspections that the slump blocks are actively moving and quantitative monitoring of the movement is required, then the installation of simple surface extensometers spanning the slump scarps could be considered as a reasonably effective and economical alternative to slope inclinometers (SI's). The simple extensometers could consist of metal rods hammered into the ground on either side of a slump scarp. Follow-up readings are taken by using a tape measure to measure the distance between these reference points. Changes in the distance over time can be used to estimate any lateral deformation that is occurring, notwithstanding any disturbance to the reference points and the level of precision achieved while using the tape measure.

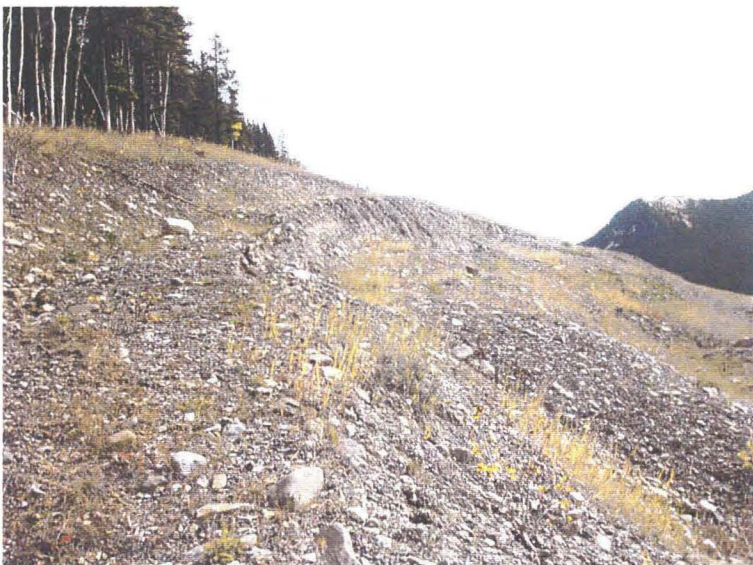
Photo 2 (middle) – Facing east along one of the visible slump scarps near the crest of the cut slope above the road. The slump scarp and vertical dropdown of the slump block is well-defined in the slope profile, however the overall visual appearance does not indicate recent significant movement of the slump block.

The natural slope above the cut slope (in the trees off the left background of this photo) has an inclination of approximately 10° and appeared to be stable.

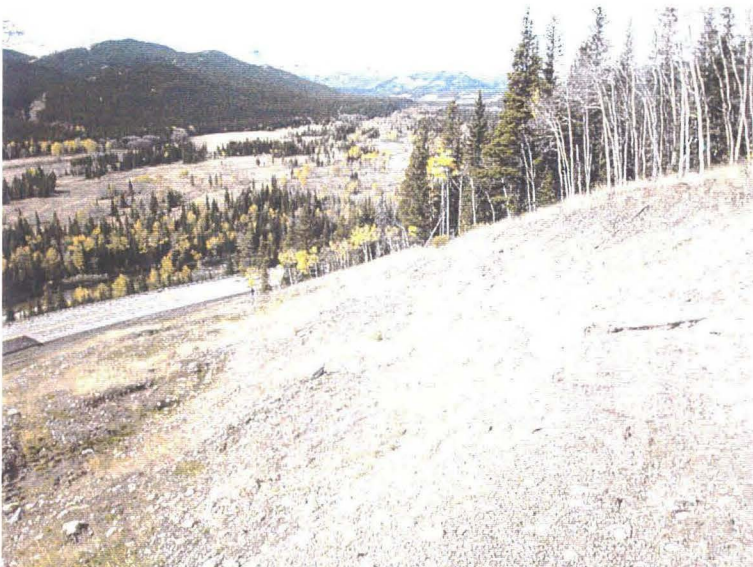
Photo 3 (bottom) – Facing west across the area shown in Photo 2, illustrating the relative position of the slump scarps in the upper portion of the cut slope and the highway.

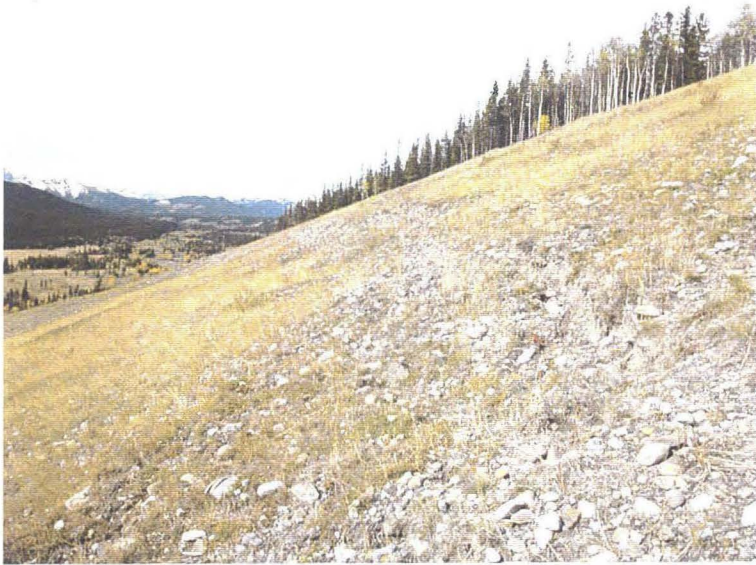
Photo 4 (top) – Facing west across the lower to middle portions of the cut slope above the highway. A slump scarp is visible in the right foreground of the photo. A number of similar scarps were noted at various locations on the cut slope, however they generally did not appear to have experienced significant movement in recent years.

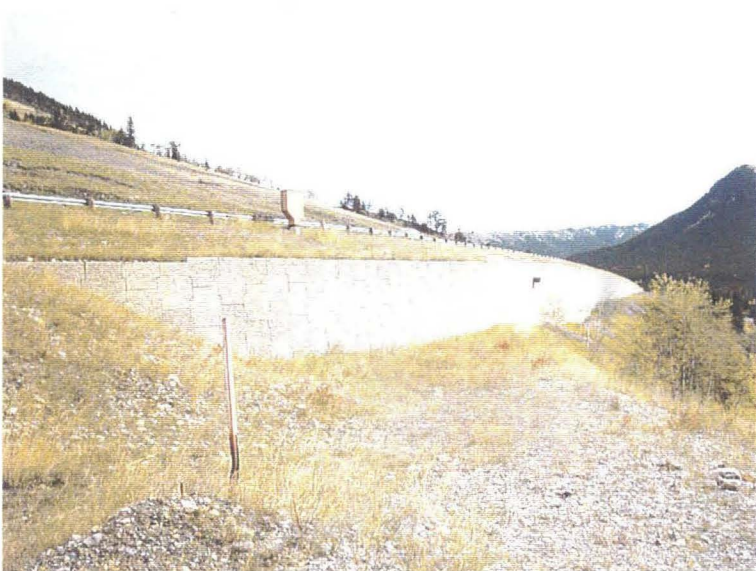
There is a vertical retaining wall below the highway, roughly centered around the Mount Armstrong viewpoint sign on the south side of the highway (Photo 5). The length of the wall is approximately 220 m. The maximum height of the retaining wall is approximately 9 to 10.5 m. The wall appears to be a "reinforced earth" style wall with a series of metal retaining straps connected to the concrete face panels and extending into the backfill behind the wall. The wall itself appears to be in good condition, with no visual signs of significant deformation or movement.

Photo 5 (middle) – Facing east across the retaining wall along the downslope edge of the highway. The red/brown signpost along the guardrail is the “Mount Armstrong Viewpoint” sign along the highway. The maximum height of the retaining wall is approximately 9 to 10.5 m. The wall appears to be in good condition, however there is a steep slope in close proximity to the base of the wall at the eastern end of the wall (right background of this photo) – see Photos 6 and 7.

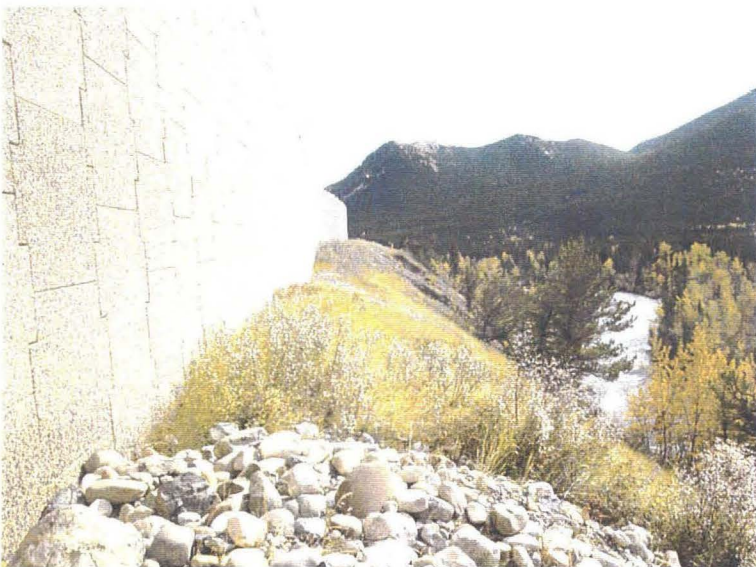
The east end of the wall is above a steep (approximately 36°) slope between the highway and the Highwood River (Photos 6 and 7). The toe of this slope is exposed to erosion along the river channel, and there are also several erosion gullies in the slope face that have formed due to surface runoff. It was not possible to safely access the gullies to check if there was bedrock exposed in the gully walls. The gully head slopes are close to the toe of the retaining wall in several locations, with a minimum offset from the toe of the wall in the order to 3 m. Some short lengths of metal strips of the type used in retaining wall backfill were exposed in one of these gully headwalls, however it is not clear if these strips were waste material from when the wall was constructed or were perhaps buried in an attempt to stabilize the soil around the head of the gully.

- Probability Factor of 5 based on the proximity of the erosion gullies to the east toe of the wall. Based on the visual observations during the site inspection, the

wall does not appear to have moved or deformed to date, however it would be prudent to check if the wall design accounted for having such a slope close to the toe of the wall.

- Consequence Factor of 4 based on the possibility of instability of the east end of the wall impacting on the eastbound lane of the highway and requiring partial closure of the highway.

Photo 6 (bottom) – Facing east along the toe of the retaining wall below the highway. The natural slope below the eastern portion of the wall is steep (approximately 36°) and the heads of several erosion gullies in this slope were within 3 m of the toe of the wall. The toe of this slope is exposed to erosion by the Highwood River, as shown in Photo 7.

1. Check the design and construction records for the wall to see if the steep slope adjacent to the east toe of the wall was accounted for in the design. If not, check how this might affect the stability of the wall.
2. Future visual inspections of the slope crest along the toe of the east end of the retaining wall to monitor for retrogression of the erosion gullies and potential destabilization of the wall.

If a higher level of monitoring for wall deformation and movement is required in the future, it should be possible to install a series of survey targets on the wall face. The installation of an SI behind the wall would also be helpful, but likely not practical because the borehole could hit some of the retaining strips in the wall backfill.

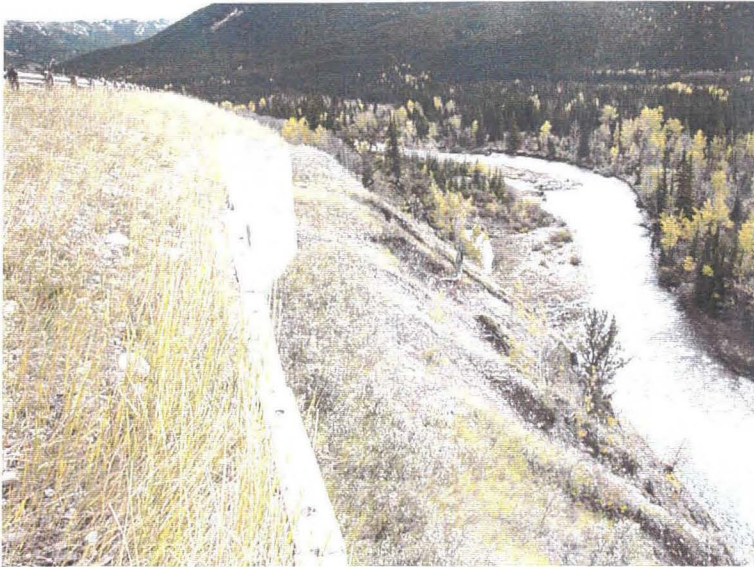
Photo 7 (top) – Eastern end of the retaining wall below the Mount Armstrong viewpoint. This view illustrates the relative position of the erosion gullies in the steep slope below the wall and the toe of the wall. The minimum offset between the toe of the wall and the head of one of the erosion gullies was approximately 3 m. Some short lengths of metal strips used in retaining wall backfill were exposed in one of these gully heads, however it is not clear if these strips were waste material from when the wall was constructed or if they had been placed in an attempt to stabilize the soil around the head of the gully.

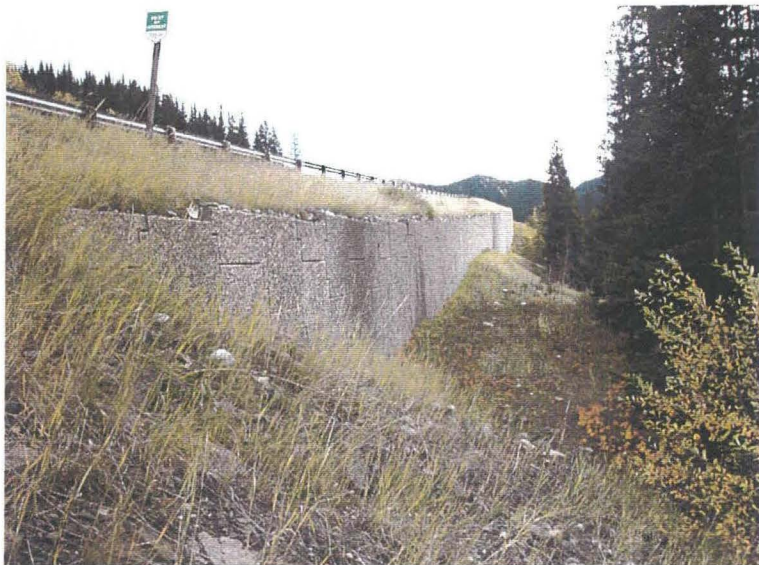
The vertical retaining wall to the west of the viewpoint sign has a maximum height of approximately 6 to 7.5 m. The length of the wall is approximately 60 m. Photo 8 shows an overall view of this wall, which also appears to be a “reinforced earth” style of retaining wall with a series of metal retaining straps connected to the concrete face panels and extending into the backfill behind the wall.

The eastern end of the wall face appears to be tilting downslope. This may be an optical illusion, however if the downslope tilt is real it may have occurred during or shortly after construction when the retaining strips for the wall were first loaded or it could indicate post-construction movement of the wall face.

- Probability Factor of 5 based on the apparent tilting of the wall and the uncertainty regarding whether or not the tilting indicates active deformation of the wall.

- Consequence Factor of 4 based on the possibility of instability of the east end of the wall impacting on the eastbound lane of the highway and requiring partial closure of the highway.

Photo 8 (bottom) – Facing east along a second retaining wall below the highway, approximately 300 m west of the Mount Armstrong viewpoint sign along the highway. The maximum vertical height of this wall was approximately 6 to 7.5 m. This wall had a distinct visual appearance of tilting outwards, especially at the east end.

1. After this segment of the highway re-opens in June 2006, using a plumb bob to determine if the wall face is off vertical, and if so measure the horizontal offset of the top of the wall relative to the toe. This survey could be repeated in the fall of 2006 in order to check if the tilt is increasing.
