Site 36 – Junction Hill Retaining Walls

This site is located approximately 1.4 km west (northbound) from the junction between Highways 40, 541 and 940 at Highwood House. There are two vertical retaining walls at this site:

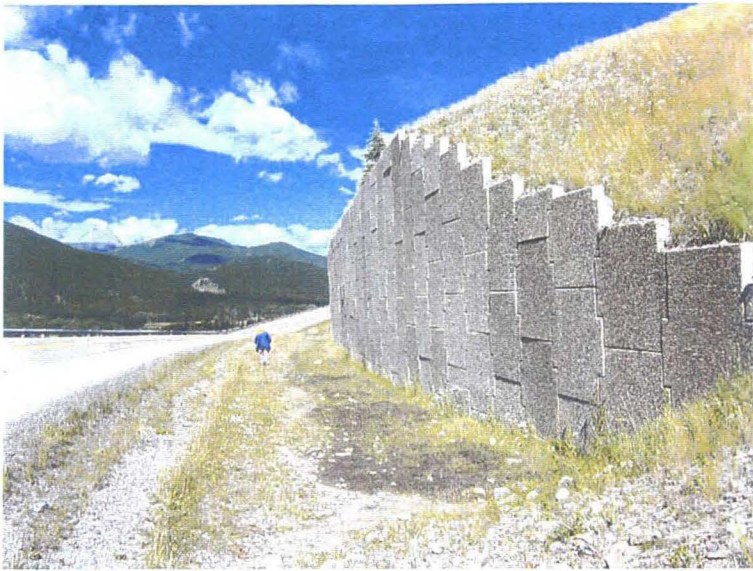
The wall above the highway appears to be off-vertical and tilted towards the highway. Vertical retaining walls are often constructed with a slight batter back from the road in order to offset an optical illusion that they are actually tilting outwards, however as shown in Photos 1 and 2, there is a distinct visual impression that the face of this wall is tilted towards the highway. It is possible that any such tilting occurred during or shortly after construction of the wall as the shear resistance along the retaining straps was first mobilized.

Photo 1 (top) – July 2005 – Facing west along the eastern end of the retaining wall above the road. The maximum height of this wall was approximately 6 to 7 m. There is a distinct visual appearance that this wall is leaning outwards. However, it is not known if any tilting of the wall towards the road occurred during or shortly after construction as the retaining strips behind the wall were loaded for the first time or if ongoing tilting of the wall is occurring.

1. Using a plumb bob to determine if the wall face is off vertical, and if so measure the horizontal offset of the top of the wall relative to the toe. This survey could be done after this segment of the highway re-opens on June 15, 2006 and then repeated in the fall of 2006 in order to check if the tilting is ongoing.

1. Establishing survey targets on the wall face and tracking their position over time in order to see if the wall face is moving or tilting outwards. This form of monitoring should only be undertaken if millimeter scale accuracy and precision can be achieved with the survey methods used.
2. Install tiltmeter(s) at one or more locations on the wall face.

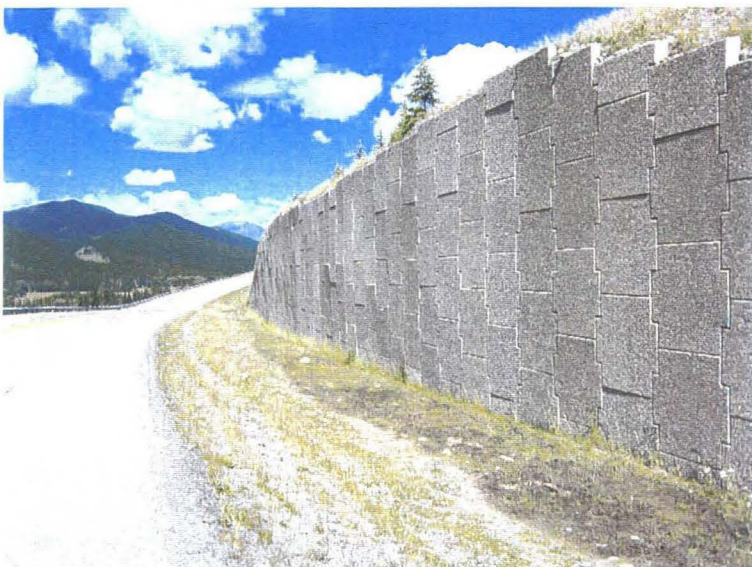
Photo 2 (middle) – July 2005 – Another view of the retaining wall above the road showing the central portion and west end of the wall.

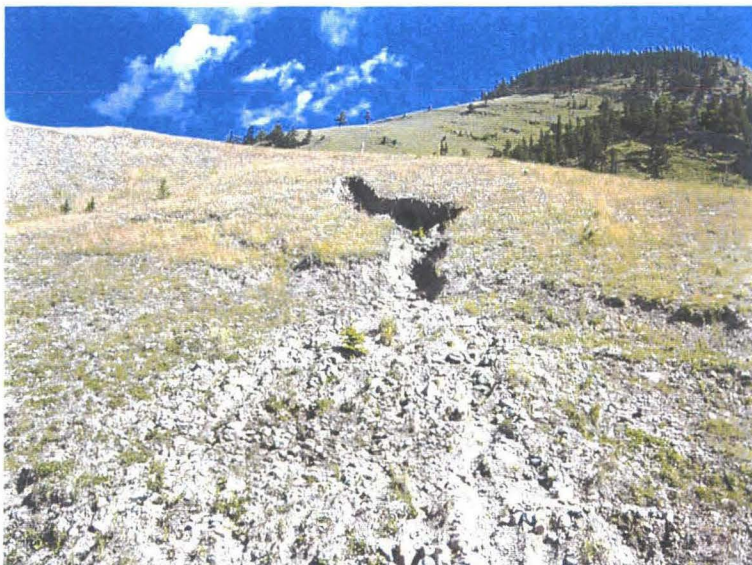
Gully erosion due to surface runoff was noted in the slope immediately east of the retaining wall above the road (Photo 3). This erosion has deposited soil into the ditch along the north side of the road. Due to the very low ditch gradient along the ditch in this area, the accumulated soil has partially blocked a culvert at the east end of the retaining wall above the road (Photos 4 and 5).

Photo 3 (bottom) – July 2005 – Gully erosion due to surface runoff on the slope above the road, immediately east of the retaining wall above the road. The eroded soil has been deposited in the ditch at the toe of the slope and partially blocked the culvert shown in Photos 4 and 5.

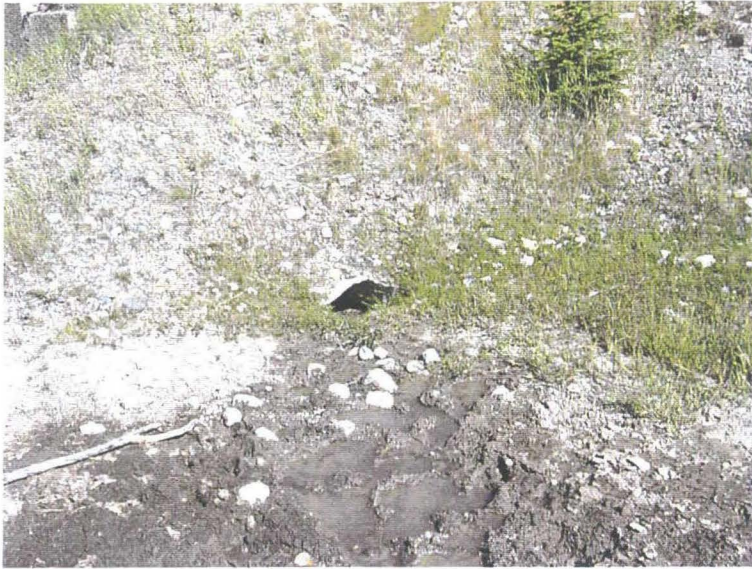
Photo 4 (top) – July 2005 – Inlet of the culvert adjacent to the east end of the wall and largely blocked by soil deposited in the ditch below an erosion area on the slope above the road (just east of the retaining wall and as shown on Photo 3).

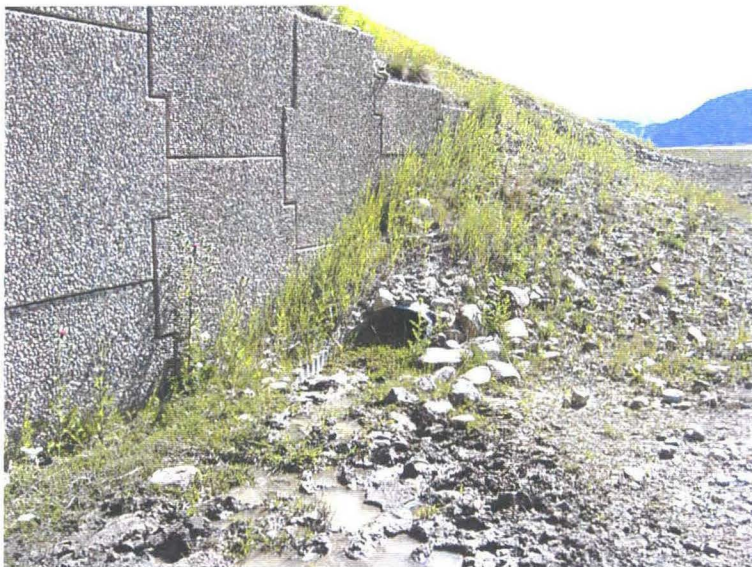
Photo 5 (middle) – July 2005 – Ponded water and soft ground in the ditch adjacent to the east end of the wall above the road. The ditch gradient in this area has effectively been lost due to cattle traffic that has reworked and softened the ground.

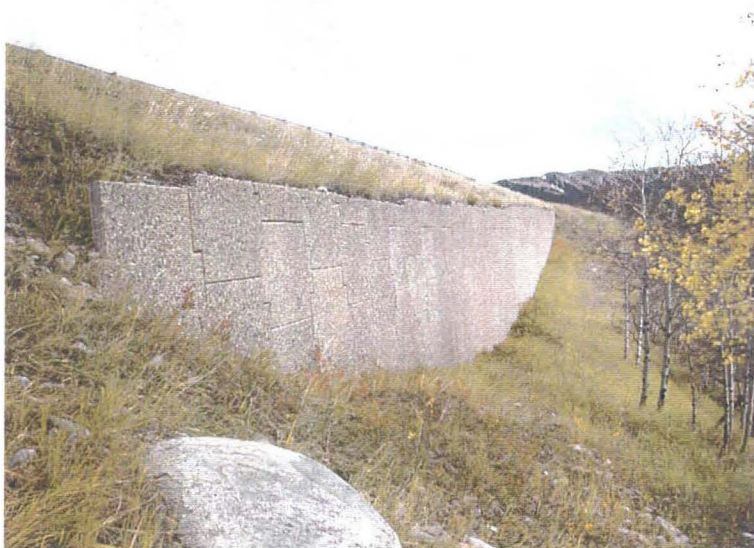
The retaining wall below the road (Photos 6 and 7) appeared to be vertical and in good condition.

Photo 6 (bottom) – September 2005 – Facing east across the retaining wall below the road. The maximum height of this wall is approximately 8 m.

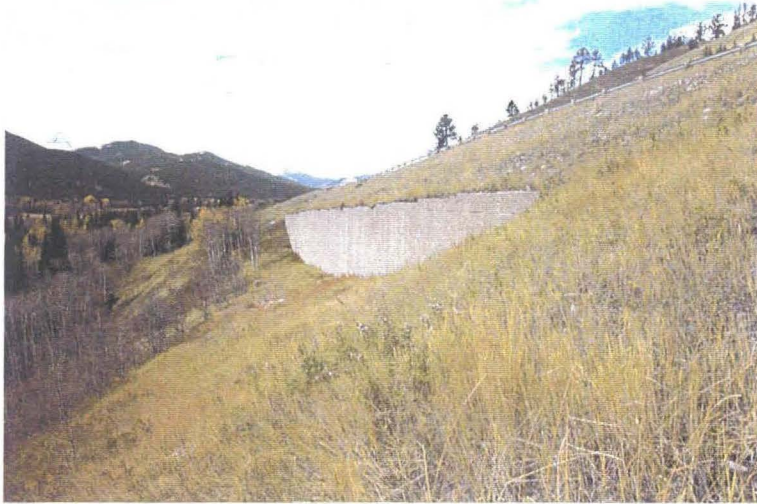
Photo 7 (top) – September 2005 – Facing west
across the retaining wall below the road.
