Site 22 – Gap Mountain Cut Slope

This site consists of a soil and rock cut slope along the northeast side of the highway approximately 3 km south of the Elpoca Creek crossing. There is a warning sign (“Watch For Fallen Rock”) posted for northbound traffic approaching this site.

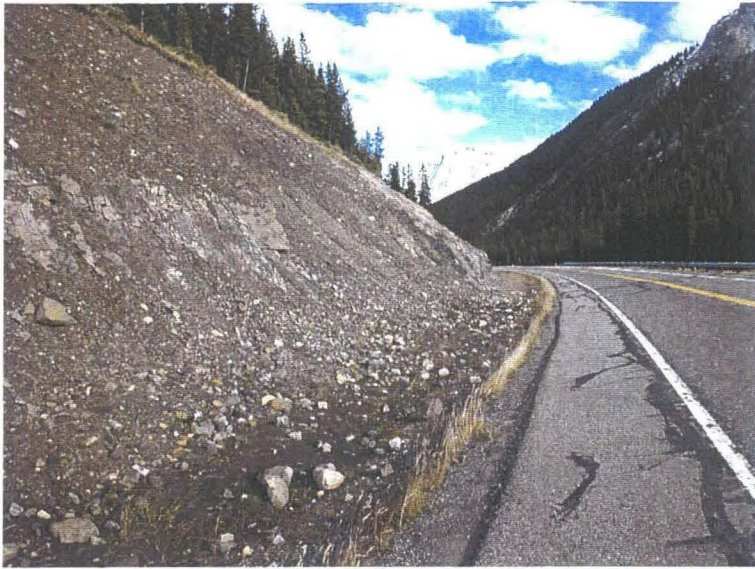
- Northern End: The upper portion of the northern end of the cut slope exposes rocky soil at an angle of about 45°. The lower portion of the cut slope exposes bedrock at an angle of approximately 60°. Gullying of the exposed soil has released cobble to boulder-sized debris which has accumulated as an apron along the toe of the slope and within the ditch. At the time of the inspection, the volume of material in the ditch was such that some debris had rolled down and been deposited within 2 m of the edge of the pavement. There were no signs of damage to the pavement from previous rockfalls. Photos 1 and 2 show views of the northern end of the site.

Based on the distribution of debris within the ditch, the most significant rockfall hazard at this site is along the northern end of the cut slope.

- Probability Factor of 14 based on the volume of debris in the ditch below the northern end of the cut slope that suggests that at least several rockfalls occur each year.

Photo 1 (top) – Facing southeast across the site. The northern end of the cut slope (visible in the foreground) exposes rocky soil at an angle of 45° overlying a rock cut at about 60° . Gullying of the exposed soil has released cobble to boulder-sized rocks and an apron of this debris has built up along the toe of this segment of the cut slope. Cobble to boulder-sized material has been deposited within 2 m of the edge of the pavement. The thickness of the exposed soil in the upper portion of the cut slope tapers out towards the southeast. The southeast end of the cut slope (in the background of this photo) exposes intact bedrock at an overall angle of 45° with very little debris in the ditch below.

It is recommended that the accumulated debris be cleared from the ditch. The ditch should also be cleaned as required in the future. This should be treated as an ongoing maintenance issue with cleaning performed as required.

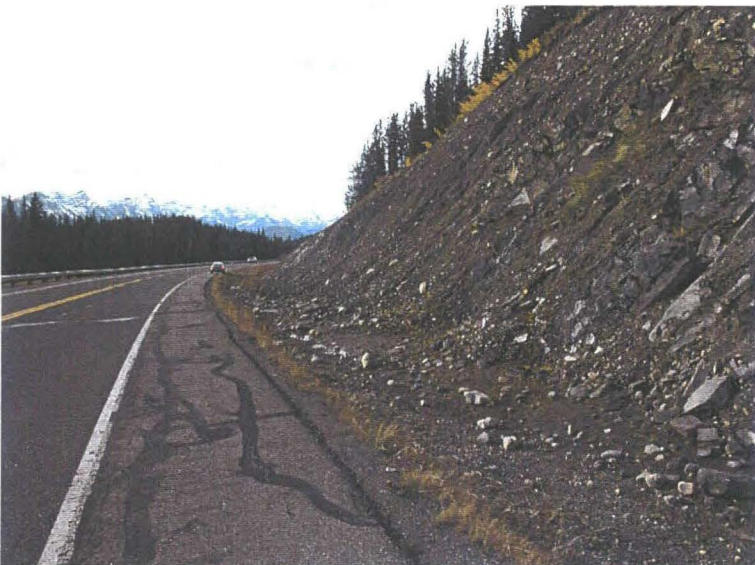
Photo 2 (middle) – Facing northwest across the northern end of the cut slope. Note the proximity of the debris in the ditch to the edge of the pavement.

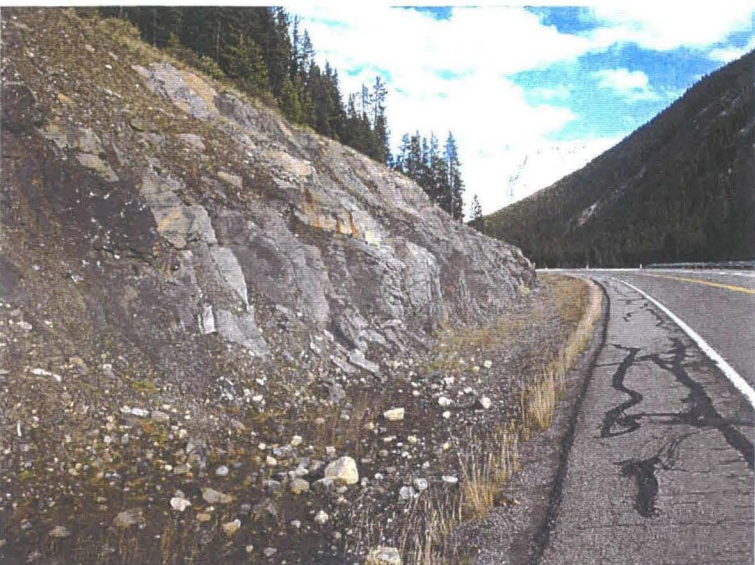
- Southern End: The exposed soil in the upper portion of the cut slope tapers out towards the southeast, such that only rock is exposed in the southern end of the cut slope. The overall slope angle is 45°, with the lowermost 2 to 3 m of the slope at approximately 60°. At the time of the inspection there was very little rockfall debris in the ditch in this area. Photo 3 shows the southern end of the site.

Photo 3 (bottom) – Closer view of the southern end of the cut slope that exposes rock. The overall cut slope angle is around 45° . The lowermost 2 to 3 m of the cut slope are at approximately 60° . There was very little debris in the ditch below this segment of the cut slope.
