Site 26 – Pocaterra Creek Slope

PROJECT: HWY 40/HWY 541 GEOHAZARDS REVIEW			
		TITLE: POCATERRA CREEK SLOPE			
CLIENT:		DATE: DECEMBER 2005	JOB No.: CG25211	CAD FILE: 25211N01.dwg	FIGURE No.: FIGURE E7
					REV. A

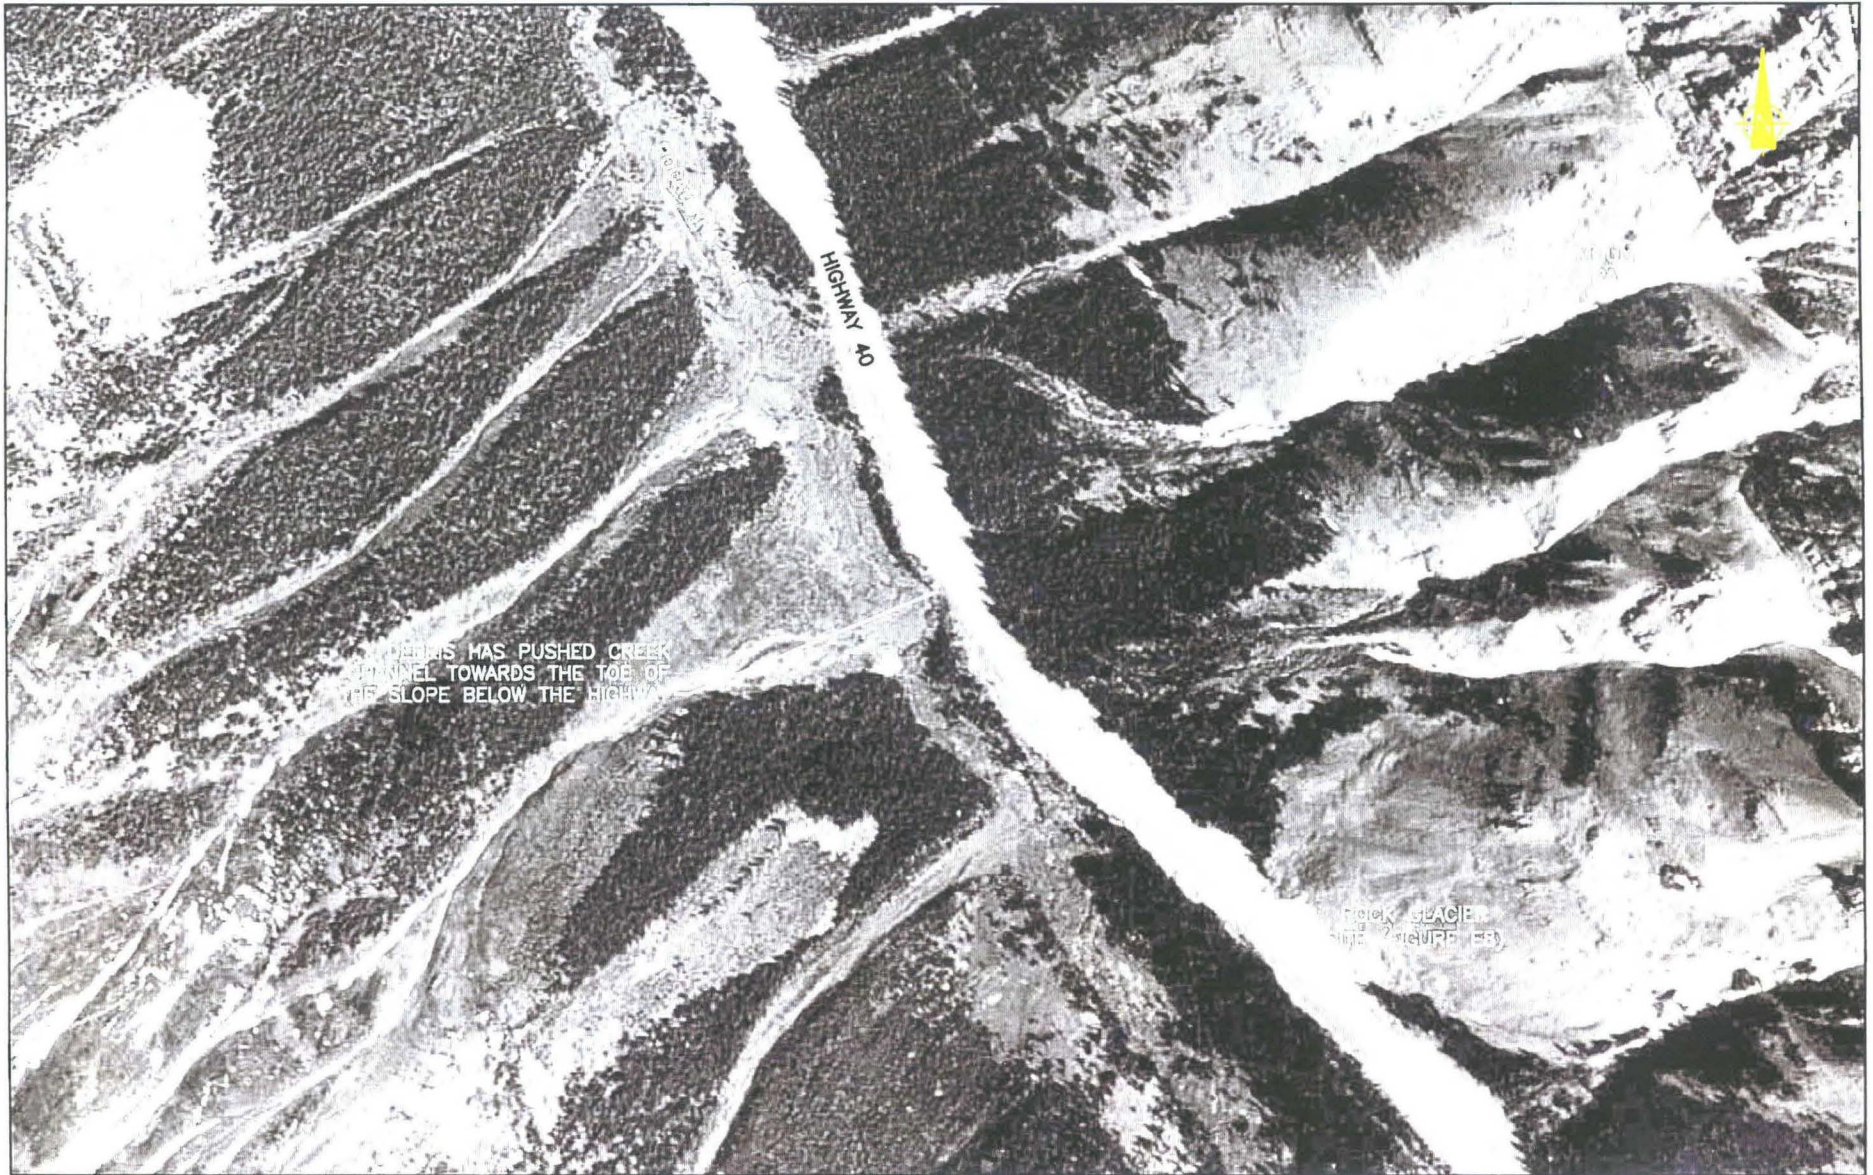
The airphoto on Figure E7 shows that debris from an avalanche track/tributary creek channel on the west side of the valley has deflected the channel of Pocaterra Creek to the east (i.e. towards the highway). It appears that the creek channel is eroding the toe of the steep slope below the highway at this location. The creek channel was confirmed to be flowing along the toe of the slope during the field inspection, however the bank erosion did not appear to be significantly destabilizing the slope below the highway. The slope did show signs of shallow soil creep (e.g. curved tree trunks) that appeared to be unrelated to toe erosion at the creek bank. There were no significant slump block scarps or signs of retrogressive instability that could threaten the highway.

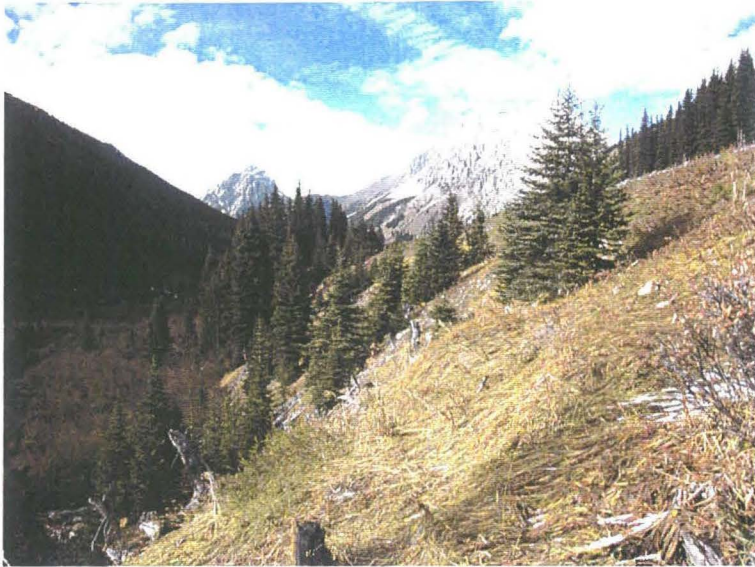
- Probability Factor of 5 based on appearance of active, shallow soil creep on the slope below the road.
- Consequence Factor of 2 based on the interpretation that if a landslide developed on the slope below the road and retrogressed back to the guardrail, a portion of the road would be affected but closure of the road would not be required.

Photo 1 (top) – Facing north across the slope below the highway. The guardrail along the west side of the highway is visible in the upper right portion of the photo. The slope angle is approximately 41° and the crest of the slope is offset approximately 6 m from the guardrail. The vertical height of the slope is approximately 25 m. The toe of the slope is along the east bank of the Pocaterrea Creek channel.

There are signs of shallow soil creep on the slope face but no indications of significant slumping or retrogressive instability that could directly affect the highway.

AMEC recommends that visual inspections of this slope be performed annually in order to:

- Monitor the offset of the crest of the slope from the guardrail,
- Check the condition of the slope face,
- Check the creek erosion conditions at the toe of the slope.

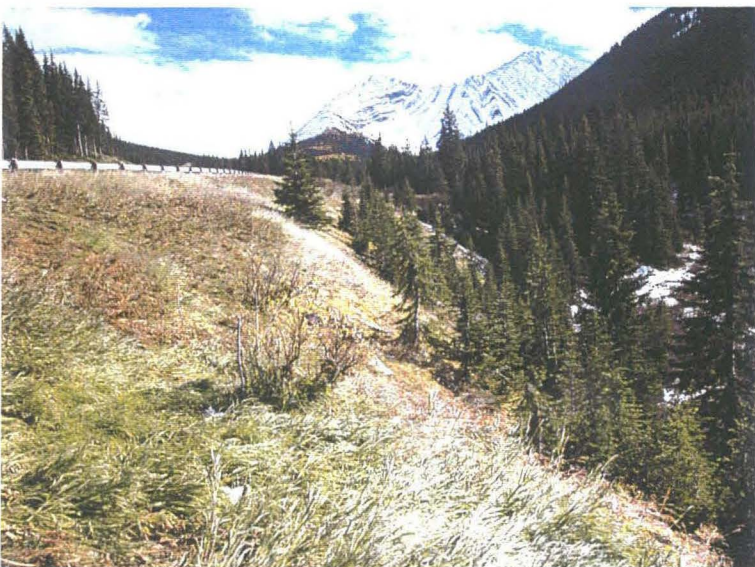
Photo 2 (bottom) – Facing south across the slope with the relative position of the highway, the slope and the Pocaterrea Creek channel visible.
