Site 25 – Elbow Pass Cut Slope

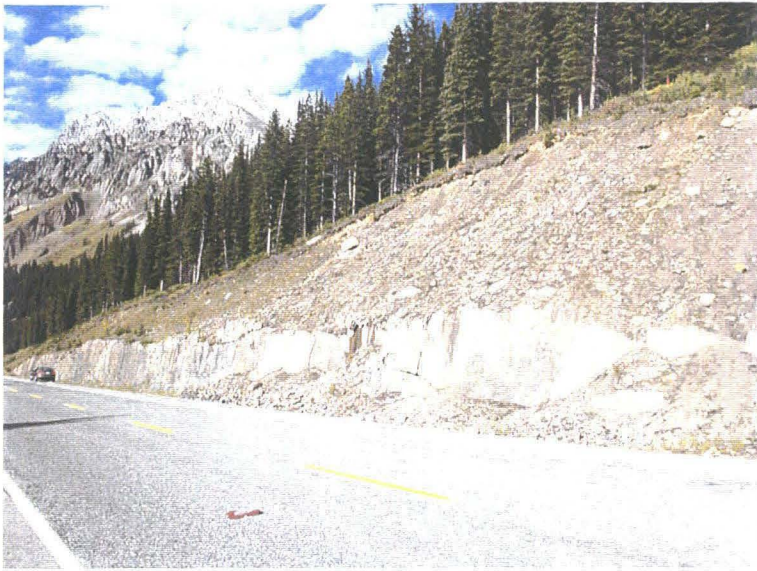
There is a soil and rock cut slope approximately 600 m south of the parking area at the Elbow Pass trailhead (Photo 1). The cut slope has a total height of approximately 6 to 8 m and consists of two distinct components:

- The upper portion of the cut slope exposes rocky soil at an angle of approximately 42° and over a vertical height of approximately 4 to 5 m.
- The lower portion of the cut slope is near-vertical and approximately 2 to 3 m high. The bedrock dips near-vertically and down towards the west, therefore the lower portion of the bedrock exposes the bedding plane.

The majority of the rockfall debris from this cut slope appears to originate from the rocky soil in the upper portion of the cut slope. The size of the rockfall debris varies from gravel to boulders. Some segments of the cut slope had significant volumes of rockfall debris accumulated in the ditch. There was no rockfall debris on the road at the time of the inspection in September 2005, however some of the debris in the ditch was within 1 m of the edge of the pavement (Photo 2).

Photo 1 (top) – Facing north across the rock cut site to the south of the Elbow Pass hiking trail parking area. The majority of the rockfall debris is generated from the exposed rocky soil in the upper portion of the cut slope.

AMEC recommends that the accumulated rockfall debris be cleared from the ditch in order to restore the full capacity of the ditch. The Consequence Factor could then be reduced to 1 and the corresponding Risk Level reduced to 14 if the ditch capacity is maintained with future clearing as necessary.

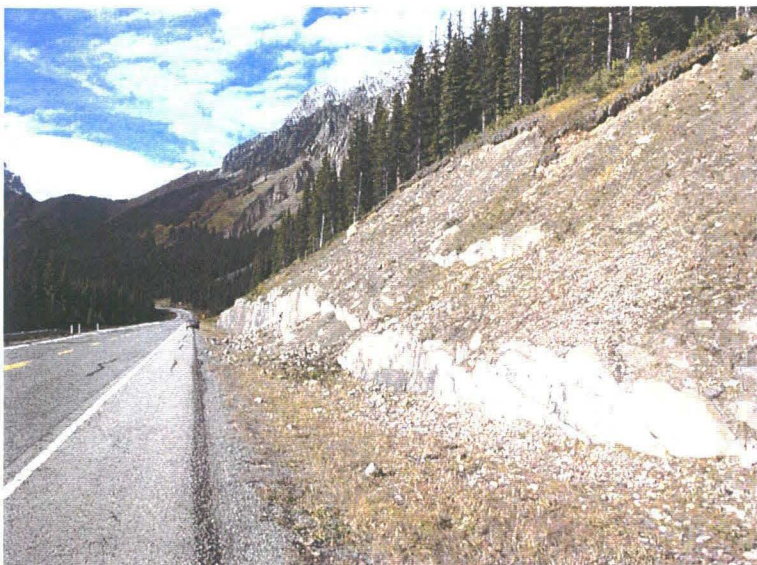
The ditch between the cut slope and the highway is typically 4 to 5 m wide and about 1.25 m deep. The ditch meets the sizing criteria for an 8 m high, 45° cut slope as shown in Figure B1 in Appendix B.

- Probability Factor of 14 based on the visual evidence of many rockfalls (possibly near-ongoing) at this site.
- Consequence Factor of 2 based on the potential for rockfall debris being deposited onto the edge of the northbound lane under the current ditch conditions.

Therefore, the recommended Risk Level for this site is 28.

Photo 2 (middle) – Facing north along the ditch. The rockfall debris from the cut slope is contained within the ditch. As the volume of debris in the ditch builds up, some of the larger rocks roll closer to the edge of the pavement. At the time of the September 2005 inspection there were some cobble-sized rocks within 1 m of the edge of the pavement.

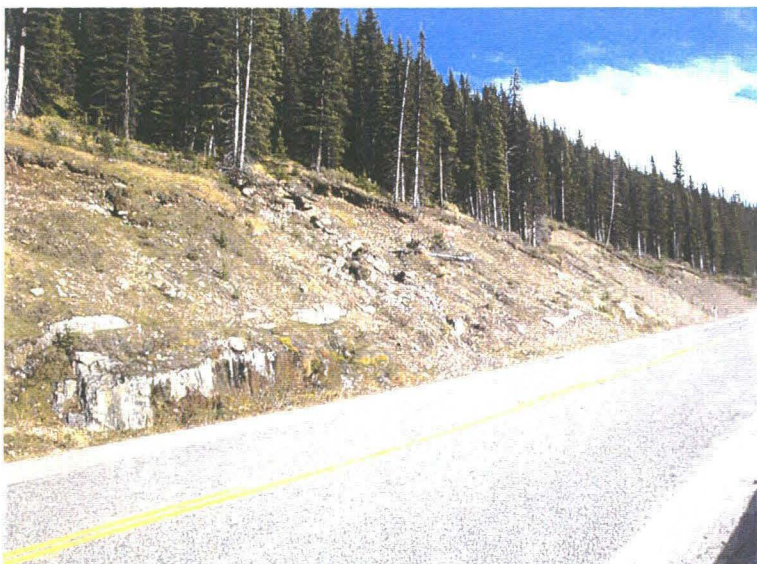
The soil cut slope approximately 630 m south of the parking area at the Elbow Pass trailhead is approximately 8 m high at a slope angle of around 40°. A slump has occurred in the soil slope and nearly blocked the ditch with debris along with almost burying a culvert inlet (Photos 3 and 4). It appears that this slump has been triggered by groundwater seepage in the cut slope and has been occurring on an ongoing basis in recent years.

- Probability Factor of 9 based on the apparent ongoing slumping in the cut slope.
- Consequence Factor of 1 based on the deposition of debris into the ditch but without any immediate impact to driver safety.

Therefore, the recommended Risk Level for this site is 9.

Photo 3 (middle) – Approximately 30 m south of the area shown in Photos 1 and 2 the cut slope is entirely in soil. At this location, a slump has occurred in the soil slope. The debris from the slump has blocked the ditch and nearly buried a culvert inlet. It appears that this slump has been triggered by groundwater seepage in the cut slope and has been occurring on an ongoing basis in recent years.

It is recommended that the slump debris be cleared from the ditch in order to restore the ditch gradient and keep the culvert inlet open. The debris should be excavated down to the elevation of the culvert inlet. Slump debris should be cleared from the ditch as necessary in the future to keep the ditch and culvert inlet clear.

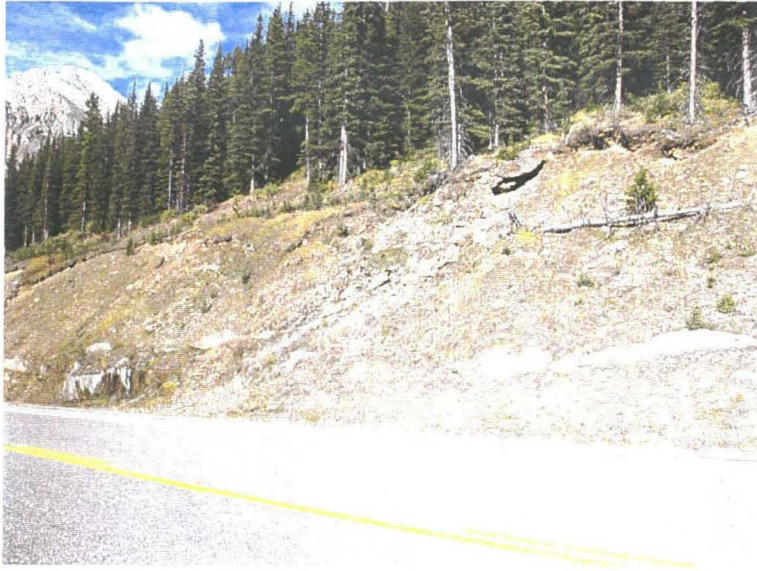
Photo 4 (top) – Another view of the cut slope slumping shown in Photo 3.
