## Site 24 – Elpoca Mountain Debris Flows

PROJECT: HWY 40/HWY 541 GEOHAZARDS REVIEW

TITLE: ELPOCA MOUNTAIN DEBRIS FLOWS

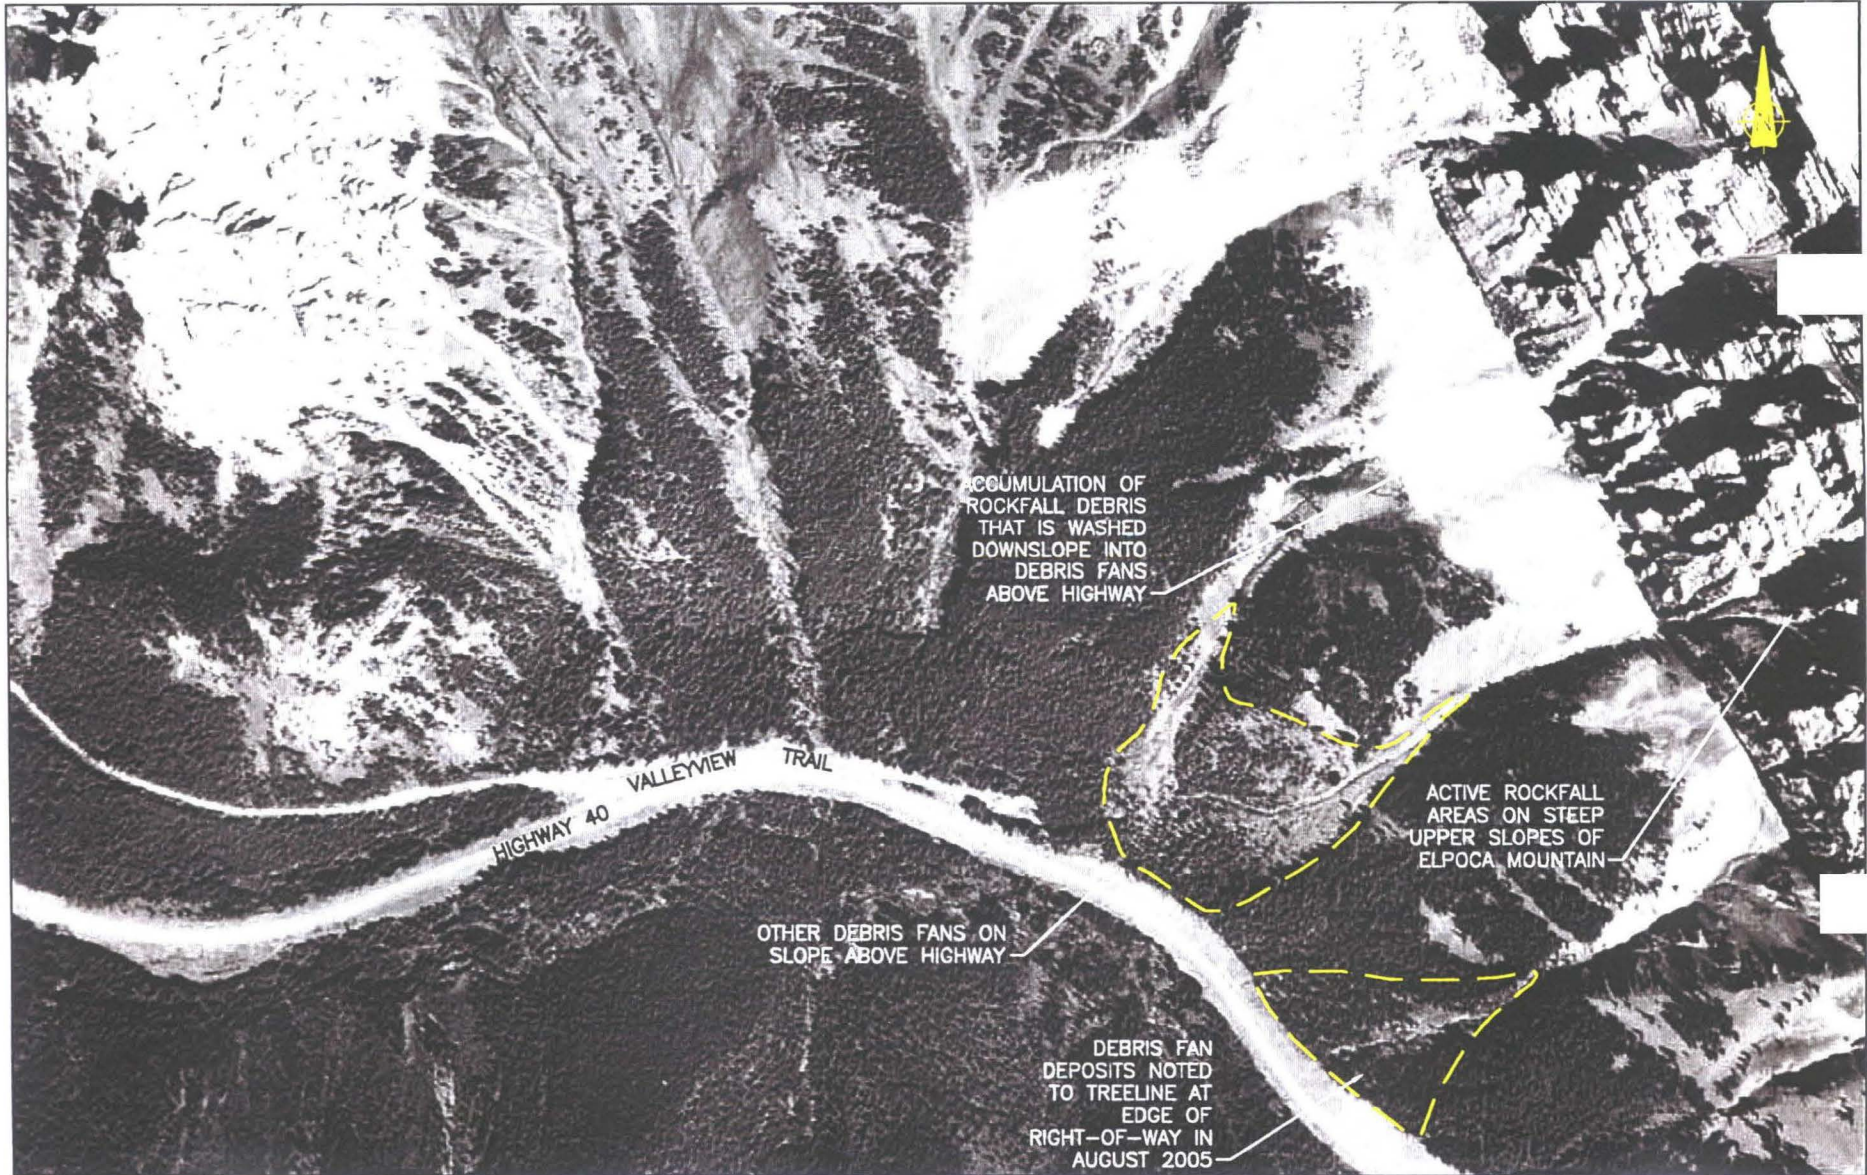
DATE: DECEMBER 2005	JOB No.: CG25211	CAD FILE: 25211N01.dwg	FIGURE No.: FIGURE E6	REV. A
------------------------	---------------------	---------------------------	--------------------------	-----------

This site is located approximately 400 m southbound from the south junction between Highway 40 and the Valleyview Trail. Figure E6 shows a 1999 airphoto of the site. There are debris flow deposits on the treed slope above the highway right-of-way. The deposits are roughly centered around a creek channel that flows down from the south ridge of Elpoca Mountain. The debris does not extend into the cleared highway right-of-way. The segment of the creek channel within the cleared highway right-of-way is well-defined and typically incised 1 m or less. There was only a trickle flow within this segment of the channel at the time of the inspection in August 2005.

The creek channel was traversed for a distance of approximately 300 m upslope of the highway. The debris flow deposits were noted in the treed area above the right-of-way and are not visible from the highway. The approximate extent of the debris flow deposits is shown on Figure E6. The segment of the creek channel between the treeline above the highway and roughly 200 m further upslope was poorly defined within the blanket of debris on the slope. It appeared that the creek channel in this area had been infilled with debris earlier in 2005 and the creek flow went overland across the debris on the slope. The debris blanketing the slope tapers out around the treeline along the east edge of the right-of-way, as shown on Figure E6.

The airphoto on Figure E6 also shows two other debris fans on the slope above the highway and a short distance northwest from the debris fan that was traversed. These debris fans appear to be similar in form to the one shown on Photos 2 to 4 and they do not extend into the cleared highway right-of-way.

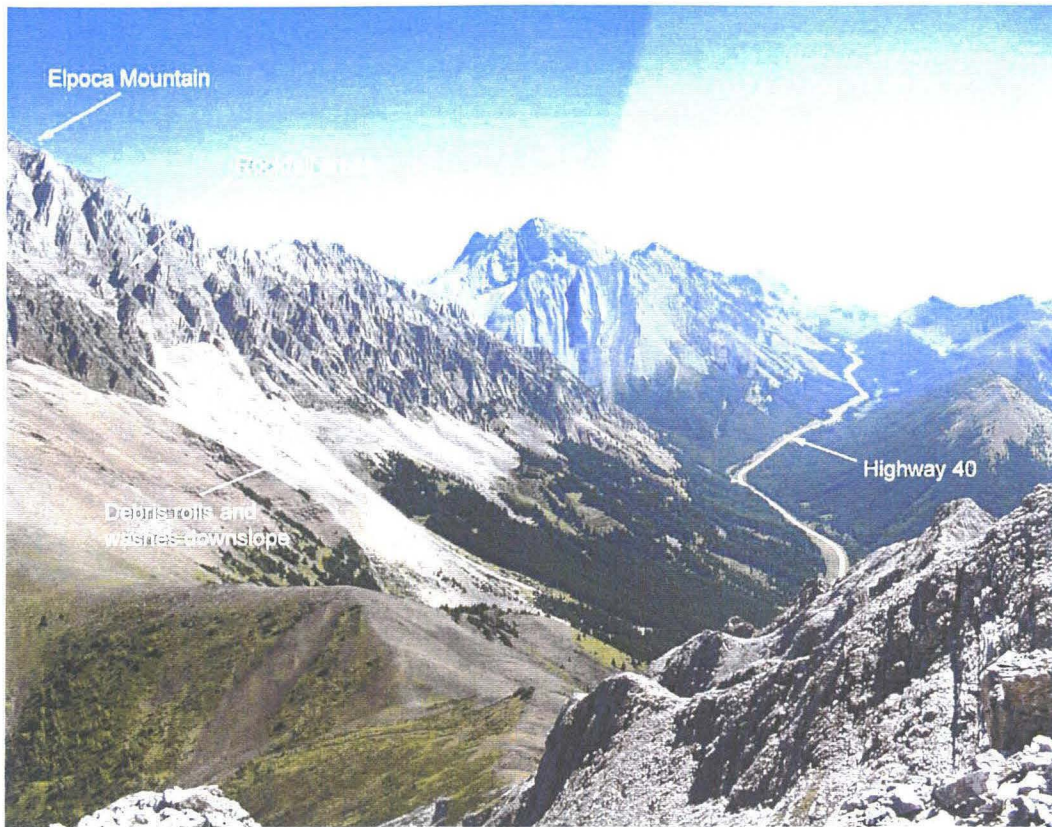
As shown in Photo 1 and on the airphoto in Figure E6, the debris fan on the treed slope above the highway right-of-way is below the steep upper slopes of Mount Elpoca where large volumes of rockfall debris accumulate above the treeline. This rockfall debris gradually moves further downslope over time due to gravity and surface runoff (rain and snowmelt) and contributes to the development of the debris fans above the highway.

**Photo 1** (top) – Facing southeast towards the lower west slopes of Elpoca Mountain from the summit of Gap Mountain. This view shows how the rockfall areas on the upper slopes of Elpoca Mountain generate debris that is subsequently transported downslope via surface runoff and tributary creeks and contribute to debris fans in the treed areas further downslope.

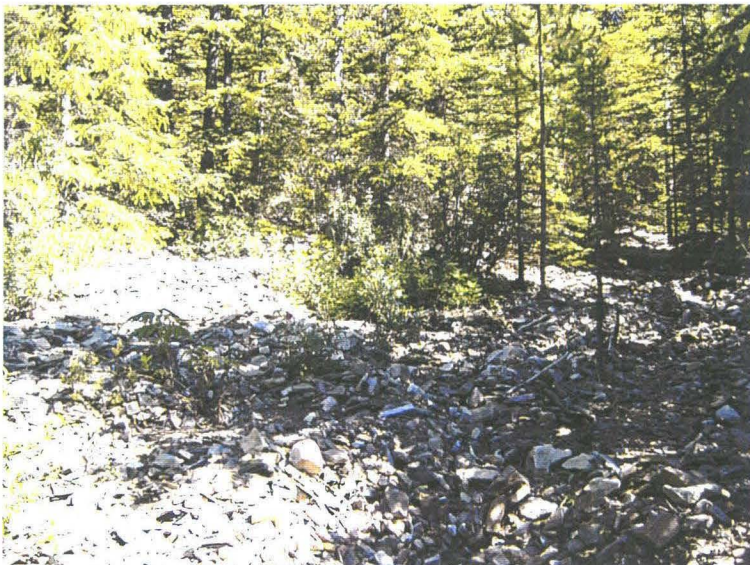
**Photo 2** (bottom) – Typical view of braided creek channel and debris flow deposits blanketing the slope approximately 50 m upslope of the cleared highway right-of-way. There is no distinct creek channel in this area (compare with Photo 3 from further upstream) and it appeared that the channel had been filled with debris earlier in 2005 and the creek flow went overland and percolated down into the debris.

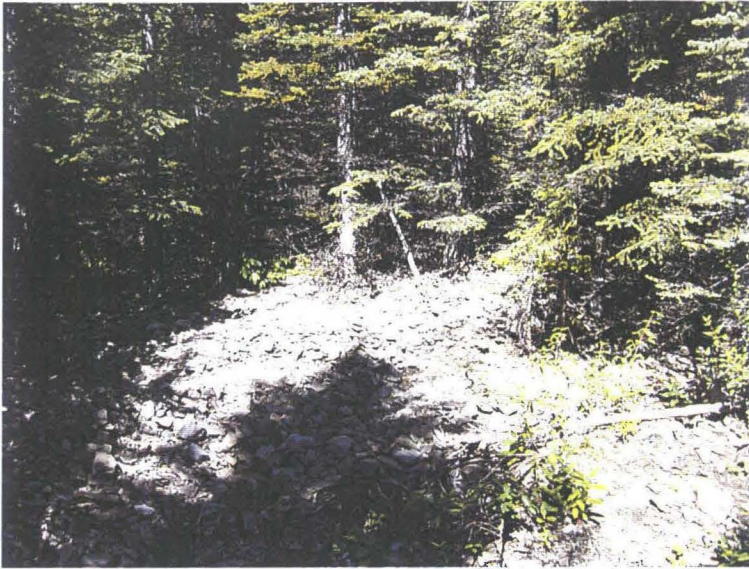
**Photo 3** (top) – Another view of the debris flow deposits upslope of the highway right-of-way.

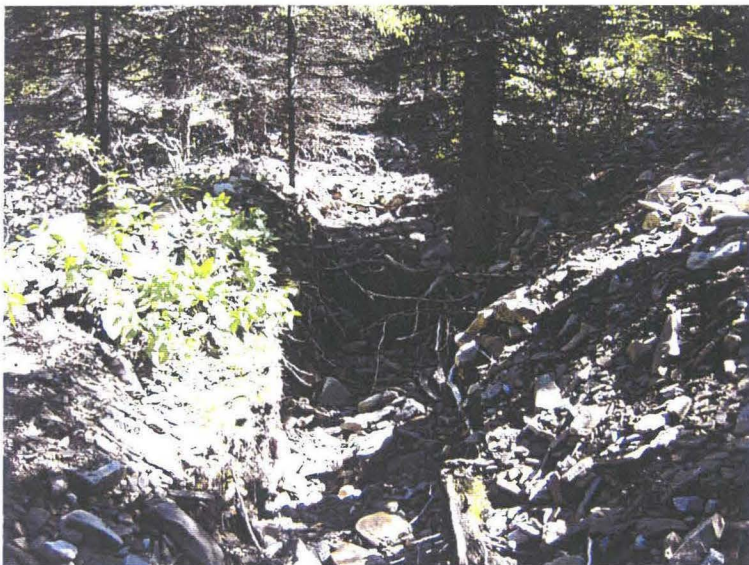
Further upslope (greater than approximately 200 m above the highway) the creek channel was incised approximately 1 to 2 m into the slope. This segment of the channel was dry at the time of the inspection. The channel in this area is surrounded by a broad area (greater than 30 m wide) of cobble to small boulder sized debris blanketing the slope. The slope inclination and creek channel gradient in this area was around 8 to 10°. It appeared that the debris had been deposited during several events in previous years, including a significant amount of “fresh” looking debris judged to be from earlier in 2005.

**Photo 4** (bottom) – Incised creek channel, approximately 1 to 2 m deep, located approximately 200 m upslope of the highway right-of-way and within an area of channel overflow debris deposition. This incised channel was not present further downstream (towards the highway) – compare with Photo 2 from further downstream and closer to the highway.
