Site 23 – Valleyview Trail

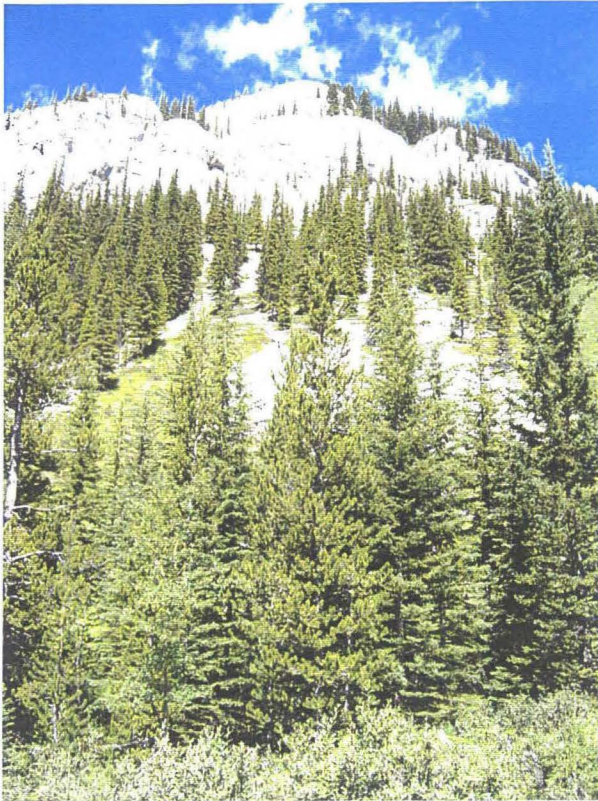
This site consists of a steep colluvium slope above the Valleyview Trail, a side-road parallel to and approximately 100 m upslope of Highway 40 in this area. The source of the colluvium is rockfall from steep slopes on the south ridge of Gap Mountain above the road. As shown on Photo 1, portions of the slope above the road that are blanketed with colluvium remain unvegetated, which suggests that debris may be actively accumulating in these areas and/or the blanket of colluvium is progressively creeping downslope towards the road.

There were no signs of debris along the Valleyview Trail road at the time of the site inspections in July and August 2005. Furthermore, it is judged unlikely that even a major rockfall from the slopes above the road would deposit debris onto the Valleyview Trail for the following reasons:

- The road elevation is approximately 3 to 5 m above the natural slope face at the toe of the road embankment sideslope.
- The portion of the slope between the road and the downslope limit of the open colluvium slope is thickly vegetated with mature trees. It is judged that any large rocks rolling down towards the road would be caught amongst the trees.

- Probability Factor of 12 based on the assumption that multiple rockfalls occur every year on the steep slopes above the Valleyview Trail.
- Consequence Factor of 1 based on no visual evidence of past rockfalls reaching the Valleyview Trail.

Therefore, the recommended Risk Level for this site along the Valleyview Trail is 12. Given that the Valleyview Trail road embankment essentially acts as a protective berm for Highway 40, the Risk Level for the adjacent segment of Highway 40 is judged to be negligible.

Photo 1 (top) – Facing upslope from the Valleyview Trail right-of-way. The open slopes above the road are blanketed with rockfall debris originating from the steep rock slopes on the south ridge of Gap Mountain, visible at the top of the photo. Portions of these slopes remain unvegetated, which suggests that debris may be deposited on an ongoing basis and/or the blanket of debris is creeping downslope over time. There were no signs of debris reaching the Valleyview Trail. The Highway 40 right-of-way below this segment of the Valleyview Trail is approximately 100 m further downslope.

No further work is recommended for this site.
