## Site 27 – Rock Glacier Site

PROJECT: HWY 40/HWY 541 GEOHAZARDS REVIEW			
CLIENT:		TITLE: ROCK GLACIER SITE			
DATE:	DECEMBER 2005	JOB No.:	CG25211	CAD FILE:	25211N03.dwg
FIGURE No.:	FIGURE E8	REV.:	A

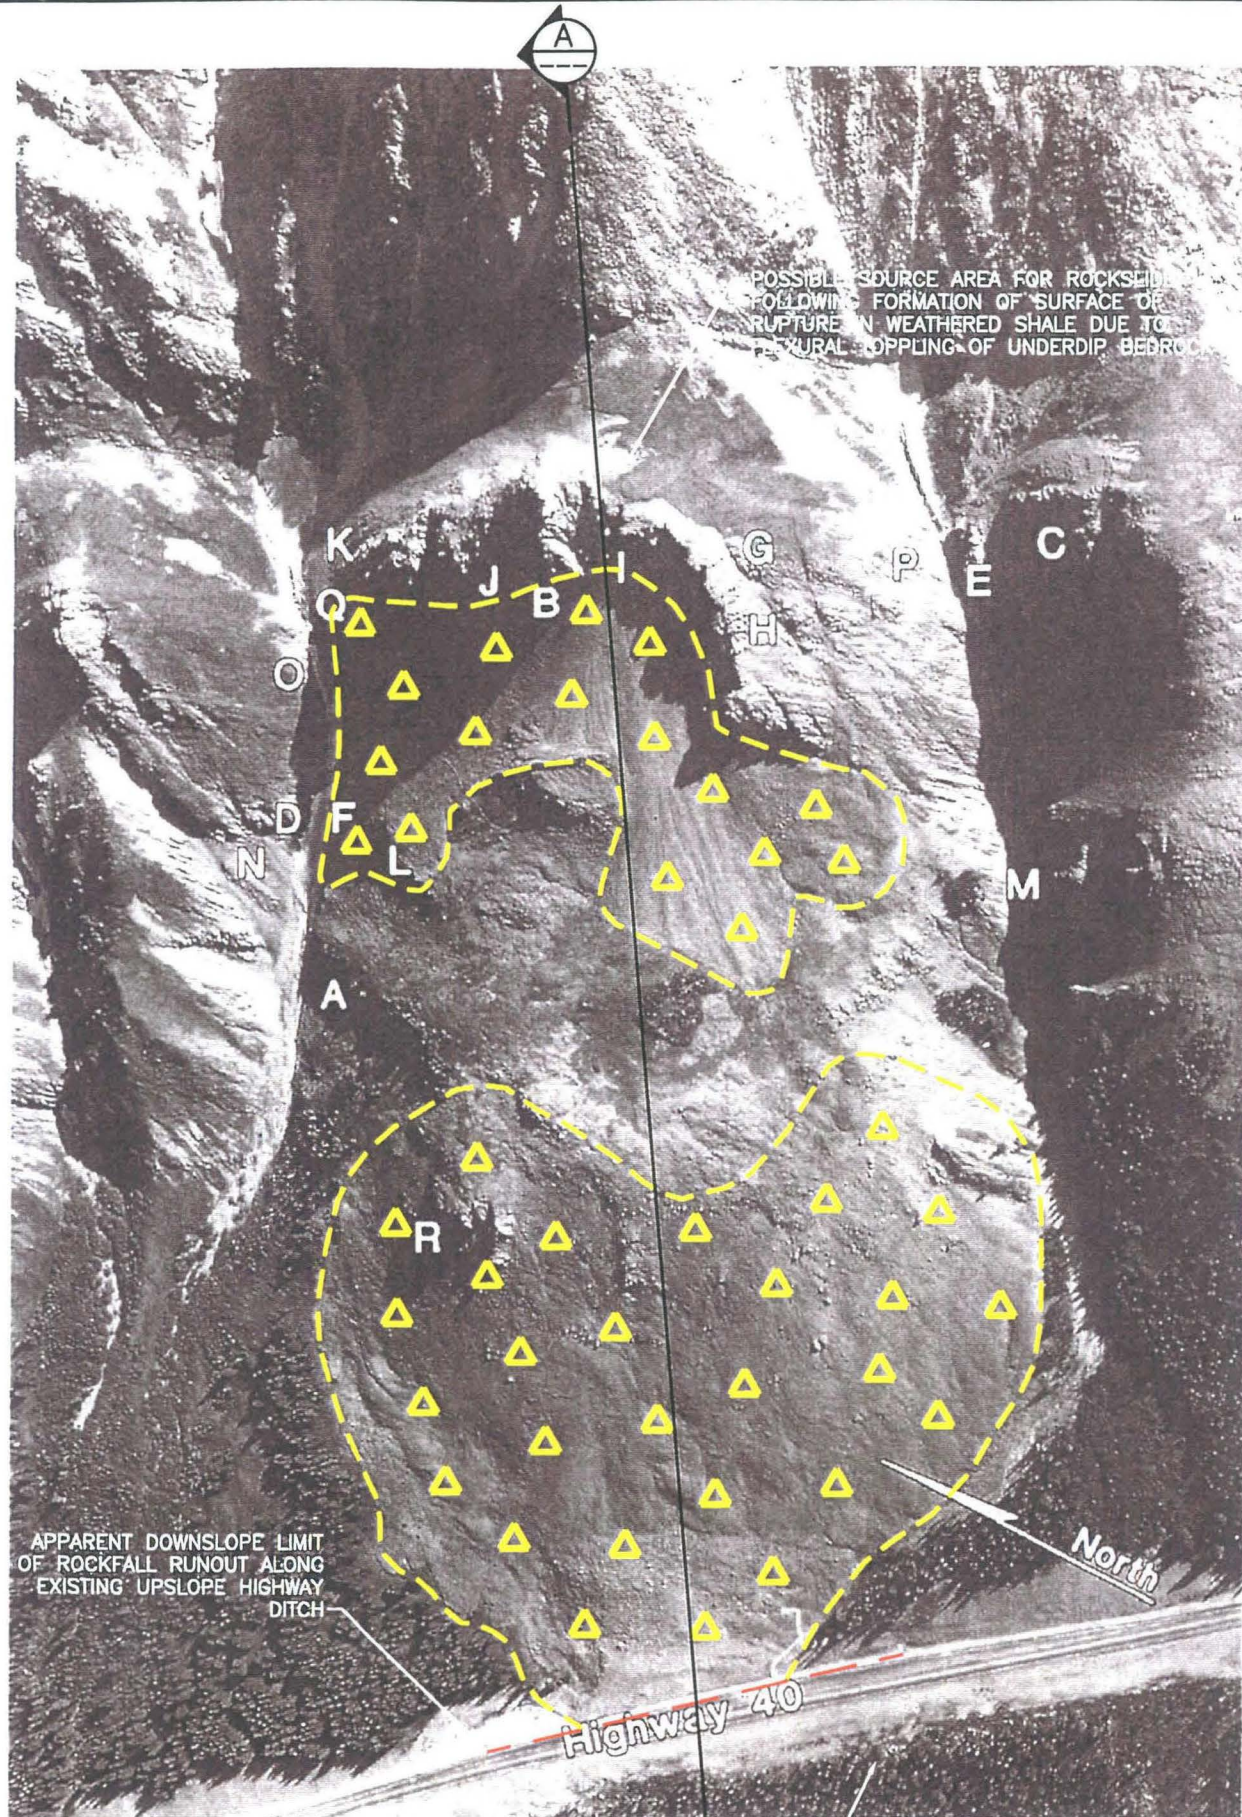
McAfee and Cruden (1996) presented the results of research on landslides at the Rock Glacier site during which hazards from rockfalls, toppling failures and rockslides were identified. A copy of an airphoto of the site from McAfee and Cruden (1996) is attached as Figure E8. This airphoto shows the proximity of the colluvium and bedrock slopes to Highway 40 and has been further annotated as noted in the following discussion.

Cruden and McAfee (1996) reported high frequency/low magnitude rockfalls from steep rock slopes at this site. This is consistent with the typical conditions at many slopes in the Highwood Pass area (Gardner, 1980). The rockfalls typically consisted of rocks with diameters ranging from a few centimeters to tens of centimeters. The approximate extent of the colluvium slope where the rockfall debris is deposited is marked on Figure E8. These rockfalls present little hazard to the highway because the existing ditch is of sufficient size to prevent rocks from rolling onto the road. However, McAfee and Cruden (1996) noted that if the upslope road ditch was to be taken as the downslope limit of rockfall runout, the rockfall shadow angle at this site is 31° whereas Evans and Hungr (1993) suggested a more conservative value of 27.5° as a preliminary value for estimating the extent of rockfall runout from colluvium slopes in the Canadian Cordillera. McAfee and Cruden (1996) also reported that there were boulders on the slope below the highway that may have been deposited by rockfall runout that pre-dated the existing highway and/or were carried downslope by avalanches.

Notwithstanding the boulders downslope of the highway and the apparent rockfall shadow angle of 31°, the rockfall hazard at the highway is judged to be low based on the lack of evidence or documented reports of rocks rolling onto the road at this site since the current highway was constructed. Also, if large rocks are carried down to the highway by avalanches this would occur when this segment of the highway is closed between December 1<sup>st</sup> and June 15<sup>th</sup> of each year and therefore present no risk to motorists.

BOULDERS NOTED DOWNSLOPE OF HIGHWAY - APPARENT ROCKFALL RUNOUT PREDATING THE HIGHWAY (REPORTED IN MCAFFEE AND CRUDEN (1996))

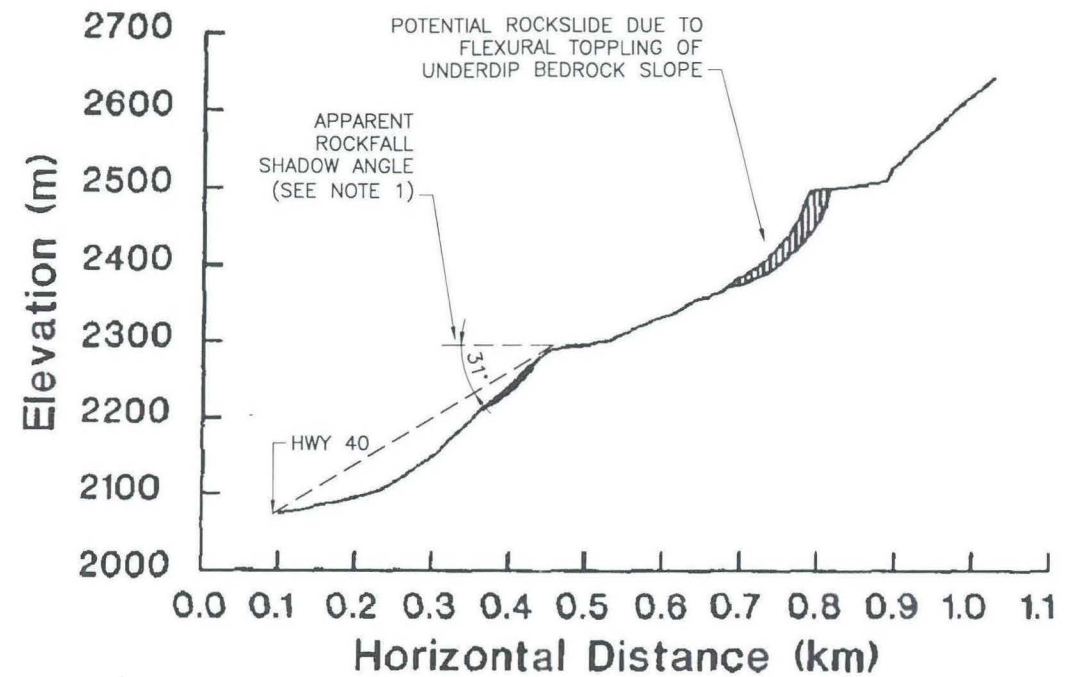
**A** SECTION

Figure E8 includes a cross-section adapted from McAfee and Cruden (1996) that shows the results of a slope stability analysis for the Rock Glacier site where a potential rockslide with a volume of approximately 50,000 m<sup>3</sup> of material was identified. The possible source area for such a slide is marked on the airphoto on Figure E8. Such a rockslide could occur as a series of smaller movements with relatively little risk to the highway, however the hazard of a single, major rockslide event cannot be ruled out on the basis of:

- Probability Factor of 3 based on the low probability of rockslide occurrence.
- Consequence Factor of 2 based on a scenario where a large rockslide originates around 2300 to 2500 m elevation above the highway (see the cross-section on Figure E8) and has a similar runout distance to the possible previous rockslide deposits identified slightly upslope of the highway. Debris from such a rockslide could encroach onto the highway and require heavy equipment to clean up, however the road would likely not be completely blocked.

1. APPARENT ROCKFALL SHADOW ANGLE TO UPSLOPE EDGE OF HIGHWAY IS 31°. MCAFFEE AND CRUDEN (1996) NOTED BOULDERS DOWNSLOPE OF HIGHWAY 40 THAT MAY INDICATE A ROCKFALL SHADOW CLOSER TO 27.5° AS SUGGESTED IN EVANS AND HUNGER (1993).

Therefore, the recommended Risk Level for this site is 6.

Additional work to clarify the Probability and Consequence Factors is likely not justified given the relatively low recommended Risk Level for this site in comparison to other sites along the highway corridor that have higher recommended Risk Levels that can be managed and reduced with relatively straightforward measures. However, there are satellite-based methods for the monitoring of ground movement that may be applicable to the potential rockslide hazard at this site and could possibly help to further characterize the slope stability conditions at this site and clarify the Risk Level relative to a large rockslide. AMEC understands that the Alberta Geological Survey (AGS) is considering the application of such methods to slope instability sites in Alberta. The Rock Glacier site may be a good candidate site for this work. AMEC recommends that the AGS be contacted to review the Rock Glacier site for this purpose.
