Site 21 – Mount Wintour Rock Cut

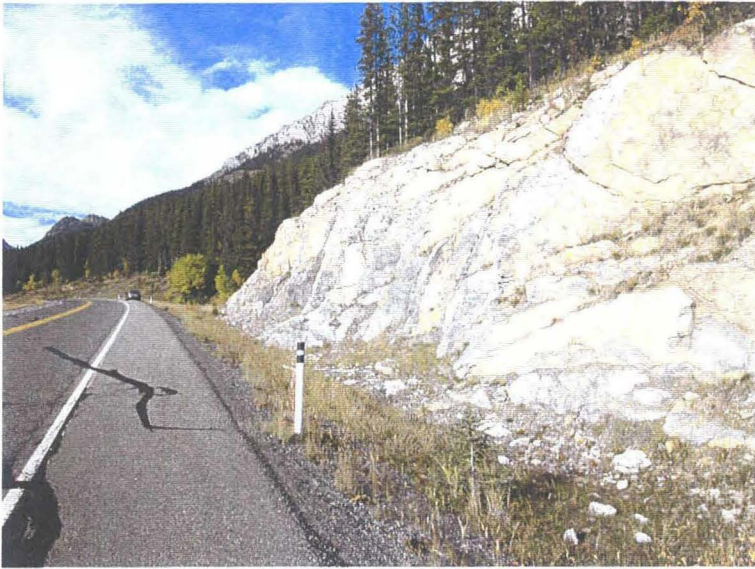
The ditch along the toe of the cut is typically 4 m wide and 1.5 m deep. Rockfall debris from the cut slope has accumulated as a relatively small apron of debris between the toe of the near-vertical cut slope and the central portion of the ditch. It is not known how much time was required for this volume of debris to accumulate. There were no rocks on the pavement at the time of the inspection, nor were there any signs of damage to the pavement from past rockfalls.

The ditch sizing criteria shown on Figure B1 in Appendix B indicate that for the maximum height of this cut slope, the ditch should be at least 4.3 m wide and at least 1.2 m deep. The existing ditch does not meet the width criteria however it slightly exceeds the depth criteria. Based on the distribution of the rockfall debris within the existing ditch and lack of evidence of past rockfalls reaching the road, it is judged that the existing ditch is sufficient.

- Probability Factor of 12 based on the volume of debris in the ditch and the visual appearance of the rock exposed in the cut slope which together suggest that several rockfalls occur at this site each year.
- Consequence Factor of 1 based on no visual evidence of past rockfalls reaching the paved surface of the road.

Photo 1 (top) – Facing north across the Mount Wintour Rock Cut site. The near-vertical cut slope exposes vertically dipping bedrock with the strike of the bedding almost parallel to the highway. Therefore, rockfall debris from this slope tends to land close to the toe of the cut slope with relatively little hazard to the highway.

It is recommended that the rockfall debris in the ditch at this site be cleaned out annually, or more frequently if required. This should be treated as an ongoing maintenance issue.

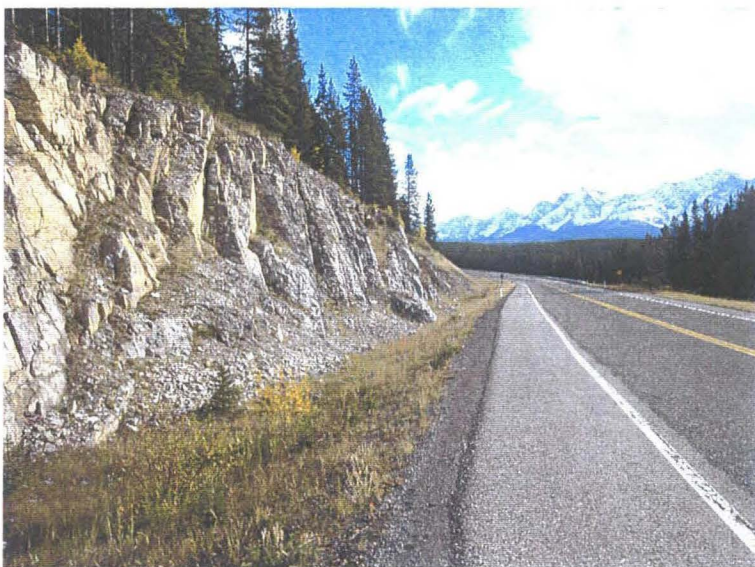
Photo 2 (bottom) – Facing south across the Mount Wintour Rock Cut site. Note how the vertical bedding faces in the exposed rock are nearly parallel to the highway.
