Site 14 – Fortress Junction – Road Cracking

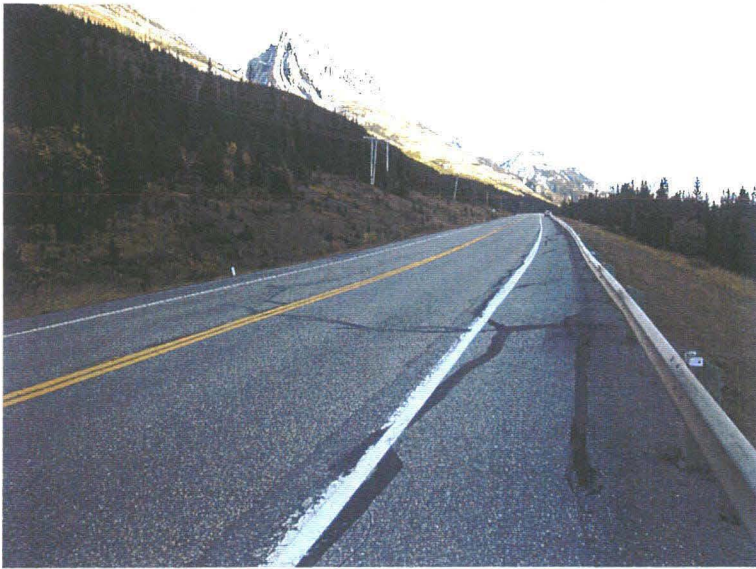
This site is located approximately 1 km south of the Fortress Junction service station. There is a series of cracks forming a circular pattern that suggests slumping of an approximately 16 m long segment of the southbound lane down towards the west (Photos 1 and 2). The vertical dropdown of the potentially slumped area varied up to a maximum of 25 mm at the time of the site inspection in September 2005. The cracks have been sealed by the maintenance contractor. It is not known when the cracks first appeared, when they were sealed or how they may have developed over time.

The apparent slumping area extends into the northbound lane (Photo 1) and is roughly centered around a culvert installed at the base of the highway fill embankment. The culvert below the embankment did not appear to have been deformed by movement of the overlying fill. The west sideslope of the highway embankment is approximately 10 m high at an angle of about 20°. There were no visible signs of slumping in the west sideslope that would be consistent with the apparent slumping defined by the cracks in the road surface.

- Probability Factor of 5 based on the moderate level of uncertainty about whether or not the apparent slumping is active.
- Consequence Factor of 4 based on the possibility that significant slumping of the area delineated by the cracks could require temporary closure and repair of the southbound lane of the highway.

Therefore, the recommended Risk Level for this site is 20.

Photo 1 (top) – Facing south along the settlement and cracking area in the southbound lane of Highway 40, approximately 1 km south of the Fortress Junction service station. The cracks are in a circular pattern suggesting slumping of the southbound lane to the west (i.e. down to the right, as seen in this photo). The cracks have been sealed by the maintenance contractor. It is not known when the cracks formed or if the slumping is active. The vertical dropdown of the southbound lane to the west of the cracks varied up to a maximum of 25 mm at the time of the inspection.

It is recommended that the potential slumping of the southbound lane be visually inspected in the spring and fall of 2006 in order to determine if the apparent slumping is active. These inspections should be coordinated with other recommended work along the highway corridor in order to economize on field time. If the observations indicate that ongoing cracking and settlement of the road surface is not occurring, then the Probability Factor could be likely be reduced.

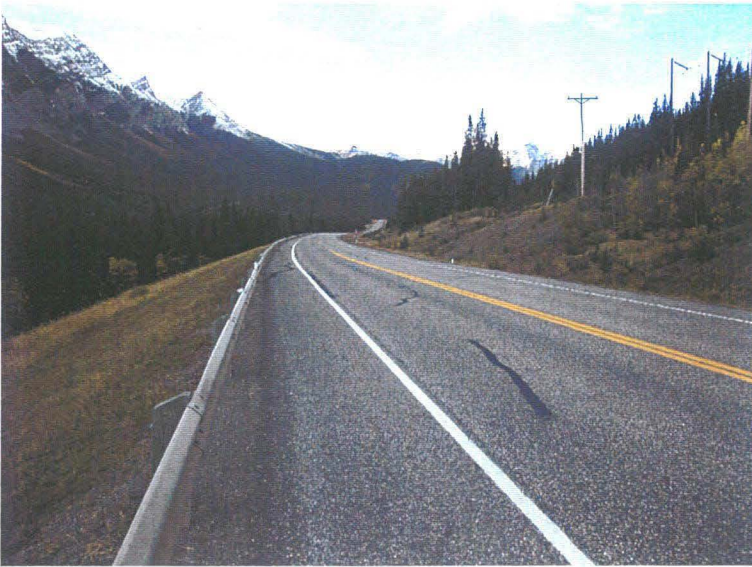
Photo 2 (bottom) – Facing north across the same area shown in Photo 1. The potential slumping affects the southbound lane and encroaches slightly into the northbound lane.
