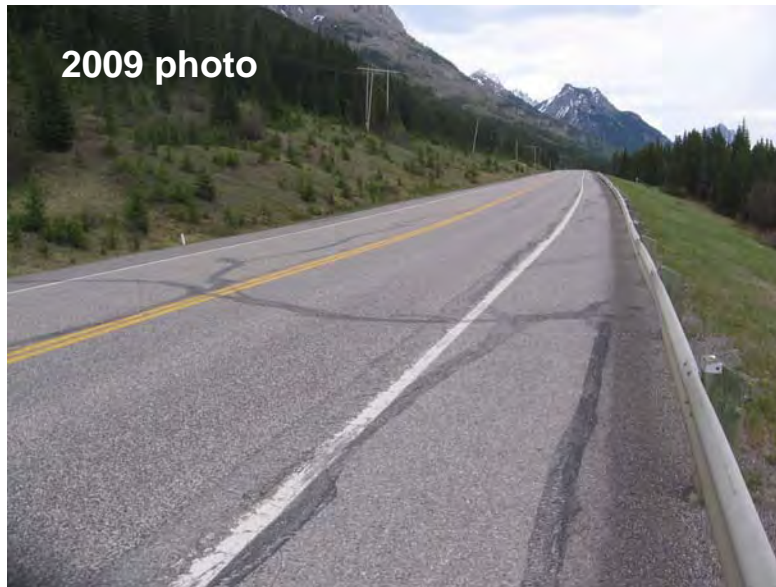
**Photo 3 (top) – June 2009**  
**Fortress Junction Road Cracking Site**  
Facing southbound across the settlement and cracking area in the southbound lane. The pattern of the cracking and downdrop is suggestive of slumping of a segment of the downslope lane, however when compared to Photo 4 from the 2005 inspection it does not appear that the damage to the road surface has worsened in recent years.

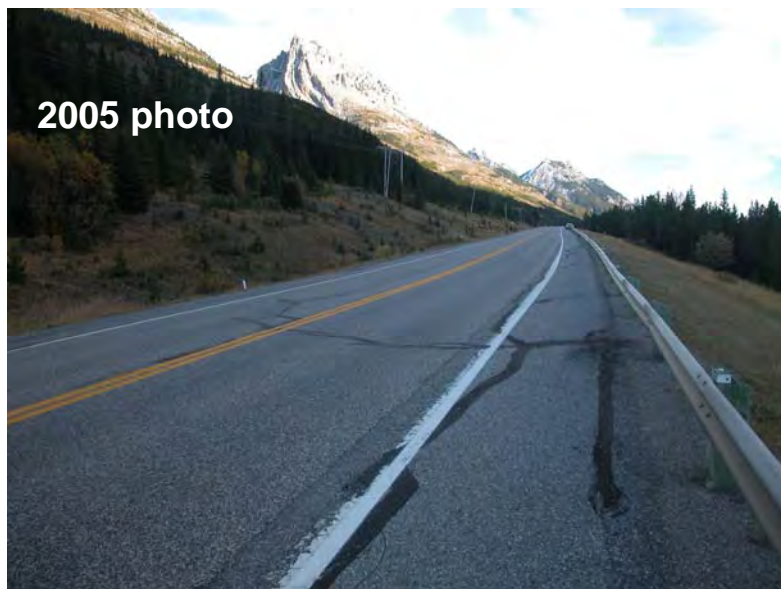
**Photo 4 (bottom) – 2005**  
**Fortress Junction Road Cracking Site**  
The same area as shown in Photo 3, as it appeared during the 2005 inspection.

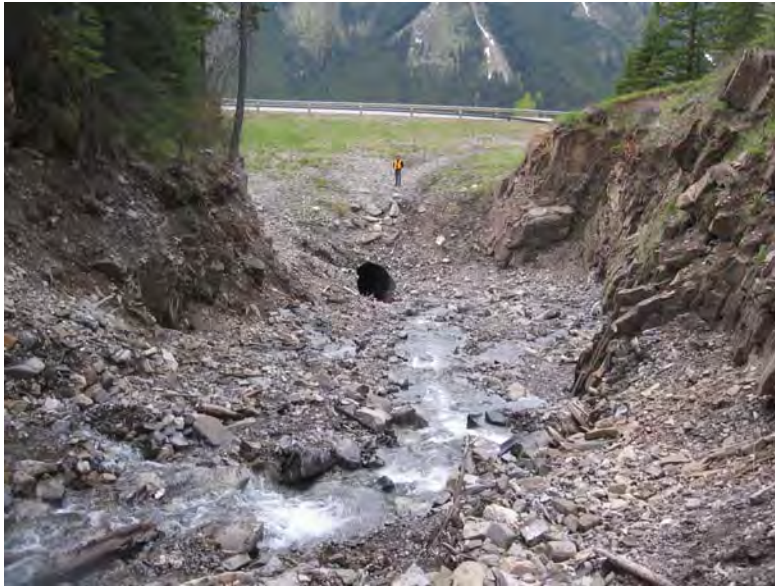
**Photo 5 (top) – June 2009  
Hood Creek**

Facing downstream towards the culvert inlet with Highway 40 visible in the background. A large volume of debris was excavated from this “basin” upstream of the culvert in 2005. It appears that relatively little additional debris has accumulated in this area since that time.

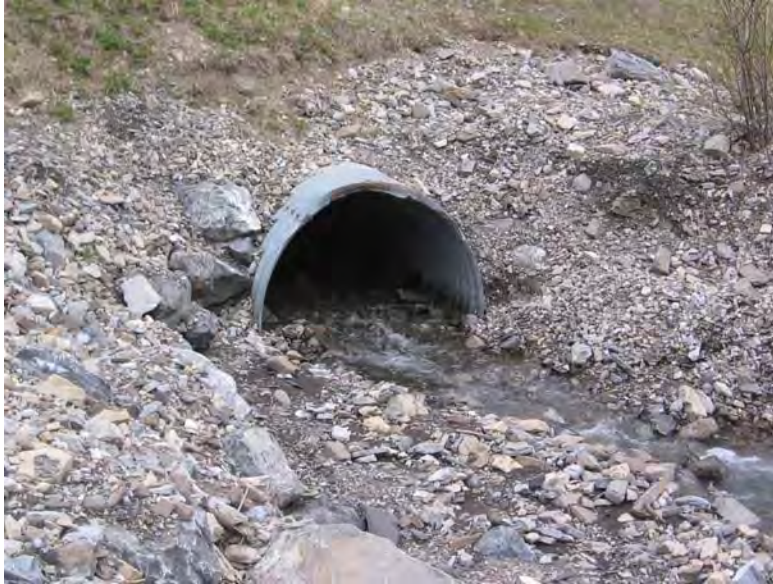
**Photo 7 (top) – June 2009**

**Hood Creek**

Culvert outlet, which was approximately 1/3 blocked with debris at the time of the June 2009 inspection. The outlet was approximately 50% blocked with debris at the time of the 2005 inspection, with the culvert pipe completely filled with debris a few metres upstream from the outlet.
