## Site 19 – Hood Creek

The Hood Creek crossing is located approximately 3.3 km north of the junction between Highway 40 and Highway 742. A debris flow hazard was identified at this crossing during the initial site inspection in July 2005. Key observations from the site inspections in July and August 2005 are as follows:

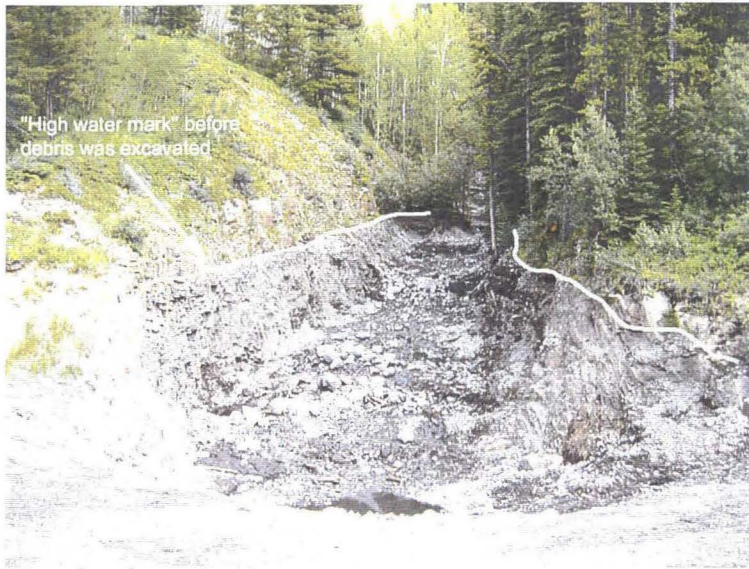
- It is understood that shortly before the July 2005 inspection, the highway maintenance contractor had excavated a large volume of debris that was blocking the culvert inlet. It is not known if the debris was deposited during a single event or had built up over multiple years. As shown in Photos 1 and 2, the channel walls around the basin just upstream of the culvert inlet showed a “high water” mark indicating that the maximum thickness of debris that was removed was in the order of 5 to 6 m and tapered back to around 1 to 2 m at a distance of approximately 80 m upstream of the highway.

**Photo 1** (top) – Facing upstream along the Hood Creek channel from Highway 40. It is understood that prior to the site inspection in July 2005, the highway maintenance contractor removed a significant volume of debris that had accumulated in the channel and blocked the culvert. Note the “bathtub ring” effect showing the high water mark from before the debris was cleared. It appeared that debris had been excavated from along the channel for a distance of approximately 80 m upstream of the highway and that around the culvert inlet the thickness of debris that was excavated was in the order of 5 to 6 m. It is not known if the debris was deposited during a single event or had built up over multiple years.

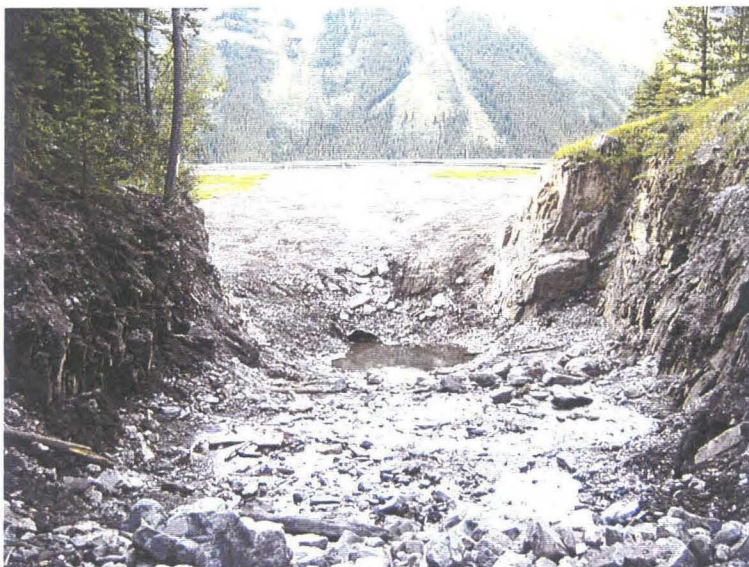
- As shown in Photos 2 and 3, the inlet and outlet of the culvert were roughly 50% (or more) filled with rock debris at the time of the site inspection. The culvert was fully blocked with debris a few metres in from either end. There was a low volume of flow along the creek at the time of the inspection and it was percolating through the debris in the culvert.

**Photo 2** (bottom) – Facing downstream towards the culvert inlet. The culvert inlet was approximately 50% blocked with debris at the time of the July 2005 site inspection and it appeared that the culvert was fully blocked with debris further in. The low volume of creek flow at the time of the inspection was percolating through the debris in the culvert.

It is recommended that the debris blocking the existing culvert be cleared if possible and/or a supplementary culvert installed at this crossing. The creek flow appeared to be percolating through the debris in the culvert without significant delay during the site inspections in July and August 2005, however the ability of the culvert to carry spring flow levels without water ponding upstream of the highway is questionable. The most efficient solution is likely to install a second culvert at this site to act as an “emergency drain” if the water and debris level in the basin upstream of the highway rises above the existing culvert inlet. It would be preferable to install the second culvert using a trenchless method in order to minimize disruption to the highway. Clearing the existing culvert could be considered if some sort of mechanical assistance is possible, or even “hand mining” in the culvert if the associated safety issues, namely working in the confined space of the culvert subject to creek flow, could be addressed. It may be possible to pump the creek flow across the highway to bypass the culvert during the work.

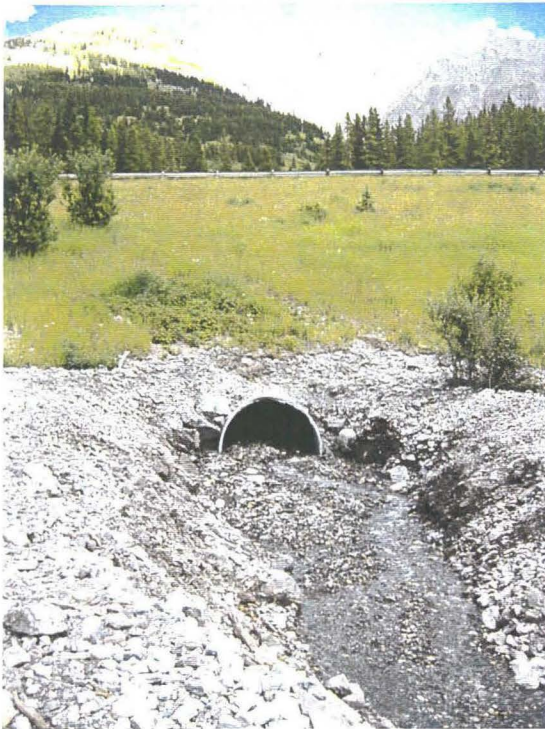
**Photo 3** (upper left) – Facing upstream towards the culvert outlet at the downstream toe of the highway embankment. The culvert outlet was approximately 50% blocked with debris at the time of the July 2005 site inspection and appeared to be fully blocked further in. It appeared that the debris along the channel immediately downstream of the outlet had been spread out and graded by heavy equipment, likely at the same time that the accumulated debris was loaded out from upstream of the culvert inlet.

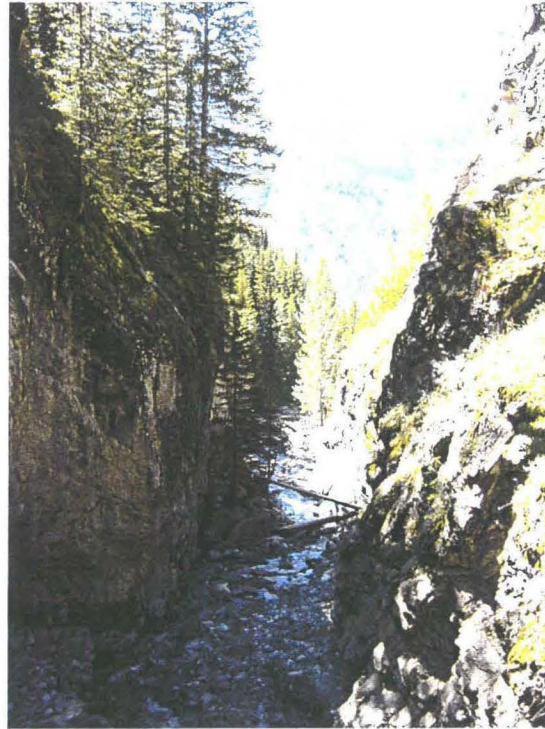
- The creek channel upstream of the highway flows through a narrow bedrock canyon, as shown in Photos 4 and 5. The downstream end of the canyon is located roughly 200 m upstream of the highway and it appears on the airphotos that the upstream end of the canyon is around 1000 m upstream of the highway. The segment of the channel within the canyon has “high water” marks indicating significant flow volumes and debris flowing down the channel earlier in 2005 (see Photo 5).

**Photo 4** (upper right) – The creek channel upstream of the highway is typically confined within a narrow bedrock canyon. This photo shows a typical view of the channel near the outlet of the canyon, approximately 200 m upstream of the highway.

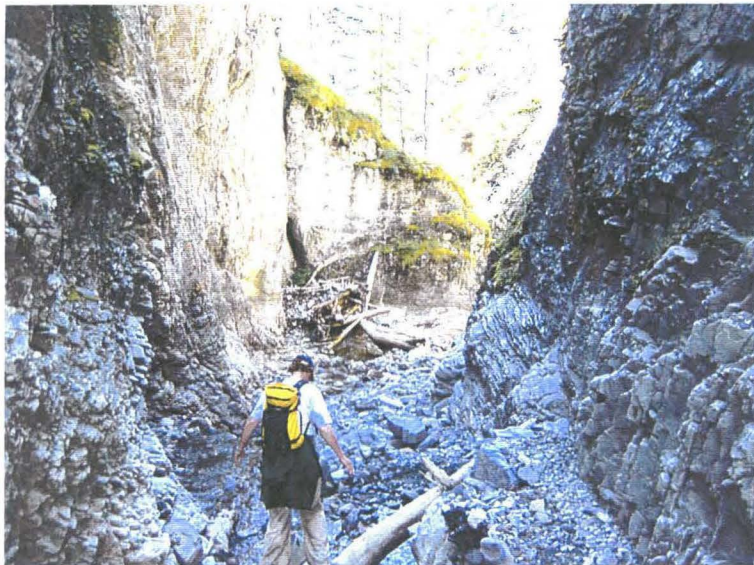
**Photo 5** (lower left) – Facing upstream along the segment of the creek channel confined within a narrow bedrock canyon. Note the volume of rock and wood debris present along the channel. The canyon walls also show a “high water” mark that was likely from peak flows during June 2005.
