CG25309.B

Alberta Transportation  
2<sup>nd</sup> Floor, 803 Manning Road NE  
Calgary, AB T2E 7M8

**Re: Southern Region Geohazard Assessment Program  
Highway 40, Rocky Creek, Hood Creek and Fortress Junction Cracking Sites  
June 2009 Inspection Report**

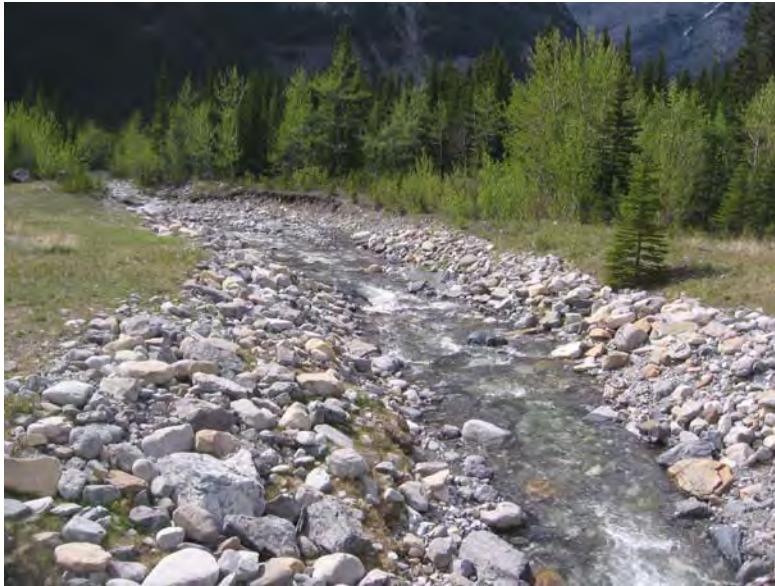
**Photo 1 (top) – June 2009**

- The creek channel was still well-entrenched into the alluvial fan deposits at the time of the June 2009 inspection, with negligible amounts of channel shifting apparent since the 2005 inspection. Photos 1 and 2 show views of the creek channel upstream and downstream of the Highway 40 bridge from the June 2009 inspection.

The assessment of little potential for unexpected or sudden shifting of the creek channel away from the bridge crossing from the 2005 inspection remains valid.

Facing downstream along the creek channel from the Highway 40 bridge. Note how the channel is well-entrenched in the alluvial fan deposits.

No further work is recommended for the Rocky Creek site. If AT would like to confirm or revise the recommended Risk Level of 24 for potential channel blockage and subsequent breaching, then an inspection of the creek channel extending well upstream of the Highway 40 crossing should be performed in order to check the channel conditions and look for evidence of past debris flows. Please refer to the 2006 report on the Highway 40 corridor review for further details.

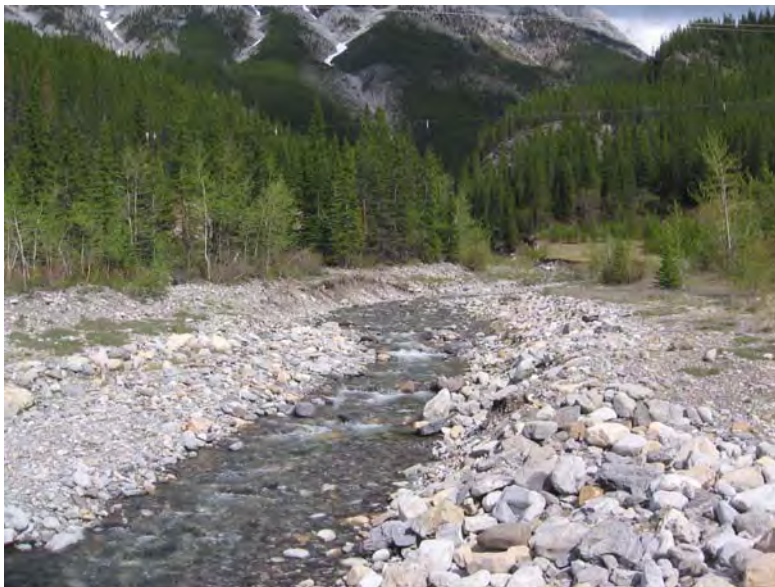
**Photo 2 (bottom) – June 2009**

Facing upstream along the creek channel from the Highway 40 bridge.

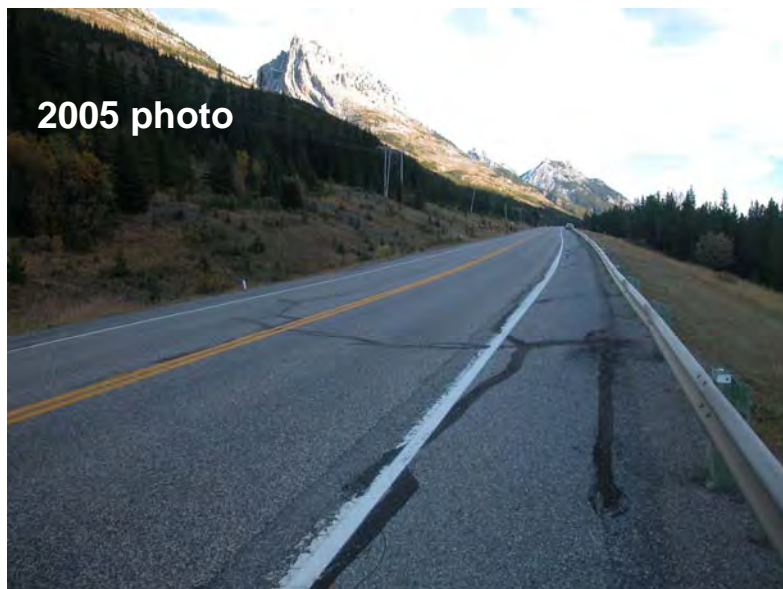
- There was little to no change in the cracking and slight dropdown of the segment of the southbound lane that was noted during the 2005 inspection. Photos 3 and 4 show comparative views of the site from the 2005 and 2009 inspections.
- No additional cracking or other damage to the road surface was noted, nor any toe bulge or visible deformation of the embankment slope below the highway.

**Photo 4 (bottom) – 2005**  
**Fortress Junction Road Cracking Site**  
The same area as shown in Photo 3, as it appeared during the 2005 inspection.

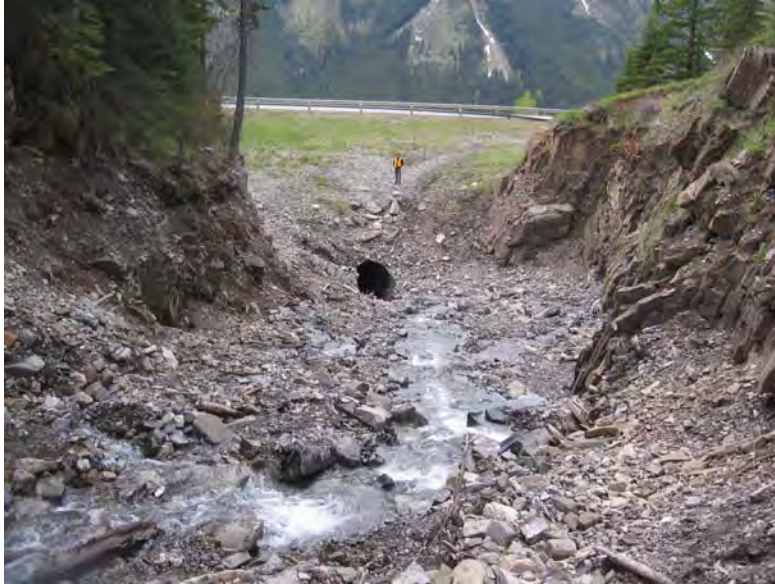
**Photo 5 (top) – June 2009  
Hood Creek**

- The creek channel upstream of the highway crossing was relatively clear of debris (Photo 5) and it did not appear that the “basin” upstream of the highway had refilled with rock and other debris since the large volume of debris was excavated out early in 2005.
- The culvert inlet was clear of debris at the time of the site inspection (Photo 6). There was some debris visible within the culvert, downstream of the inlet.
- The culvert outlet was approximately 1/3 full of debris at the time of the site inspection (Photo 7).

Therefore, the recommended Risk Level for this site is 14. This is a reduction from the Risk Level of 45 recommended after the 2005 inspection.

Facing downstream towards the culvert inlet with Highway 40 visible in the background. A large volume of debris was excavated from this “basin” upstream of the culvert in 2005. It appears that relatively little additional debris has accumulated in this area since that time.

No further inspections of this site are recommended, unless in the future AT or maintenance contractor personnel note significant debris accumulation in the "basin" upstream of the culvert inlet.

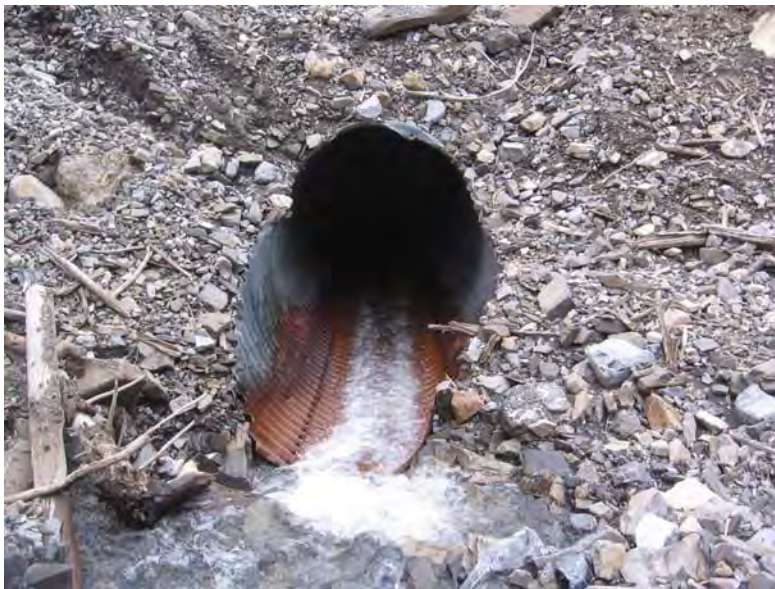
**Photo 6 (bottom) – June 2009  
Hood Creek**

For reference, at the time of the 2005 inspection, the culvert inlet and outlet were both approximately 50% blocked with debris and the culvert pipe was fully blocked with debris a few metres in from either end. The low volume of creek flow during the 2005 inspection was percolating through the debris in the culvert despite the debris blockage.

Closer view of the culvert inlet, which was clear of debris at the time of the June 2009 inspection. The inlet was approximately 50% blocked with debris at the time of the 2005 inspection, with the culvert pipe completely filled with debris a few metres in from the inlet.

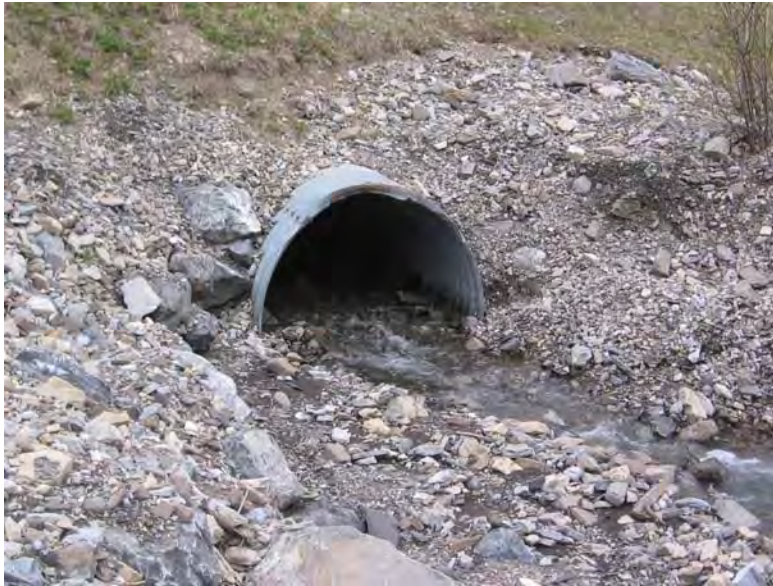
**Photo 7 (top) – June 2009**

Assuming that the maintenance contractor did not take any special measures to clear the culvert itself of debris after the 2005 inspection, it appears that most of the debris that filled the culvert at the time of the 2005 inspection was somehow eroded away by creek flows between 2006 and 2009. During the same period only nominal amounts of additional debris accumulated along the channel immediately upstream of the culvert. Such “natural flushing” of the culvert was not expected and the recommendations from the 2005 inspection included clearing the existing culvert if possible and/or installing a second culvert to act as an “emergency drain” if the culvert blockage led to impounding of water upstream of the highway. It appears that this was not actually necessary.

Culvert outlet, which was approximately 1/3 blocked with debris at the time of the June 2009 inspection. The outlet was approximately 50% blocked with debris at the time of the 2005 inspection, with the culvert pipe completely filled with debris a few metres upstream from the outlet.
