## Site 18 – Rock Cuts Between Ripple Rock Creek and King Creek

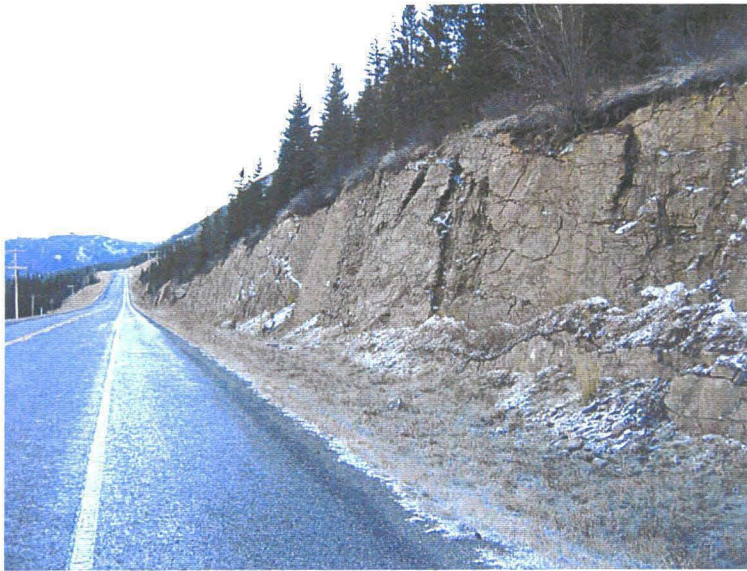
**Photo 1** (top) – Facing north along a rock cut along the east side of Highway 40, between the Hood Creek and Ripple Rock Creek crossings. These cut slopes are approximately 4 to 5 m high and the near-vertical cut face exposes westerly-dipping, near-vertical bedding planes that are parallel to the highway. Minor volumes of rockfall debris have accumulated at the toe of the cut slope over time. At the time of the inspection there were no rocks on the road or signs of damage to the pavement from previous rockfalls.

It is recommended that the accumulated rockfall debris be cleaned from the ditch as a proactive measure. In the future, the ditch should be cleaned out annually in order to maintain its full capacity.

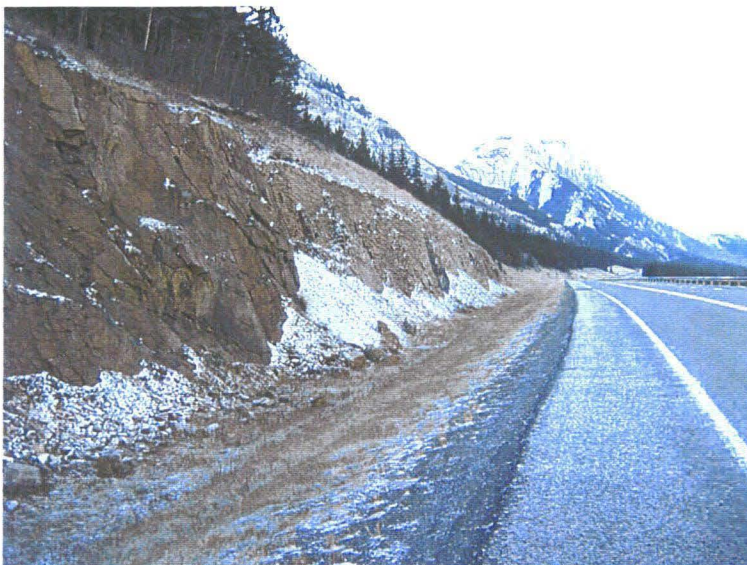
**Photo 2** (middle) – Facing south across a rock cut south of the Hood Creek crossing.

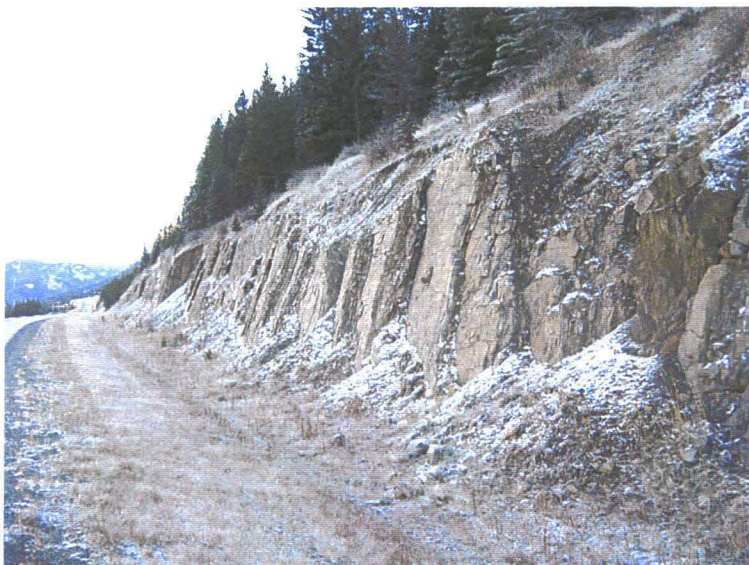
**Photo 3** (bottom) – Facing north across a rock cut south of the Hood Creek crossing. Note the relatively small volumes of rockfall debris along the toe of the slope and the relatively wide ditch.
