Site 17 – Ripple Rock Creek

The Ripple Rock Creek crossing is located approximately 4 km south of the Fortress Junction service station. The culvert at this crossing is a multiplate culvert with a diameter of greater than 2 m.

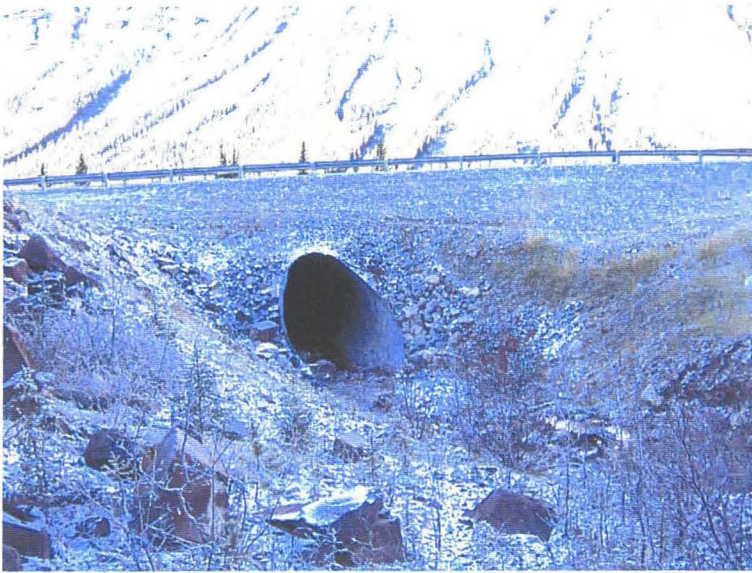
Photo 1 (top) – Facing the culvert inlet at the Ripple Rock Creek crossing. The diameter of the multiplate culvert is greater than 2 m and aside from a minor accumulation of gravel and cobbles near the inlet, it was completely clear of debris.

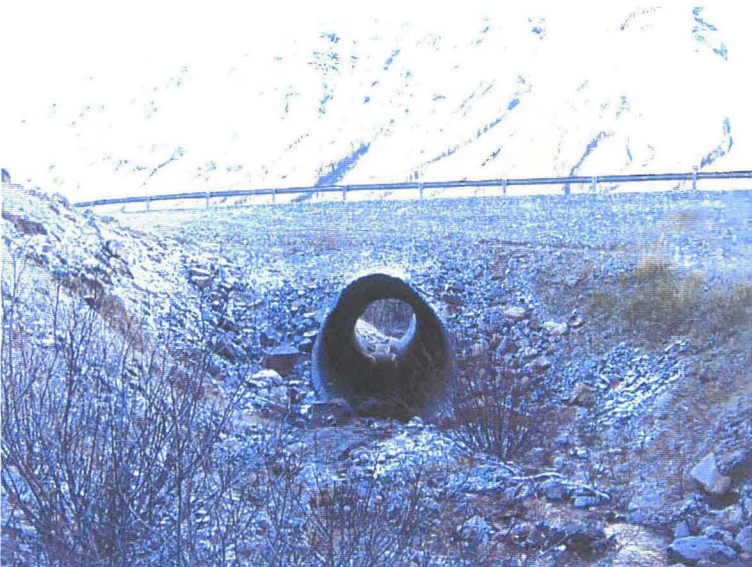
Photo 2 (middle) – Facing downstream through the culvert at the Ripple Rock Creek crossing. Note the lack of debris along the portion of the channel immediately upstream of the culvert inlet.

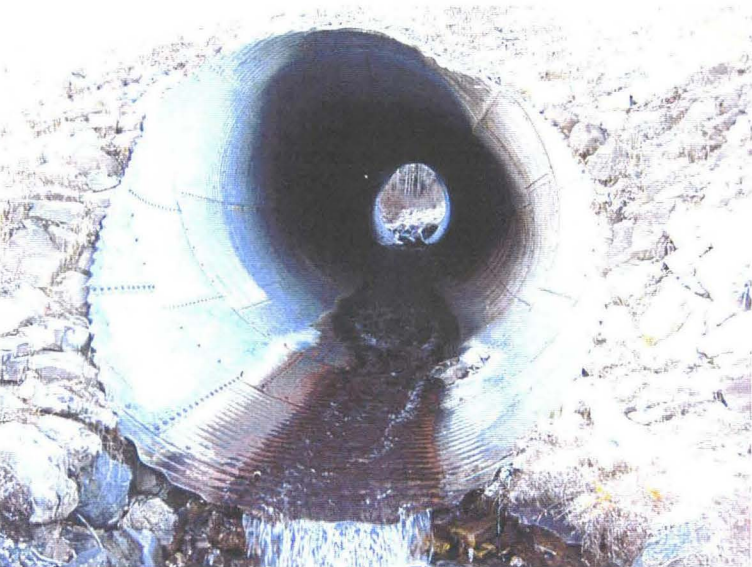
As shown on Photo 3, there is a drop-off of approximately 1 m at the culvert outlet at the west toe of the highway embankment. The channel around the culvert outlet is well-armored and the creek channel further downstream is well-incised into a natural fluvial fan further downslope, therefore it was judged that the hazard of erosion and undermining around the culvert outlet is low.

Photo 3 (bottom) – Facing upstream through the culvert at the Ripple Rock Creek crossing. There was a minor drop-off at the culvert outlet, however the channel below the culvert was well-armored and no signs of erosion that could undermine the culvert outlet were noted.
