## Site 16 – Grizzly Creek

The Grizzly Creek crossing on Highway 40 is located approximately 2.5 km south of the Fortress Junction service station and at the south boundary of Spray Valley Provincial Park. The creek is carried below the highway via a culvert of greater than 1 m diameter.

The following key observations were noted during the site inspection in September 2005:

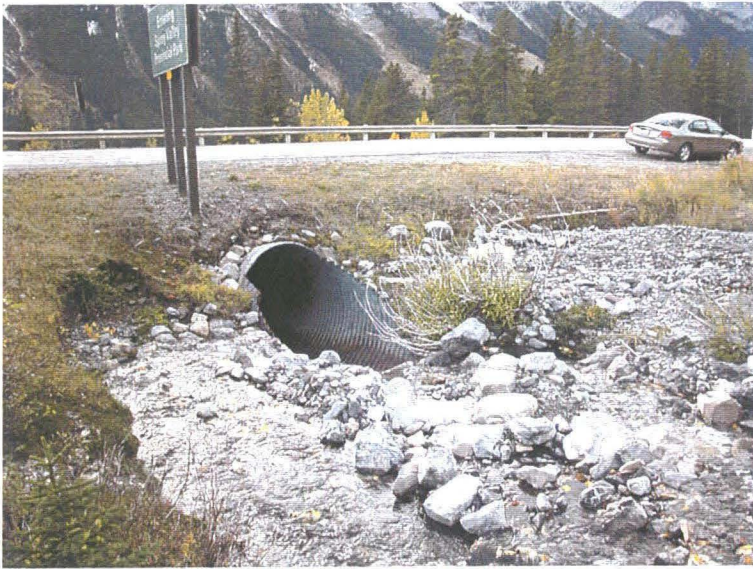
- The culvert was clear of debris at the time of the inspection. There was an accumulation of gravel to boulder-sized material along the channel immediately upstream of the culvert inlet. This buildup of material had deflected the creek flow a few metres to the south. As shown in Photo 1, this has resulted in erosion of the highway embankment sideslope immediately south of the culvert inlet.

- There was a deposit of gravel to cobble-sized debris in the ditch and on the highway embankment sideslope to the north of the culvert inlet (on the right hand side of Photo 1) that appeared to have been deposited earlier in 2005.

**Photo 1** (top) – Facing west towards the culvert inlet at the Grizzly Creek crossing. The culvert itself was clear of debris at the time of the inspection, however a buildup of gravel to boulder-sized deposits along the channel immediately upstream of the inlet had raised the elevation of the base of the creek channel above the culvert base and deflected the creek flow a few metres to the south. This has resulted in erosion of the highway embankment sideslope immediately south of the culvert inlet. Note also the granular debris in the ditch and on the highway embankment sideslope to the north of the inlet (on the right hand side of the photo) – this debris appeared to have been deposited earlier in 2005.

1. The accumulated debris in the creek channel immediately upstream of the culvert inlet should be removed so that the creek channel flows directly into the culvert.
2. The eroded area on the highway sideslope immediately south of the culvert inlet should be armored to prevent further erosion of the exposed soils. The boulders in the debris to be removed from upstream of the culvert inlet could be used for this purpose.

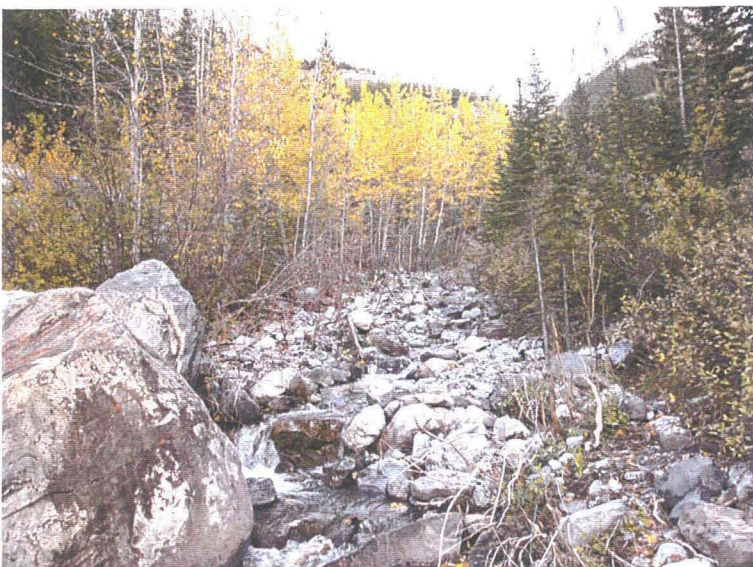
- The creek channel was traversed over a distance of approximately 200 m upstream of the highway. The creek channel is well-defined and lined with boulders (Photos 2 and 3). There were numerous areas and pockets along the channel where sand and gravel debris had been deposited on the upstream side of trees and boulders above the main flow channel. It appeared that these deposits occurred during peak flows earlier in 2005.

**Photo 2** (middle) – Typical view of the Grizzly Creek channel, facing upstream approximately 30 m from the highway crossing. The channel is well-defined and the creek flows across/around boulders. Gravel to cobble-sized particles as well as wood debris was noted along the channel. There were numerous areas along the channel where sand to gravel sized debris had been deposited on the upstream side of trees and boulders above the main flow channel – indicating peak flows earlier in 2005.

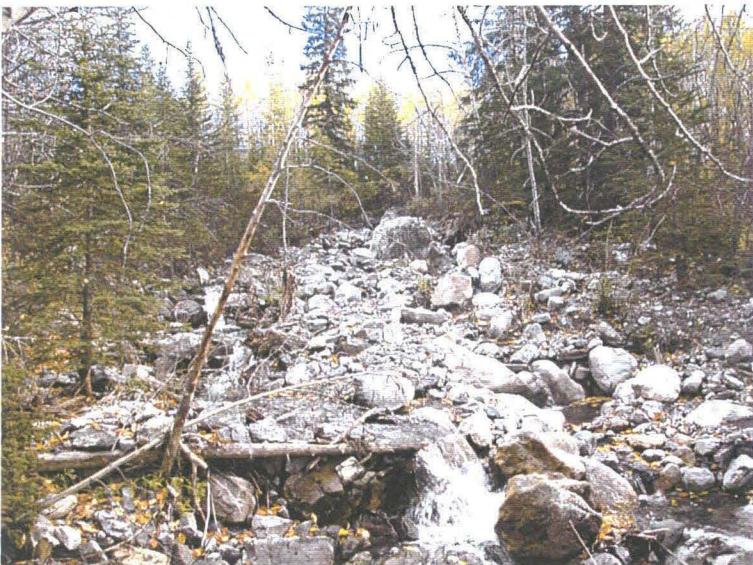
**Photo 3** (bottom) – Typical view of the Grizzly Creek channel, facing upstream approximately 100 m from the highway crossing.

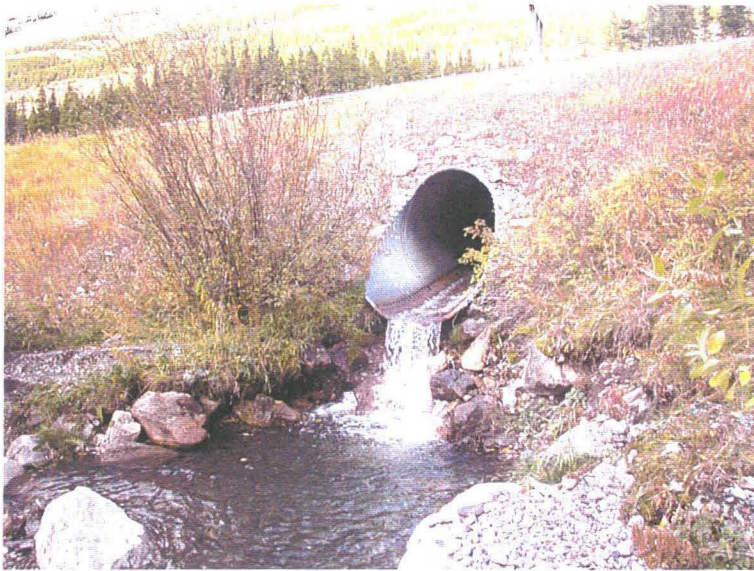
- As shown on Photo 4, there is an approximately 1.5 m drop at the culvert outlet on the west side of the highway. The channel below the outlet is naturally well-armored with boulders and the discharge from the culvert has not caused any erosion that could undermine the culvert outlet.

**Photo 4** (bottom) – The outlet of the Grizzly Creek culvert on the west side of the highway. There is an approximately 1.5 m drop at the culvert outlet, however there does not appear to have been problematic erosion below the culvert outlet to date.
