Site 13 – Creek North of Fortress Junction I

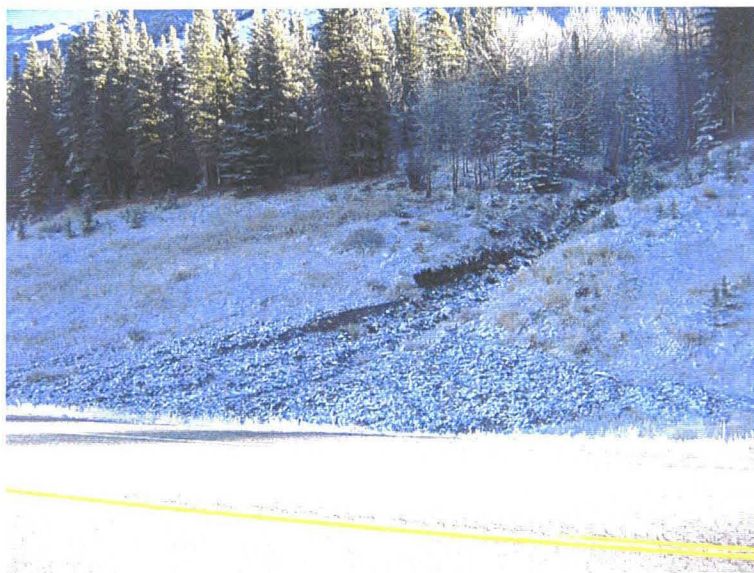
This site is located at an unnamed creek channel approximately 500 m north of the Fortress Junction service station. A fan of cobble to boulder sized debris was noted in the upslope (east) ditch and along the small creek channel above the highway during the site inspection in October 2005 (Photos 1 and 2). As shown in Photo 2, the culvert to carry the creek flow beneath the highway fill embankment is offset approximately 15 m north of the current position of the creek channel.

- Probability Factor of 9 based on the deposition of the debris fan in the upslope road ditch during the heavy rains in June 2005.
- Consequence Factor of 2 based on the assumption that if a future significant rainfall event caused a similar amount of debris to wash down the creek channel, it would build upon the existing debris fan, nearly fill the ditch and possibly begin to encroach onto the road surface.

Therefore, the recommended Risk Level for this site is 18.

Photo 1 (top) – Fan of debris that has been deposited along the upslope (east) side of Highway 40 at an unnamed creek crossing approximately 500 m north of the Fortress Junction service station. The debris consisted of cobble to boulder sized rocks that appeared to have washed down along the creek channel during peak flows earlier in 2005.

It is recommended that the debris fan in the upslope road ditch be cleared in order to restore the ditch capacity. When this is completed, the Consequence Factor can be reduced to 1 (i.e. the existing ditch should be sufficient to contain debris without it flowing onto the highway) and the Risk Level reduced to 9.

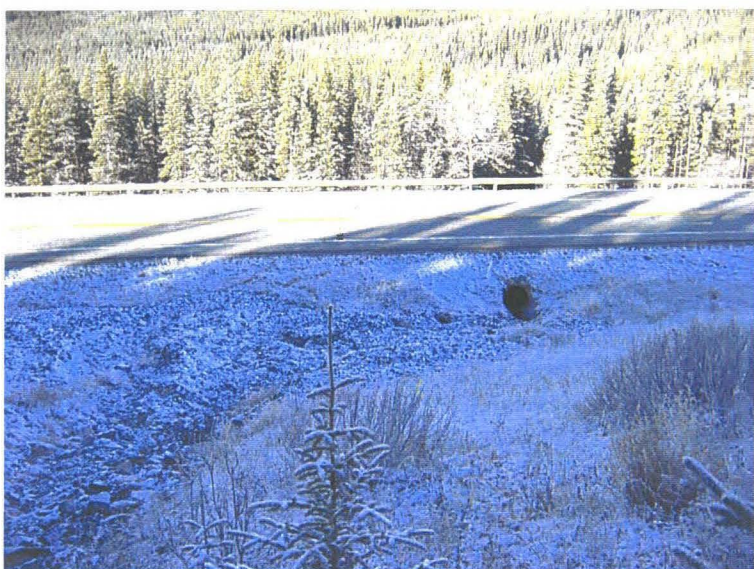
Photo 2 (middle) – Facing downstream along the creek channel. The debris fan shown in Photo 1 is on the left side of this photo. Note how the culvert inlet is offset to the north (to the right, as seen in this photo) of the current position of the creek channel.

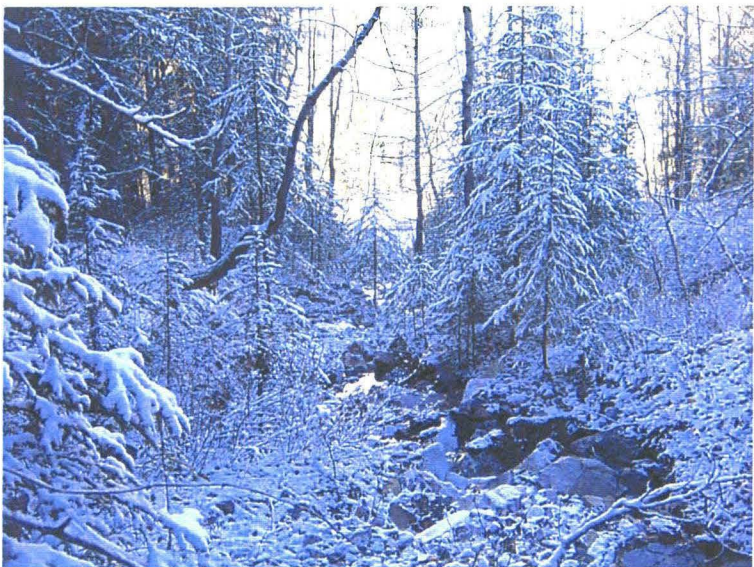
It appeared that the debris has washed down from the creek channel above the road earlier in 2005. The creek channel above the highway was traversed for approximately 300 m. The channel width typically ranged from 1 to 2 m and it was incised through the thin surficial soils and exposed boulder sized rocks (Photo 3). There were no major erosion areas noted along this segment of the channel or signs of large volumes of debris flowing along the channel that would be consistent with a debris flow event originating along the channel and depositing the debris fan in the upslope road ditch. Based on the observations during the site inspection, it appears that cobble to boulder sized rocks in the debris fan in the ditch were washed downslope from various locations along the channel during peak flows, likely during heavy rains in June 2005, rather than during a single debris flow event. The same peak flows probably caused the channel downcutting into the surficial soils between the apex of the fan and the edge of the cleared highway right-of-way.

Photo 3 (bottom) – Facing downstream along the creek channel, approximately 30 m upslope from Highway 40. The creek channel was traversed for a distance of approximately 300 m above the highway and the channel was typically as shown in this photo – a narrow channel incised through thin surficial soils and exposed boulder sized rocks.
