Site 12 – Rock Cut North of Fortress Junction

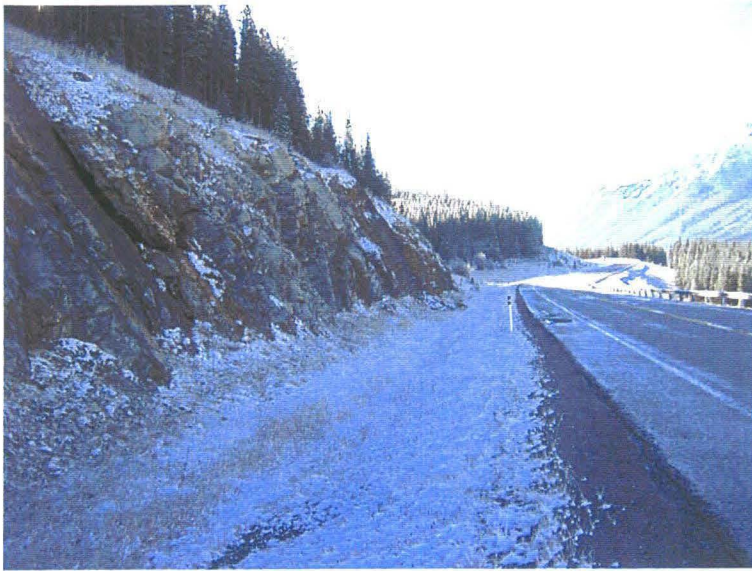
This site consist of a rock cut slope along the east side of Highway 40, approximately 1 km north of the Fortress Junction service station. The cut slope is near-vertical and approximately 8 m high. The cut slope exposes bedded rock that is steeply dipping down towards the southwest and towards the road. Photo 1 shows a typical view of the cut slope.

There were minor volumes of rockfall debris in the ditch at the time of the inspection during October 2005. The rockfall debris was deposited along the toe of the cut slope. There were no rocks in the central portion of the ditch or on the pavement. There were no signs of damage to the pavement from past rockfalls.

Photo 1 (top) – Facing south along the rock cut north of Fortress Junction. The cut slope is near-vertical and approximately 8 m high. There were minor volumes of rockfall debris along the toe of the cut slope, but no rocks on the road or signs of damage to the pavement from past rockfall.

It is recommended that the rockfall debris along the toe of the cut slope be removed annually as a proactive measure to maintain the maximum ditch capacity.

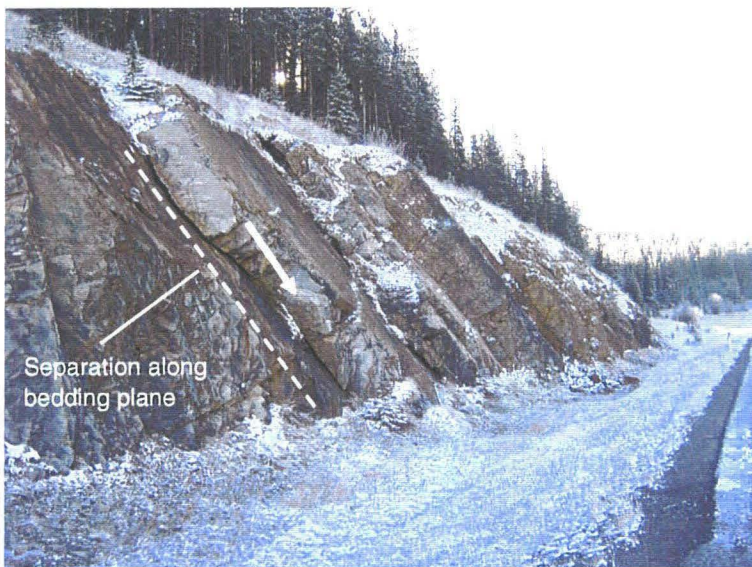
The rockfalls from the cut slope appeared to mostly originate along bedding plane contacts exposed in the cut slope. As shown in Photos 2 and 3, some of the bedding plane contacts have separated and gravel to cobble sized rocks are raveling out. Photo 3 also shows a toppling failure developing in the cut slope. These rockfalls are judged to be a minor hazard to the highway because the debris will be contained within the ditch.

Photo 2 (middle) – Closer view of a segment of the rock cut slope showing separation along the exposed bedding planes. Water will flow into these gaps and freeze/thaw effects will cause the openings to grow larger during future years and also cause rockfalls due to weathering and breakup of the outer face of the cut slope. It is judged that the debris from such rockfalls will be contained within the ditch. It is possible that boulder-sized rocks will break off and slide down along the bedding planes, but they would be contained within the ditch.

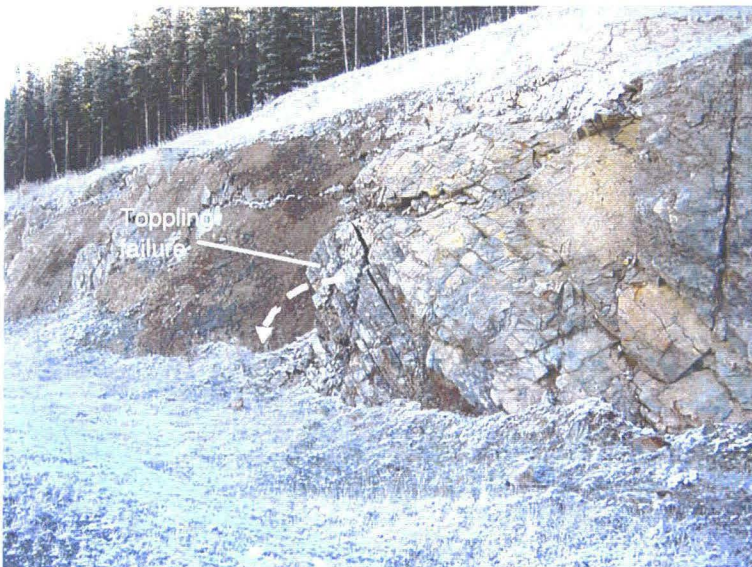
Photo 3 (bottom) – A developing toppling failure caused by cracking and weathering of the outer face of the cut slope. This, and other similar locations along the cut slope, are judged to be a minor hazard to the highway because the debris will be contained within the ditch.
