Site 11 – Creek North of Fortress Junction II

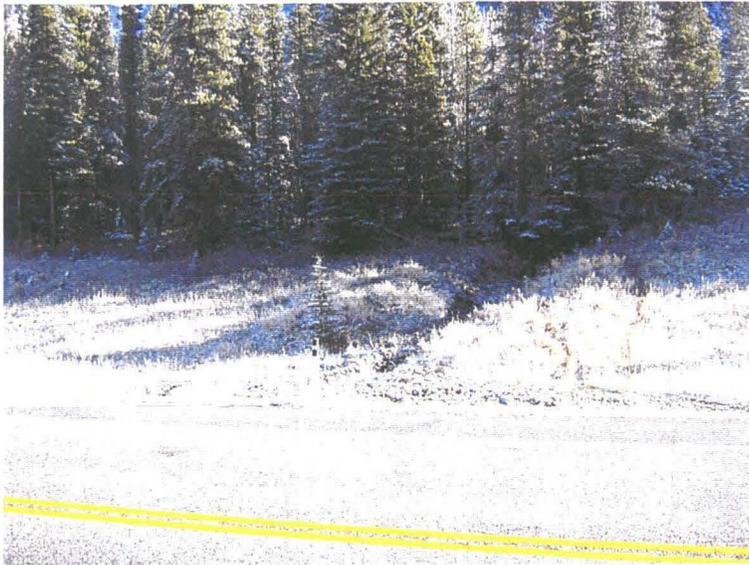
This site is located at an unnamed creek channel approximately 1.8 km north of the Fortress Junction service station. A fan of cobble sized debris was noted in the upslope (east) ditch and along the small creek channel during the site inspection in October 2005 (Photos 1 and 2). It appeared that the debris washed down from the creek channel above the road during peak flows earlier in 2005. There was no surface flow along the creek channel at the time of the site inspection. As shown in Photo 2, the culvert placed to carry this creek beneath the highway fill embankment is offset approximately 10 m north of the current position of the creek channel.

There were no significant erosion areas noted along the segment of the channel that was traversed, nor were there any signs of a debris flow event that originated further upstream having flowed down the channel. It is judged that the debris in the upslope road ditch was washed downslope from various locations along the channel during peak flows, likely during heavy rains in June 2005, rather than as a single debris flow event.

- Probability Factor of 9 based on the deposition of the debris fan in the upslope road ditch during the heavy rains in June 2005.
- Consequence Factor of 2 based on the assumption that if a future significant rainfall event caused a similar amount of debris to wash down the creek channel, the debris would nearly fill the ditch and possibly begin to encroach onto the road surface.

Photo 1 (top) – Fan of debris that has been deposited along the upslope (east) side of Highway 40 at an unnamed creek crossing approximately 1.8 km north of the Fortress Junction service station. The debris typically consisted of cobble sized rocks that appeared to have washed down along the creek channel during peak flows earlier in 2005.

It is recommended that the debris in the upslope road ditch be cleared in order to restore the ditch capacity. When this is completed, the Consequence Factor can be reduced to 1 (i.e. the existing ditch should be sufficient to contain debris without it flowing onto the highway) and the Risk Level reduced to 9.

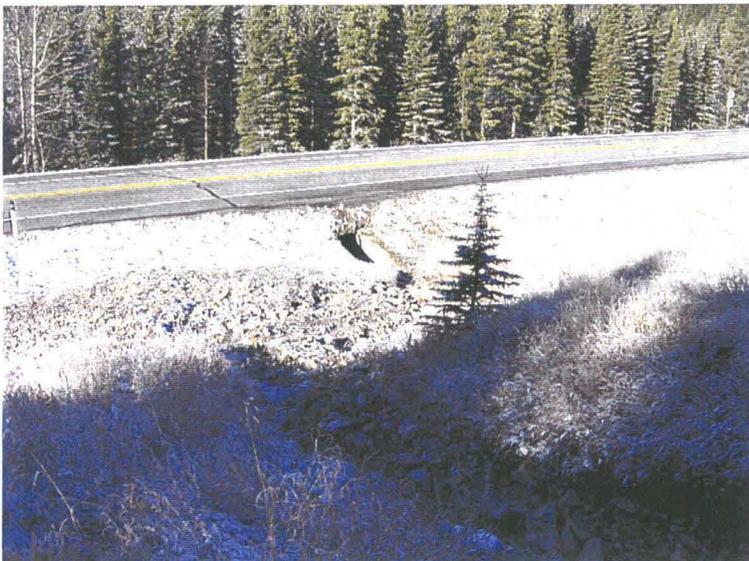
Photo 2 (bottom) – Facing downstream along the creek channel. The debris fan shown in Photo 1 is on the left side of this photo. Note how the culvert inlet is offset to the north (to the right, as seen in this photo) of the current position of the creek channel.

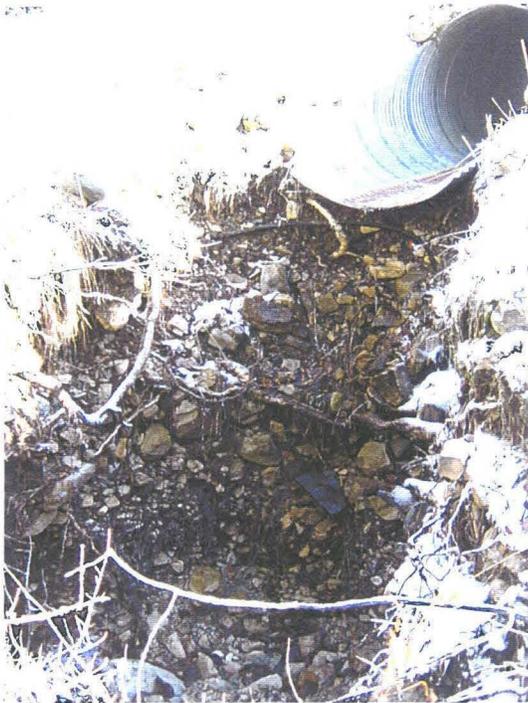
Photo 3 shows the culvert outlet at the west toe of the highway embankment sideslope. There was an approximately 1.5 m drop below the culvert outlet and some soil erosion had occurred along the channel in this area. However, no significant erosion into the sideslope had occurred and the culvert outlet had not been undermined.

Photo 3 (top) – Culvert outlet at the west toe of the highway embankment sideslope. Some erosion has occurred around an approximately 1.5 m drop-off from the culvert outlet. There has not been any significant undermining of the culvert outlet to date.
