### **Site 32 – Lineham Ridge Creek I**

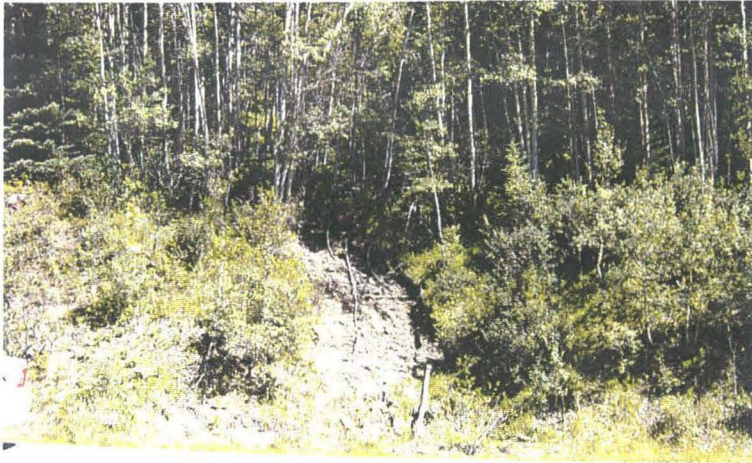
The creek crossing at the highway was inspected in August 2005. There was rocky soil exposed along the segment of the creek channel immediately above the road (Photo 1) indicating that higher flow volumes earlier in the year had caused some channel erosion just above the culvert inlet. Further upslope (into the trees above the road, as seen on Photo 1), the creek channel was relatively well-defined and incised into the natural slope face. There were no debris levees visible along the channel. The segment of the channel with visible erosion just above the highway flows across a cutslope along the northeast side of the highway that is approximately 2 to 3 m high. The inclination of the cutslope is greater than the creek channel gradient on the natural slope face further upslope, therefore the visible channel erosion is the result of the oversteepening of this short segment of the channel.

- Probability Factor of 1 based on the appearance of the creek channel. It is judged that the probability of a debris flow along this channel is very low.
- Consequence Factor of 4 because if a debris flow occurred along this channel, the existing culvert and ditch would not be sufficient to contain and convey the debris below the road and partial closure of the road for debris clearing would likely be required.

Therefore, the recommended Risk Level for this site is 4.

**Photo 1** (top) – Facing upslope across the highway at the creek crossing. The exposed soil along the creek channel indicates recent erosion (i.e. during 2005). The culvert was clear of debris and there were no signs of problems with the culvert capacity or debris accumulation.

No additional work is recommended for this site.
